Investigation of PCB Failure after SMT Manufacturing Process

An ACI Technologies customer inquired regarding printed circuit board (PCB) failures that were becoming increasingly prevalent after the SMT (surface mount technology) manufacturing process. The failures were detected by electrical testing, but were undetermined as to the location and specific devices causing the failures. The failures were suspected to be caused predominately in the BGA (ball grid array) devices located on specific sites on this 16 layer construction. Information that was provided on the nature of the failures (i.e., opens or shorts) included high resistance shorts that were occurring in those specified areas. The surface finish was a eutectic HASL (hot air solder leveling) and the solder paste used was a water soluble Sn/Pb (tin/lead).

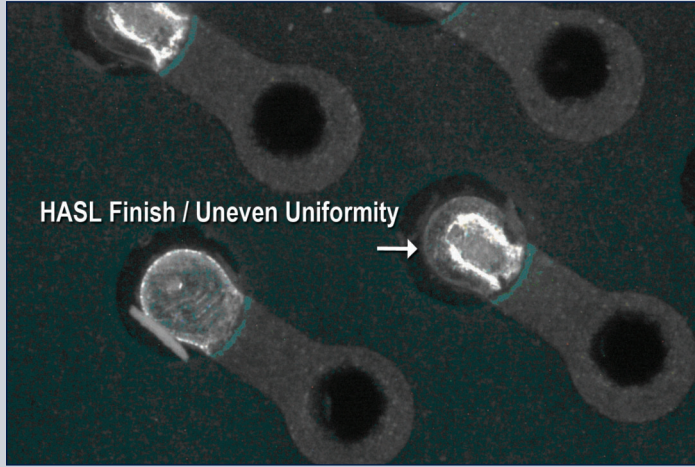
- solder mask overlap into the pad areas
- exposed copper (Cu) under the HASL surface finish
- non-uniform HASL finish in certain cases (Figure 1)

Figure 1: Non-uniform HASL finish.

The analysis of the HASL board finish indicated a non-uniform thickness, and at certain locations, the finish was thin enough to allow the underlying copper to overwhelm the alloy analysis.

The HASL surface finish is non-uniform, with exposure of copper and very thin layers of HASL in some areas.

ENIG (Electroless Nickel Immersion Gold) should be considered as a board surface finish instead of HASL, if available. It is the most common finish for BGAs, and would eliminate the non-uniform surface finish.

Application of a more uniform HASL surface will assure complete coverage of the underlying pad and will alleviate the exposure of the underlying copper, while reducing the risk of oxidation.

The HASL bath should be analyzed to determine if contamination exists from excessive metals and other residuals from the soldering process.

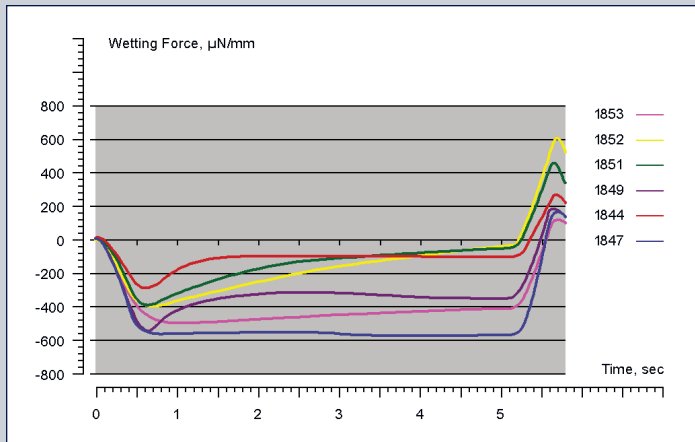
The wetting balance test showed significant issues with the wettability of the HASL board at various locations (Figure 2 on next page). Criteria from IPC J-STD-003 suggest time to buoyancy corrected zero, T_0 (where the wetting force goes positive), should be less than 1-2 seconds. In every sample tested, T_0 was greater than 5 seconds.

The wettability of the HASL board is well below the recommended wetting criteria as specified by the IPC specifications and can be a primary concern during assembly. Residual oxides on the surface of the HASL may prevent proper wetting, or form weak intermetallic interfaces when reflowed. The type and amount of oxide residue can be ascertained through SERA (Sequential Electrochemical Reduction Analysis).

Figure 2: Wetting balance curves showing $T_0 > 5$ seconds.

Reducing the liquidus time by 30 seconds may help alleviate excessive formation of oxides on the solder.
