THE PROXIMITY OF MICROVIAS TO PTHs AND ITS IMPACT ON THE RELIABILITY

Abstract

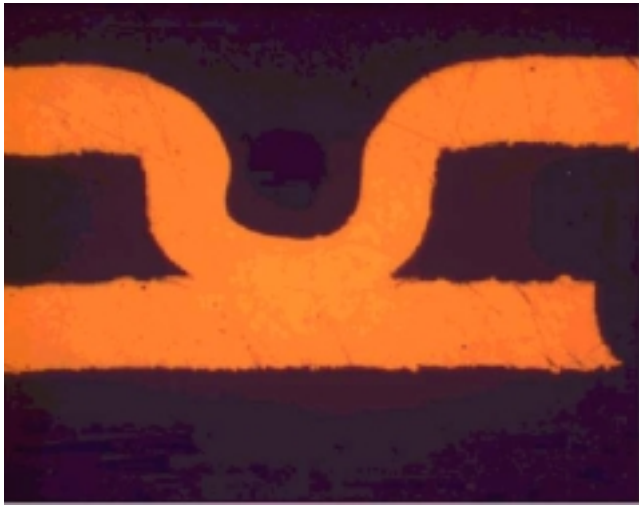
[Figure 2a](#) shows a cross section of a YAG drilled microvia fabricated by Vendor D. Vendor D used only the YAG laser to fabricate vias. The build-up dielectric layer in the boards from Vendor D was non-reinforced (no glass fibers in the epoxy dielectric). The effect of the dielectric material used and the via formation technology on the failure mechanism is summarized in the [Table 1](#).

a. Cross Section of a YAG Laser Drilled Microvia from Vendor 1

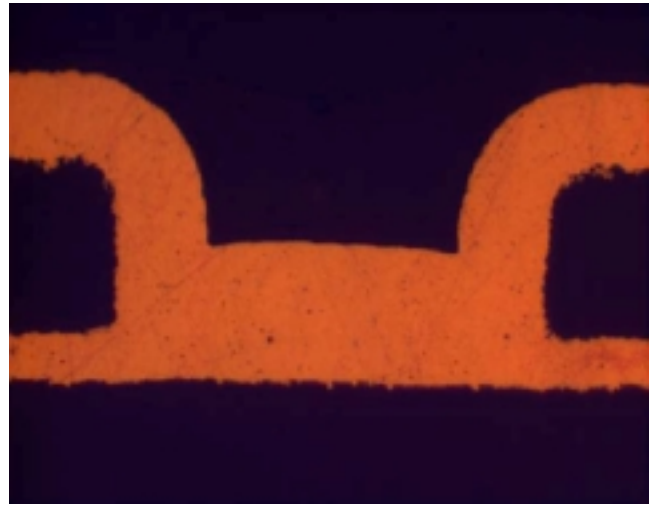
Vendor L provided photodefined microvias for reliability evaluation. The boards from Vendor L were based on IBM's "Surface Laminate Circuit" (SLC[®]), sequentially laminating photoimageable dry film dielectric layers over a multilayer FR-4 sub-composite. [Figure 2b](#) shows a cross section of a microvia from Vendor L. It is observed in this cross section that the via wall angles are rather straight. The straight via wall is characteristic of the photo process.

b. Cross Section of a Photo Processed Via from Vendor 4

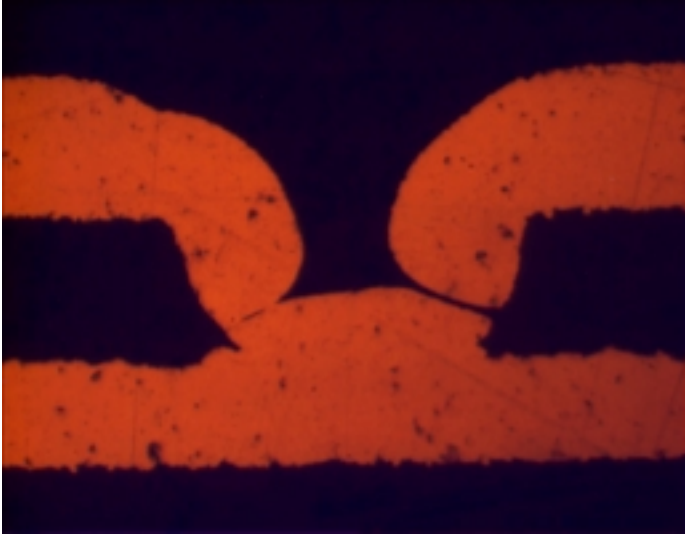
Figure 3a shows the cross section of a time zero via failure that had a break in the hole wall by Vendor D. This could be due to the entrapment of air bubbles during plating or the improper cleaning of plating resist residue. Figure 3b shows the cross section of an improperly plated via that resulted in a time zero failure in a board from Vendor D.

a. Cross Section of a Via with a Break in the Hole Wall (Time Zero Cross Section)

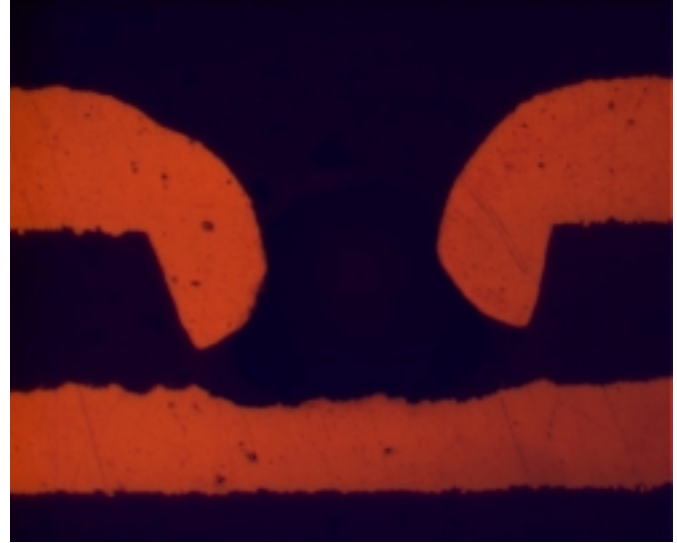
b. Cross Section of an Improperly Plated YAG Laser Drilled Via from Vendor 2 (Time Zero Cross Section)

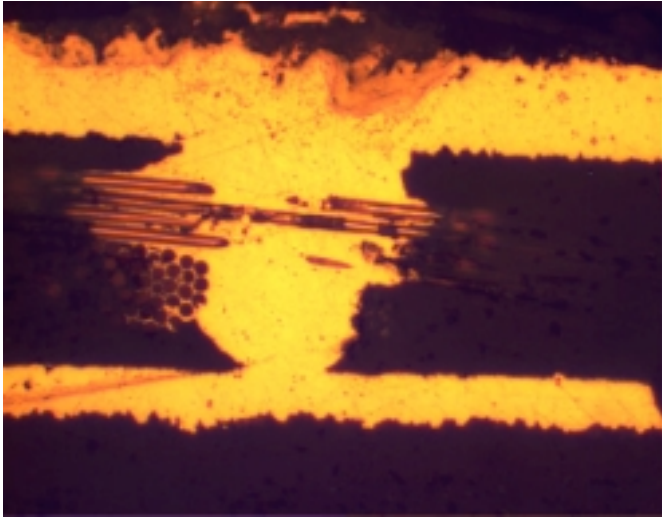
To understand the failure mechanisms, cross sections of the failed samples are presented in the following sections. Figure 5 shows the cross section of a failed microvias after different stages of LLTS cycles. Figure 5a shows the cross section of a failed microvia after 1100 LLTS cycles. This via was at a distance of 40 mils from a 20 mil PTH. It should be recalled that Vendor M used a YAG and a CO₂ laser to fabricate microvias. The CO₂ laser possesses high energy that debonds the glass fibers from the glass reinforced composite. The presence of fibers debonded in the via area has led to the migration of plating along the fibers. The via structure at a distance of 5 mils (center to center distance of 27 mils from 20 mils PTH) from a PTH was examined to check for possible shorts to the PTH due to migration of plating along the debonded glass fibers. Although bias testing has not been performed, continuity testing of the unbiased samples showed no cases of migration or bridging.

a. Failed Microvia at a Distance of 40 mils from a 20 mil PTH after 1100 LLTS Cycles

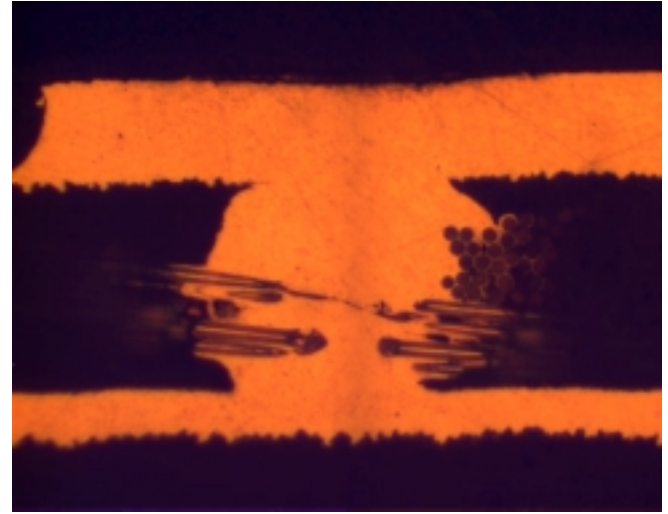
To determine the failure mode after 2000 LLTS cycles, failed samples were cross sectioned and analyzed. Figure 5b shows the cross section of a via at a distance of 40 mils from a 50 mil PTH that failed after 2000 LLTS cycles. A crack can be seen through the via that caused the high resistance value. It is important to note that vias at a distance of 40 mils failed earliest. In addition, cracks can be seen in the cross section. As the testing progresses, these cracks propagate and lead to failures as shown in

b. Failed Microvia at a Distance of 40 mils from a 50 mil PTH after 2000 LLTS Cycles

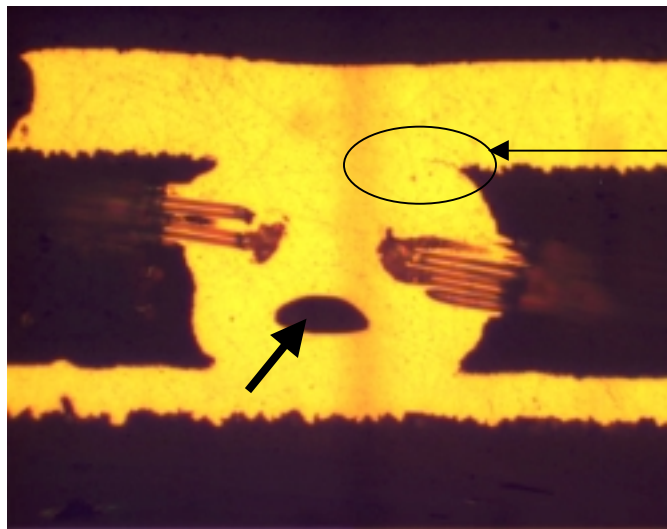
Figure 5c. This figure shows the cross section of a via at a distance of 40 mils from a 50 mil PTH. A void in the plating can be seen in the cross section. In addition, cracks propagating from the periphery can be seen in the cross section.

c. Cross Section of a Via Showing a Void in the Copper Plating

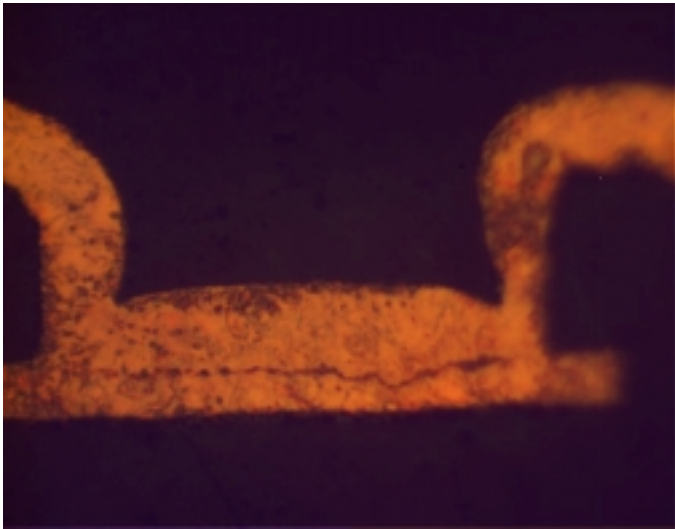
Figure 7 shows cross sections of a microvias from Vendor L after different stages of LLTS testing. Figure 7a shows a failure in a via at 40 mils from a PTH. The cause of failure was found to be a crack at the via-pad interface. Microetching of the cross sectioned sample was carried out to make the crack more visible. It was observed that the crack was initiated at the via-pad interface. Due to a sharp corner at the via-pad interface, it becomes a high stress concentration region and is susceptible to crack initiation. It can be seen that via wall angles are straight, which is characteristic of a photo defined via. It can be observed from Figure 7a that the plating thickness at the bottom of the via is slightly less than the plating thickness at the top. This could be due to the straight via walls. Negative slope can be observed from the cross section after the plating. This might result in a break at the via-pad interface in an extreme case [Joshi, 1999]. A similar failure was observed in the via at a distance of 5 mils from 50 mil PTH after 1100 LLTS cycles. Figure 7b shows the cross section of a functional via at a distance of 5 mils from a 35 mil PTH after 2000 LLTS cycles. Uniform plating thickness can be seen from the cross section.

a. Failed Microvia after 1100 LLTS Cycles

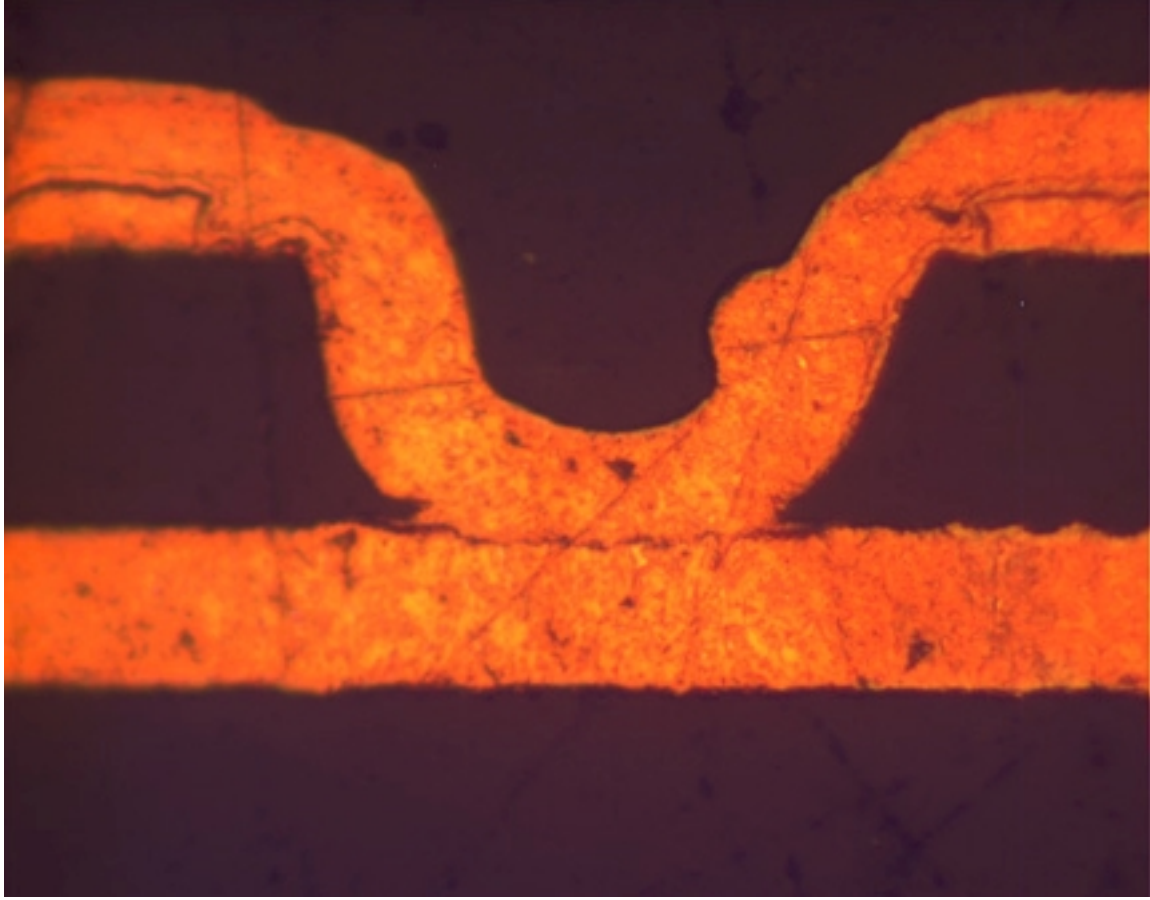
Figure 8. Cross Section of a Failed Via after 1100 LLTS Cycles

Table 4 shows the number of failed vias in samples provided by Vendor D. It can be observed from the table that only 5 failures were reported. The samples were tested for 2000 LLTS cycles. The failed via was cross sectioned to determine the failure mode. Microetching of the cross sectioned sample was carried out to make the crack more visible as shown in the Figure 8. Again, it was observed that the crack was initiated at the via-pad interface.

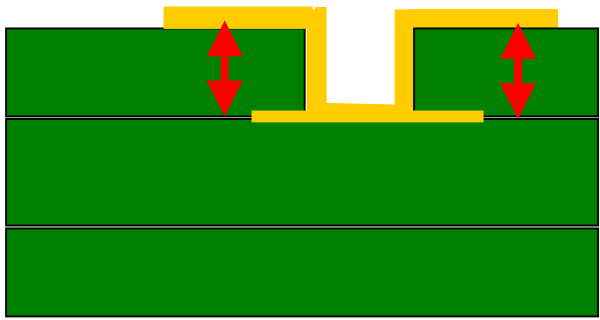
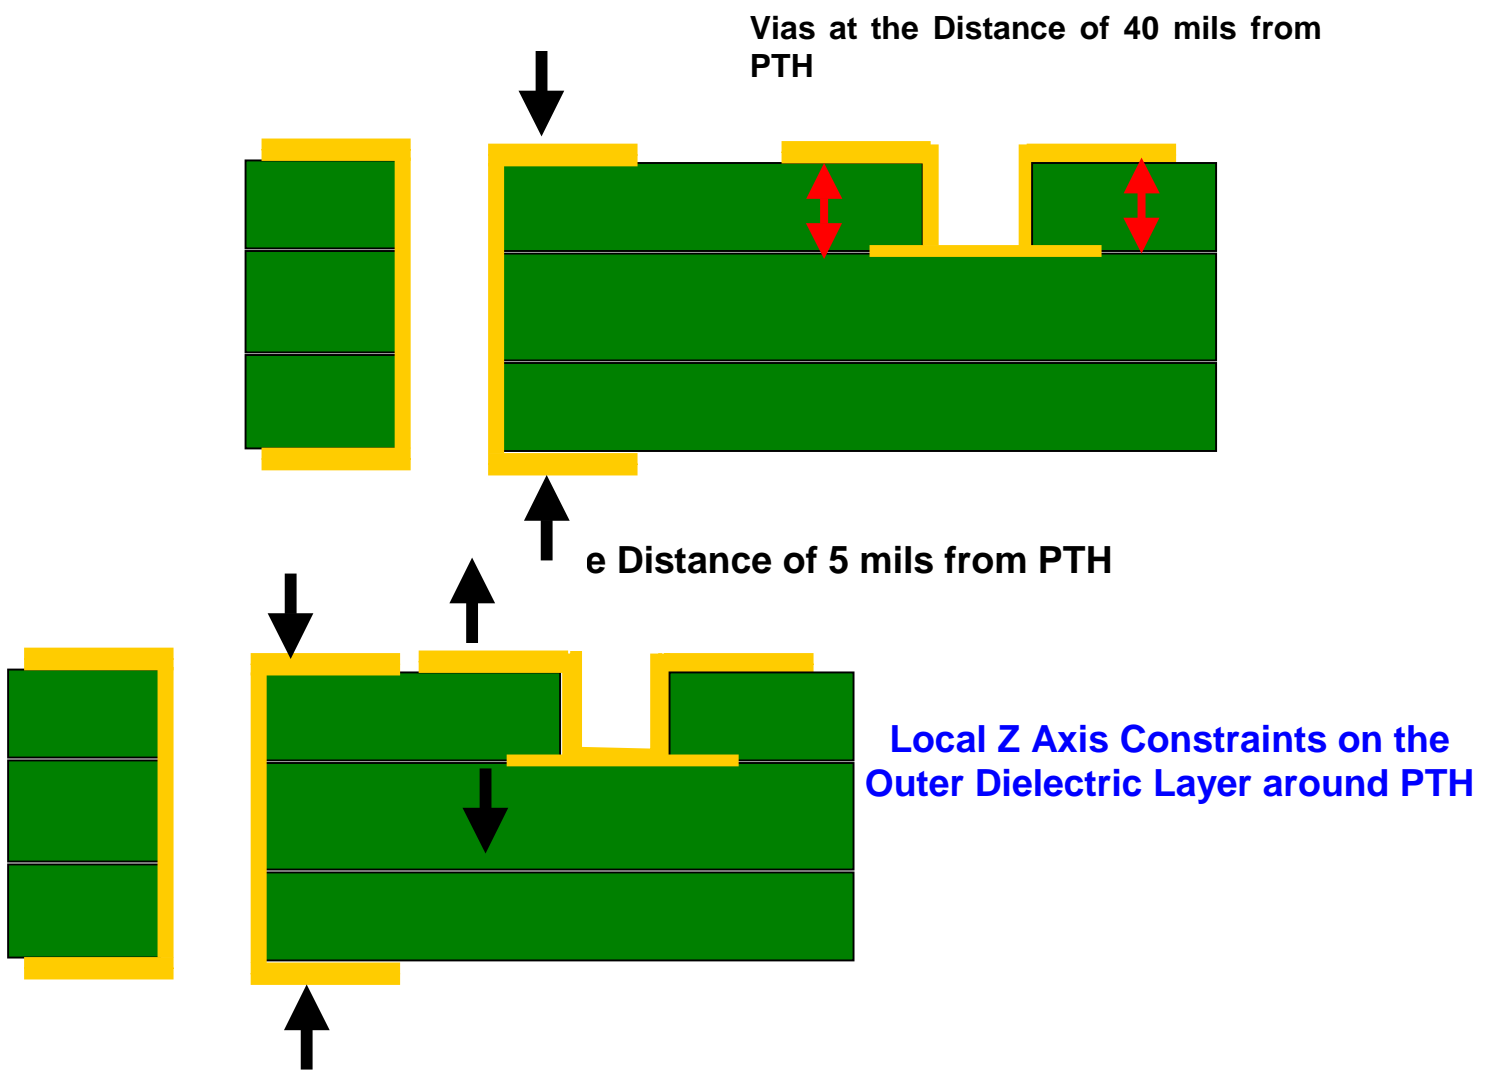
Figure 9. Failure Mechanism for the Higher Frequency of the Failures of Vias at the Distance of 40 mils from the PTH

It was observed that the vias at a distance of 40 mils from PTHs showed greater number of failures as compared to other vias. It should be remembered here that via size was held constant at 5 mils. It was observed that a crack at via and pad interface was a dominant failure mode. Figure 9 describes the mechanism behind higher frequency of failures observed in vias at the distance of 40 mils from PTH. It is proposed that the mechanical interlocking and Z-axis CTE of the copper PTH prevent the high CTE of the epoxy/glass layers from expanding. This in turn causes a local 'Z' axis constraint on the outer dielectric layers around the PTH. This reduces the occurrence of the main failure mode for microvia technology that is separation of via from the stop pad in case of vias at the distance of 5 mils from the PTH. Figure 10 shows the cross section of a 5 mil failed via near a 35 mil PTH after 1500 LLTS cycles. It can be clearly seen from the cross section that the via did not register on the stop pad and just managed to establish contact with the stop pad. A crack can be seen in the region circled in the photograph (Figure 10). It can also be seen that the YAG laser drilled down into the underlying dielectric. Additionally, the laser missed the stop pad and drilled down into the underlying dielectric layer that resulted in poor plating thickness at the bottom of the via. An inward curve can be seen from the photograph of the cross section that eventually resulted in a failure. It is interesting to see debonded glass fibers near the cracks.

Expansions Experienced by the Top Dielectric Layer Cause the Failure at Via and Stop Pad

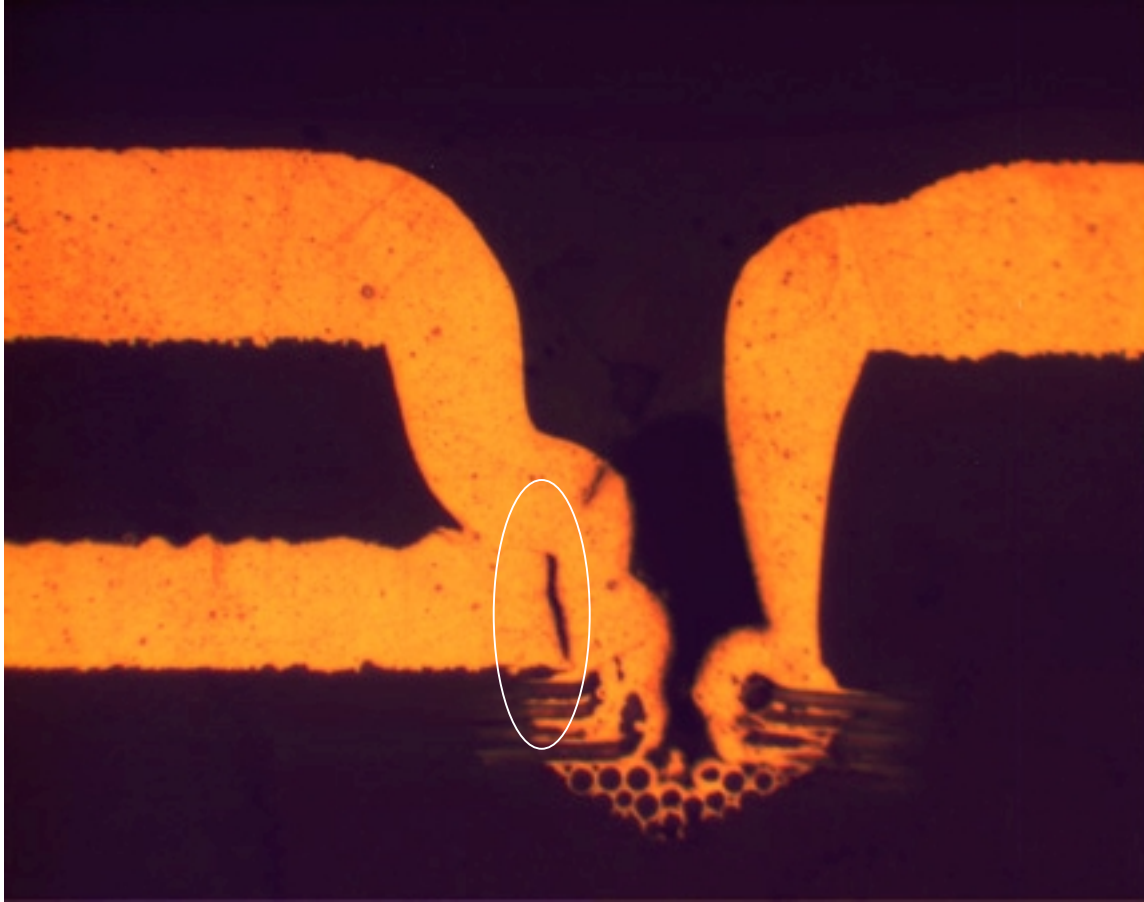
- Misregistered vias (those that just manage to establish contact with the stop pad) affect reliability and result in early failure. This was observed for only YAG laser drilled vias from Vendor D. Hence, the YAG laser parameters used by Vendor D need to be optimized.

Figure 10. Cross Section of a Via that Failed due to Misregistration to the Stop Pad
