Nondestructive Inspection of Underfill Layers Stacked up in Ceramics-Organics-Ceramics Packages with Scanning Acoustic Tomography (SAT)

Justin Zeng, Francoise Sarrazin, Jie Lian, Ph.D., Zhen (Jane) Feng, Ph.D., Lea Su,
Dennis Willie, David Geiger
Flex International Inc.
Milpitas, CA, USA
Masafumi Takada, Natsuki Sugaya
Hitachi Power Solutions Co., Ltd.
Tokyo, Japan
George Tint, Ph.D.
HDI Solutions, Inc.
Santa Clara, CA, USA

Ceramics packages are being used in the electronics industry to operate the devices in harsh environments. In this paper we report a study on acoustic imaging technology for nondestructively inspecting underfill layers connecting organic interposers sandwiched between two ceramics substrates.

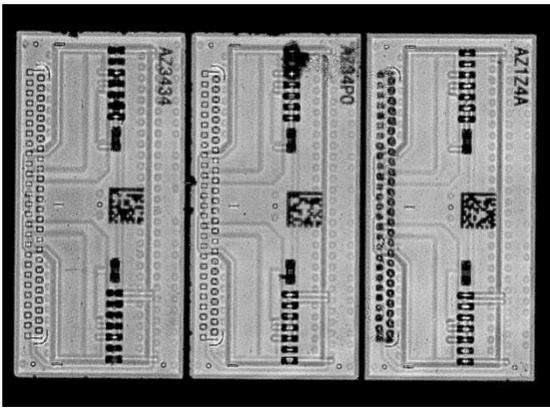
Figure 7(a). C-scan image from Gate #1 representing bottom layer of HTCC1 at 100MHz probe frequency. All 3 units show very similar images, except the shadow of misplaced surface mount condenser is seen differently at the center unit.

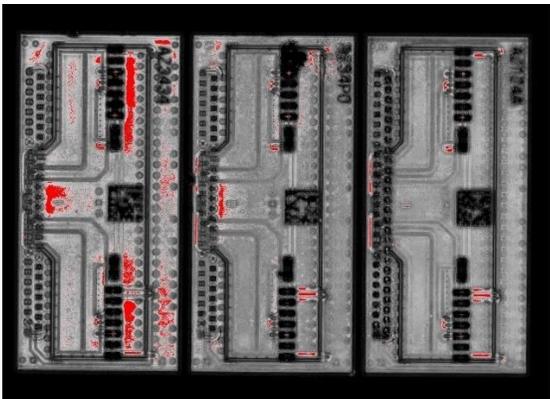
Figure 7(c). C-scan image from Gate #3, UF1 and polymer 1 Interface at 100MHz probe frequency. The inspection algorithm is set so that red color paint will highlight whenever a delamination or void is detected. Serious flaws can be seen in the left middle of the left most unit possibly from UF1.

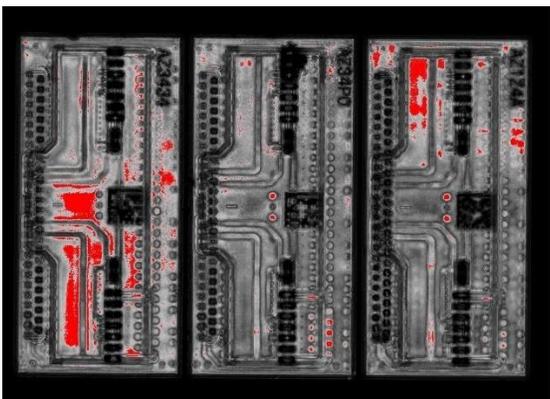
Figure 7(d). C-scan image from Gate #4, top of UF2 at 100MHz probe frequency. Both Left and Right units show significant delamination or less dense material regions as highlighted by red color. UF1 and some part of UF2 have flaws.

Recalling the images on Figures (2) to (5), the right side sample is the one we emphasize in this capability study with electrical fails at unknown area. The SAT inspection of this sample indicates that while upper underfill layer is free from flaws, top left corner of lower underfill layer (UF2) has delamination as shown in Figure 7(d). This flaw area is also appeared in Figure 7(e) at the attachment to the surface of HTCC2. All these flaw locations can also be confirmed by taking multiple synchronized A-scan waveforms of interested locations on the samples and by comparing their peak heights.

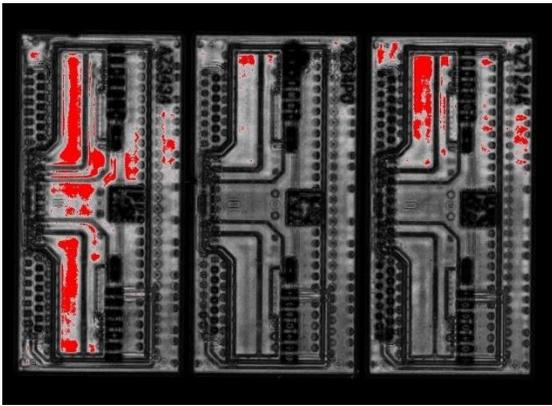
Figure 7(e). C-scan image from Gate #5, UF2, organics interfaces at 100MHz probe frequency. Both Left and Right units show significant delamination or less material regions.

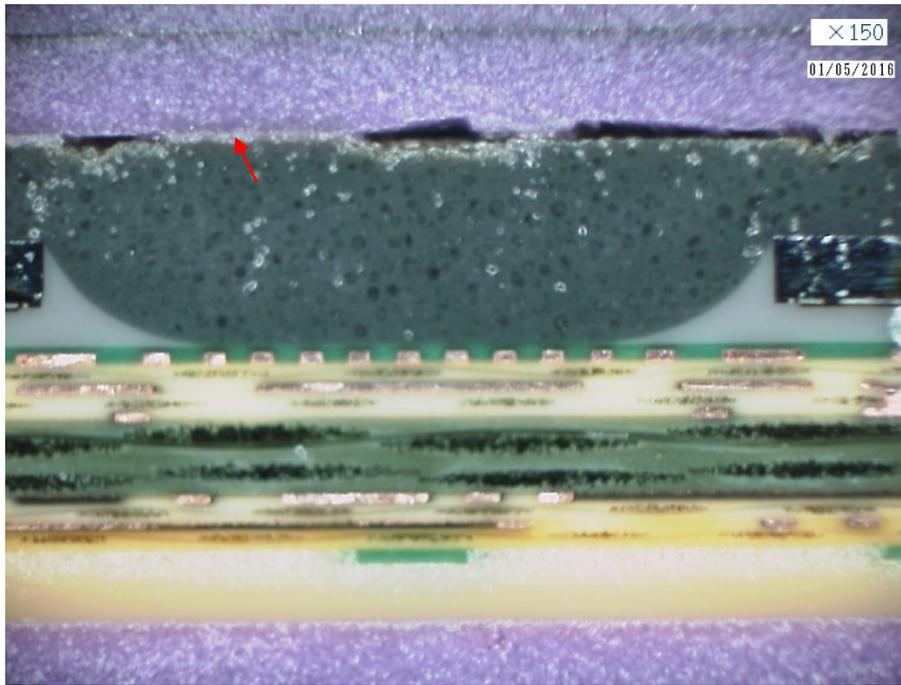
We have selected the left most package of Figure 7 which showed delamination flaws from the top to the lower polymer layer to cross-section if we can confirm the flaws highlighted by red color. As expected the upper layer flaws at the center of the device are clearly observed under 150 x optical microscope as shown in Figure 8.

Figure 8. Cross section image of center region with 150x optical microscope

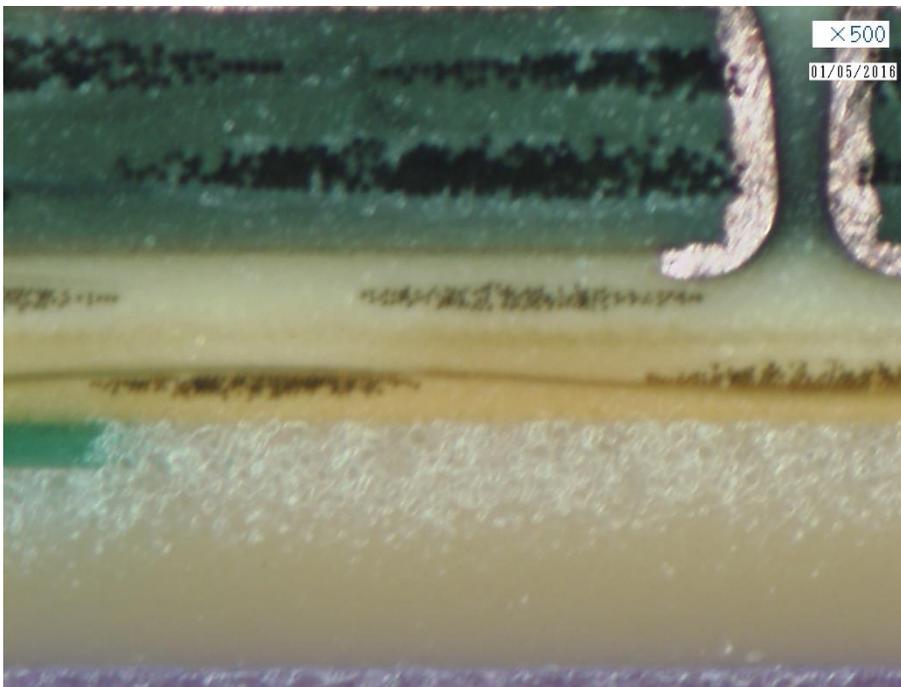
The delamination at lower level are somewhat difficult to distinguish optically at 150 x, and required higher magnification and image comparison. We carefully have inspected lower level joints at higher magnification up to 500 x as well as by comparing with images of similar location of a different part. We noticed stronger contrasts at the boundary indicating a signature of thin delamination at the stack-up joint.

Figure 9. Cross section image of center region with 500x optical microscope, the lower level delaminations are somewhat difficult to distinguish by optical cross sections.

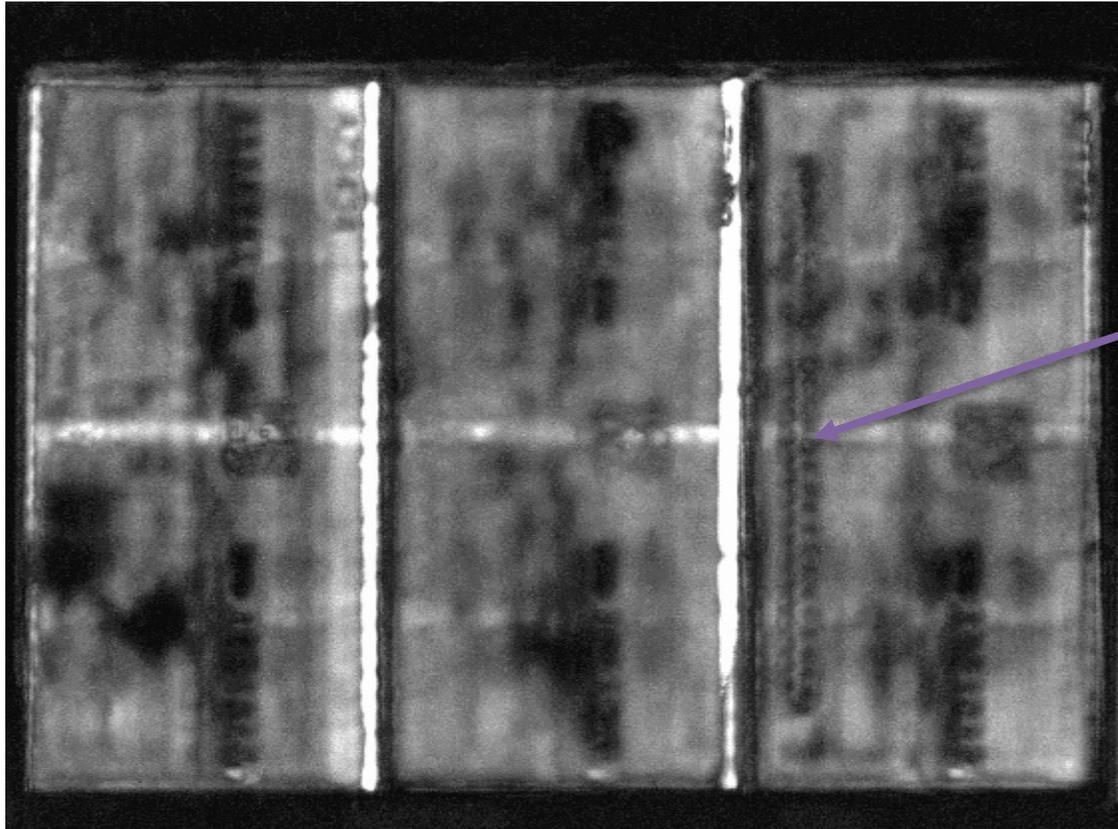
Desoldered joints

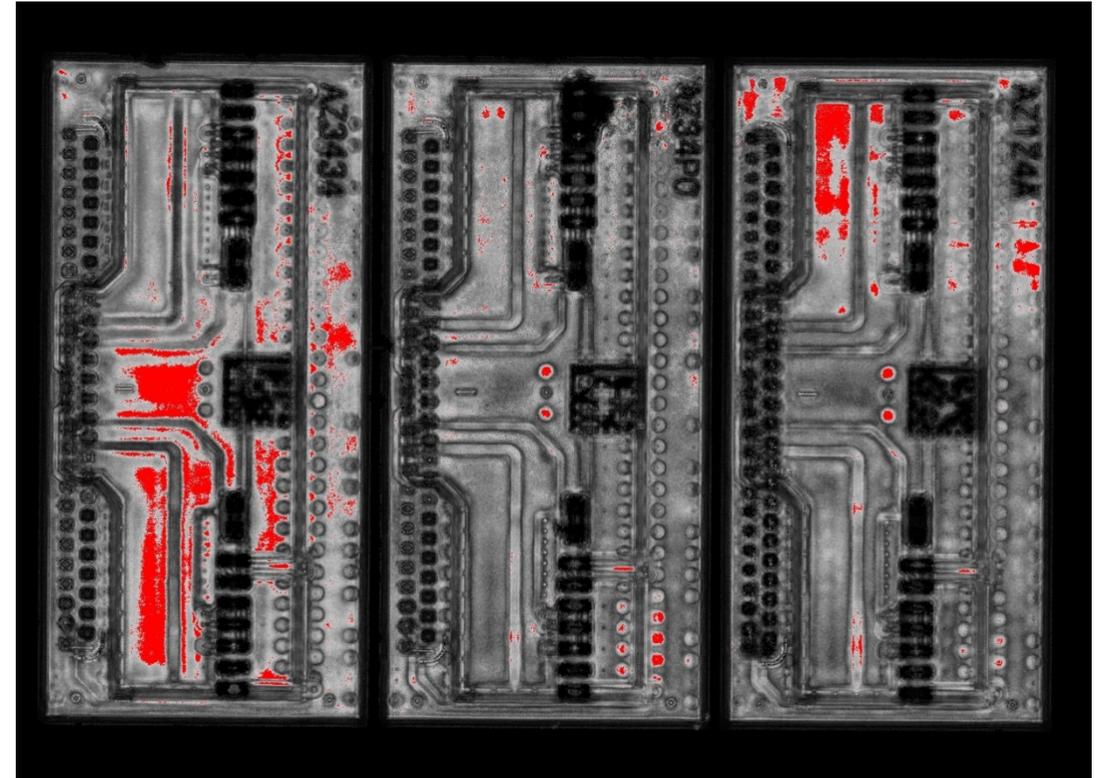
Gate 4

UF1 layer flaw regions are highlighted by red color

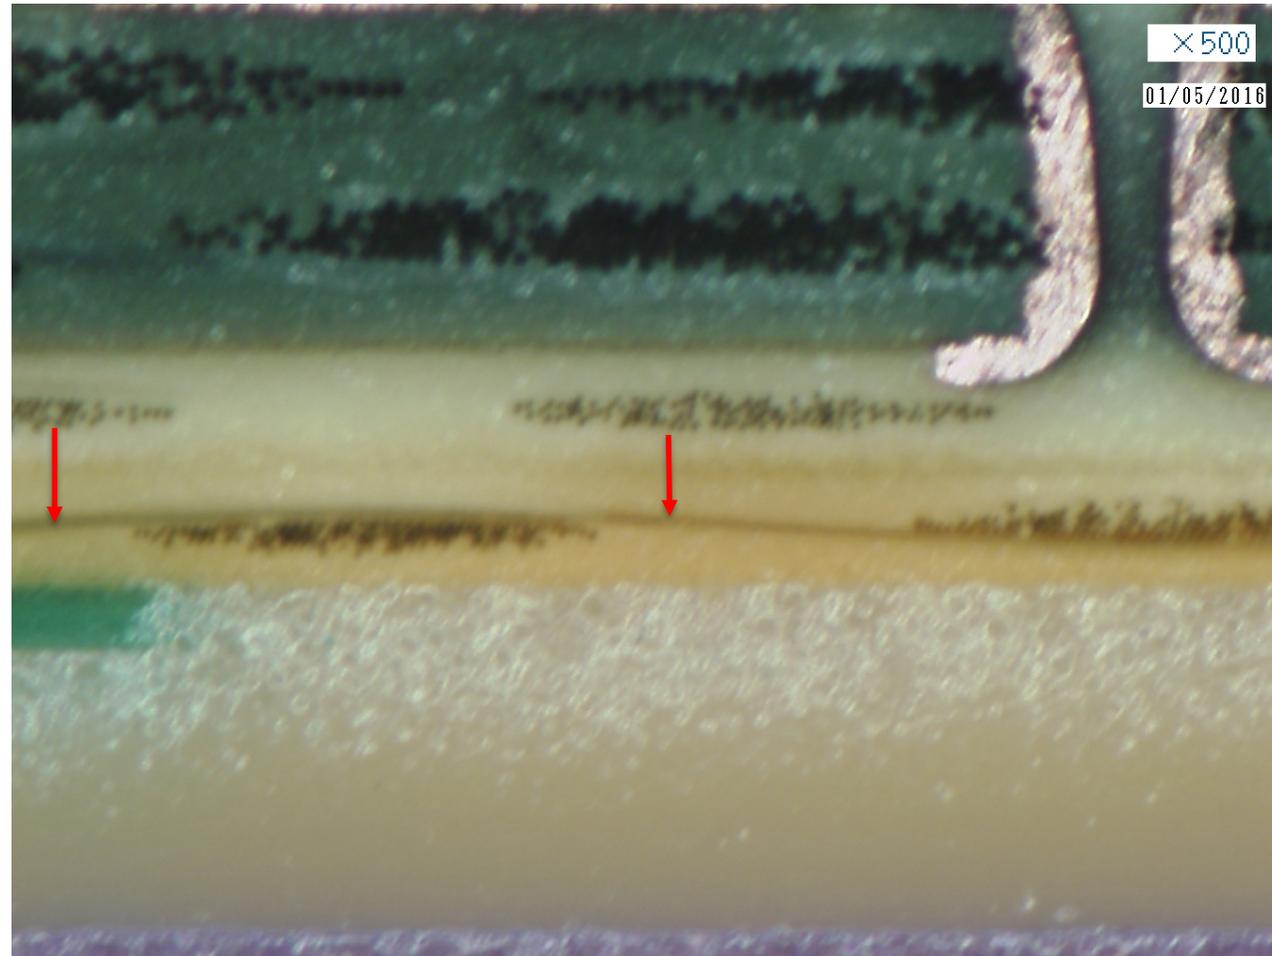
Deeper layer/ difficult to distinguish optically

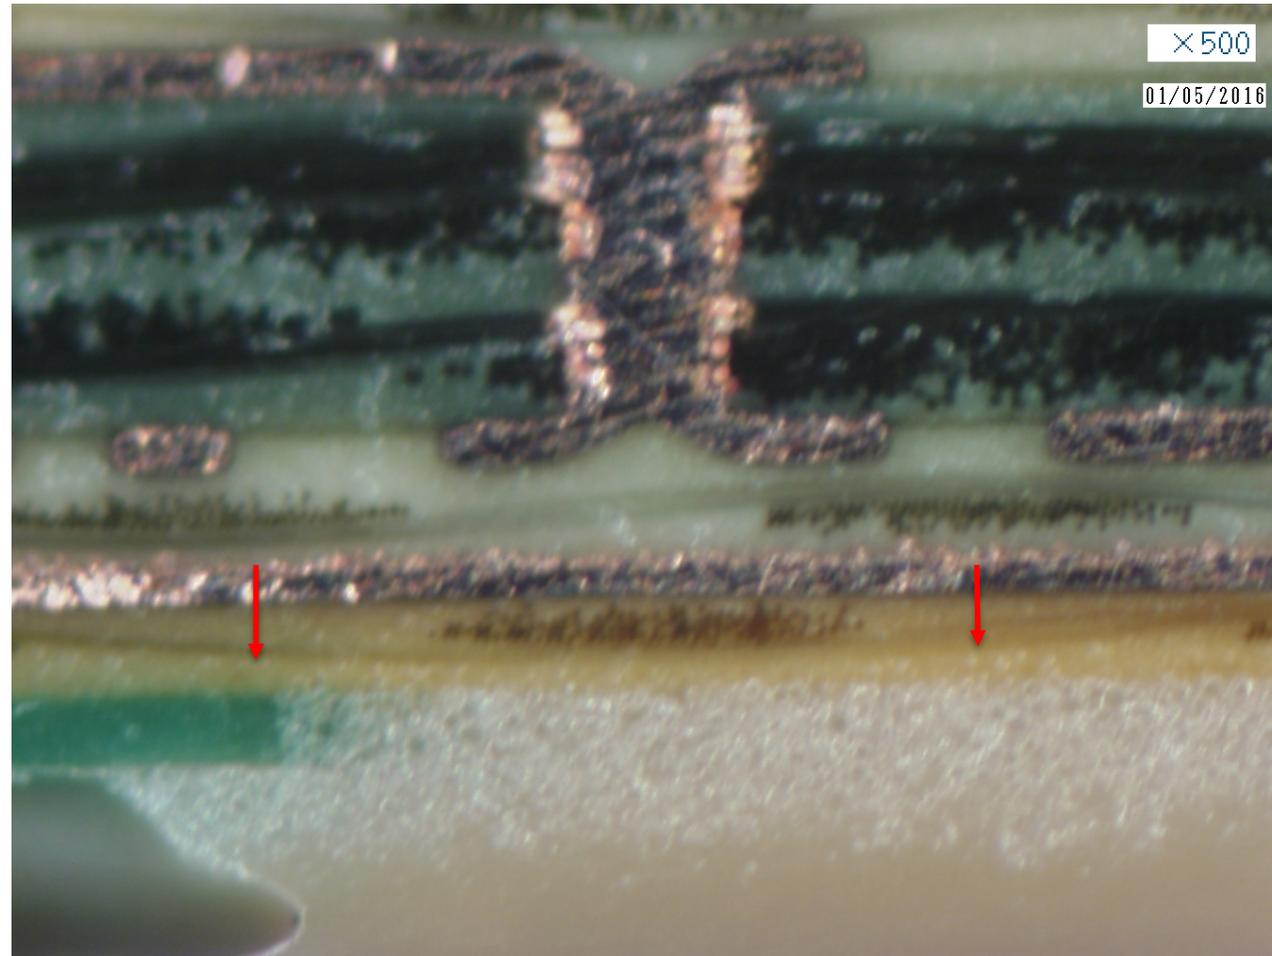
Deeper layer/ good joint
