BLACKPAD REVISITED

M. Simard-Normandin, C. Banks MuAnalysis Ottawa, Ontario, Canada martine@muanalysis.com

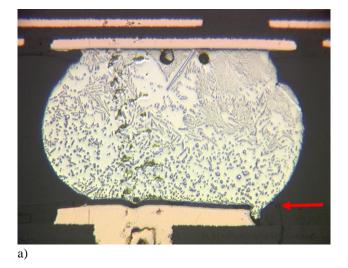
Many techniques are available, each with strengths and weaknesses. X-Ray imaging detects solder bridges, missing solder, voids, but is not so good at detecting cracked solder, as explained in Figure 1. Acoustic microscopy detects delamination inside a component and bowing but cannot see a cracked BGA ball because the BGA substrate has too much absorption. Failure analysis techniques are good at detecting excess current because that generates heat or light. When it comes to opens, since there is no signal, there is no tell tale signature. One needs to resort to electrical tests for continuity if possible, do Dye and Pry or cross-sections, which are both destructive. SQUID (Superconducting Quantum Interference Device) analysis is very expensive and quite difficult to interpret.

Figure 1. Why are BGA cracks so hard to see? a) Crosssection optical image of a ball separated on the board side. The viewing direction for optical microscopy (before cross-section) is indicated by the arrow. Along the edge of the package, the solder wraps around the edge of the solder pad hiding the crack from view. b) Cross-section SEM image of a ball separated on the component side. Even if optical inspection had been possible, the crack is hidden by the solder mask. Encapsulation epoxy has been used to prepare these parts for cross-section. The epoxy expands during curing opening up existing cracks. Before encapsulation the cracks were most likely closed, remaining hidden to X-Ray examination.

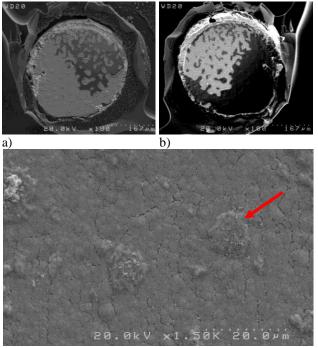
Figure 6. a) SEM image of a board pad after Dye and Pry test. Approximately half of the pad is covered with dye (darker region). The rest of the dye adhered to the solder ball during the pry. b) SEM image of the partially dyed

solder ball remaining on the component after Dye and Pry. c) Higher magnification image of the light region on the board pad.

Mud cracks are present overall and there are small clumps approximately $10\mu m$ across (red arrow, Figure 6c). These are small regions of intermetallic formation. EDX (Energy Dispersive X-Ray) analysis of the mud crack region reveals a high level of phosphorus, attributed to the formation of the Ni₃P layer at the nickel surface.

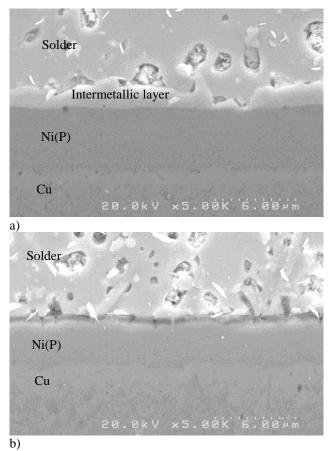
In solder joint cross-sections, in addition to mud cracks, one sees that the intermetallic layer is not uniform in parts affected by blackpad. See Figure 7.

Figure 7. SEM cross-section images of a) a good board and b) a board affected by blackpad. On the bad board, the intermetallic layer is not continuous and the mud crack affected Ni_3P layer has formed on top of the nickel.

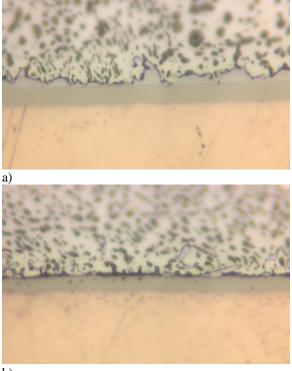
One does not need an electron microscope to confirm back pad, optical images of the same parts as in Figure 7 are shown in Figure 8.

Figure 8. Optical images corresponding to the SEM images in Figure 7. There is no intermetallic layer on the bad board.
