### 11.3.2 Printed Circuit Board Failure Analysis

## IT'S CAF (CONDUCTIVE ANODIC FILAMENT) TIME

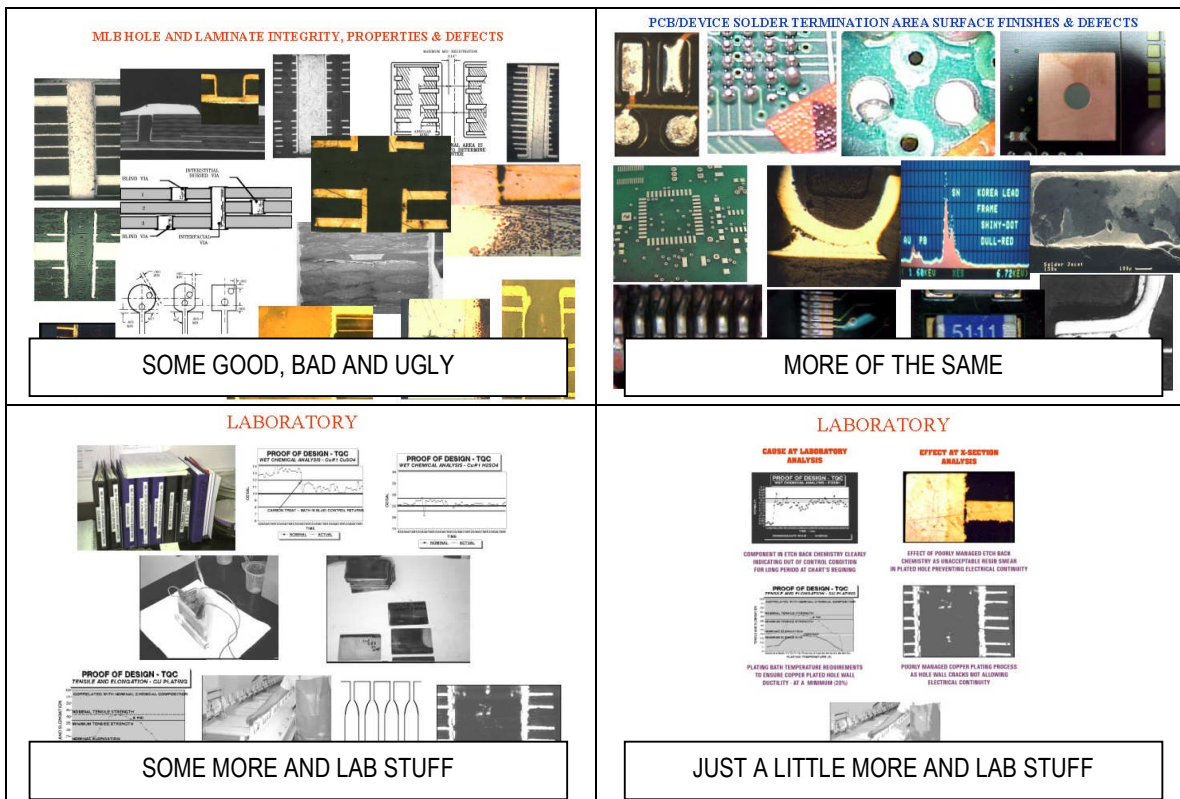
NICE KNOWING WHERE ONE IS AS CAUSE

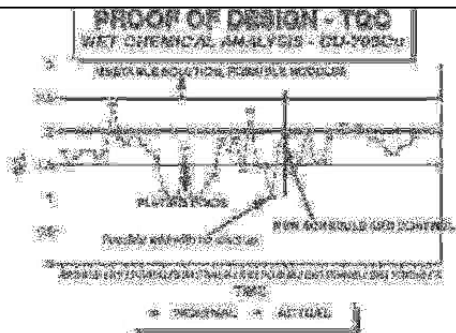
EFFECT TRACEABLE TO CAUSE

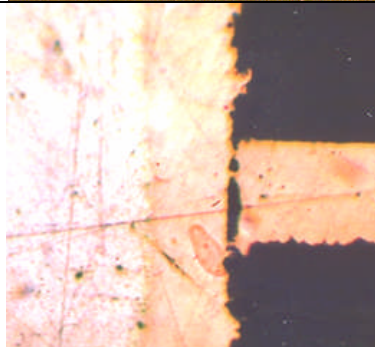
EFFECT AS RESIN SMEAR

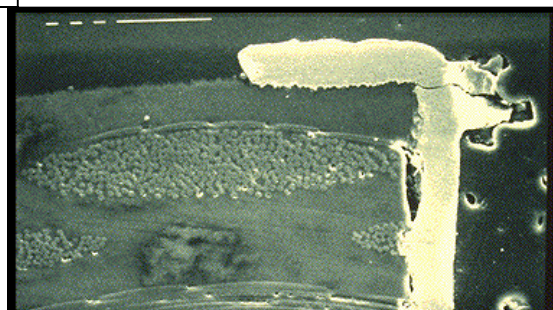
EFFECT AS HOLE WALL PULL AWAY AND...

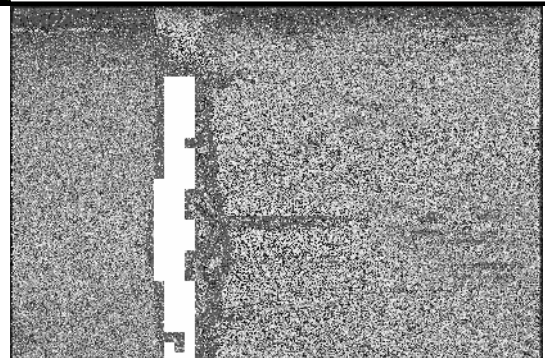
EFFECT AS HOLE WALL PULL AWAY AND...

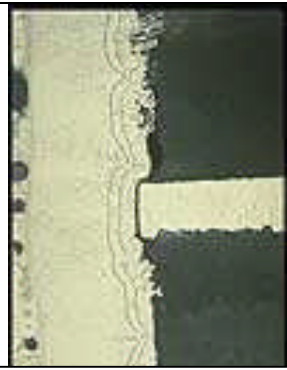
EFFECT AS INNER LAYER SEPARATION (ILS)

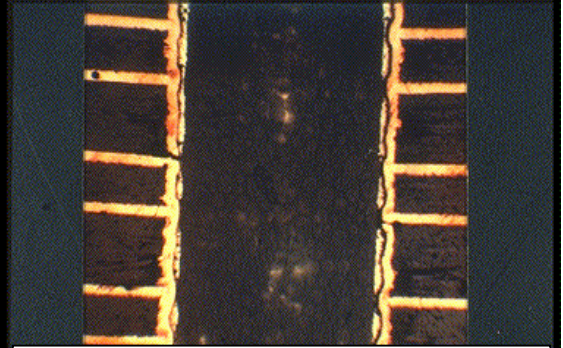
CAUSE AS CU PLATE BATH TEMPERATURE

ONE NEGATIVE EFFECT AS HOLE CRACK

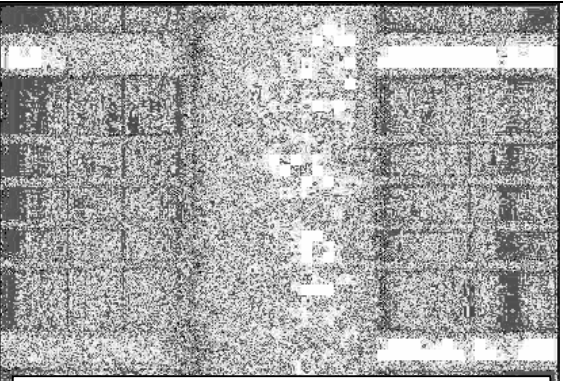
CAUSE AS GOOD PRE-PROCESS AUDITING

EFFECT AS NEAR PERFECT PLATED HOLE

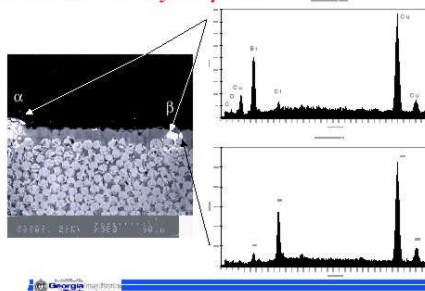
CAF formed with same flux (Flux 4) that caused military field failure.

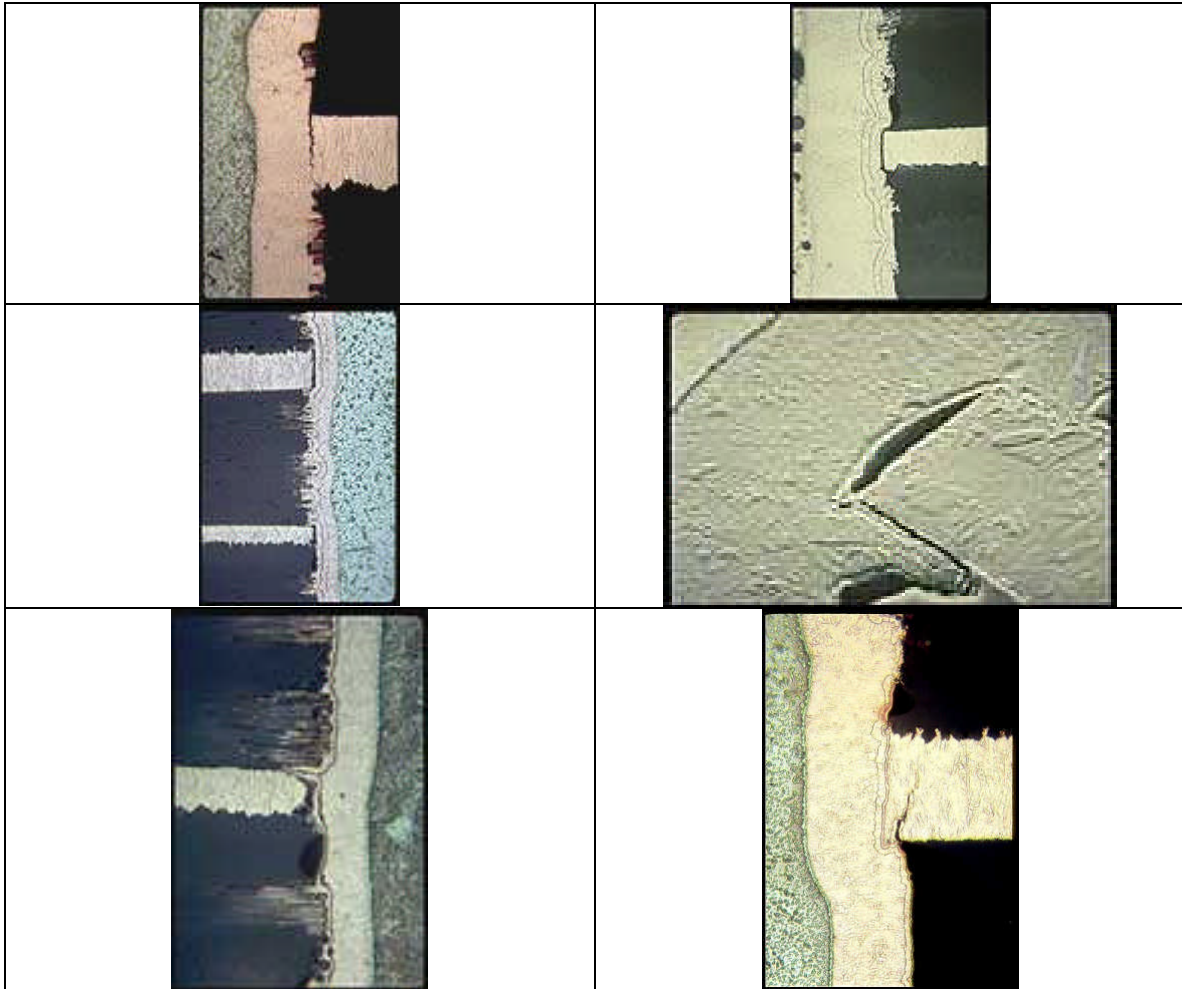
Inner layer separation images are in the following. ILS is easily prevented as indicated in the foregoing information concerning plating and other MLB required chemistries. There is no need to see any of this.

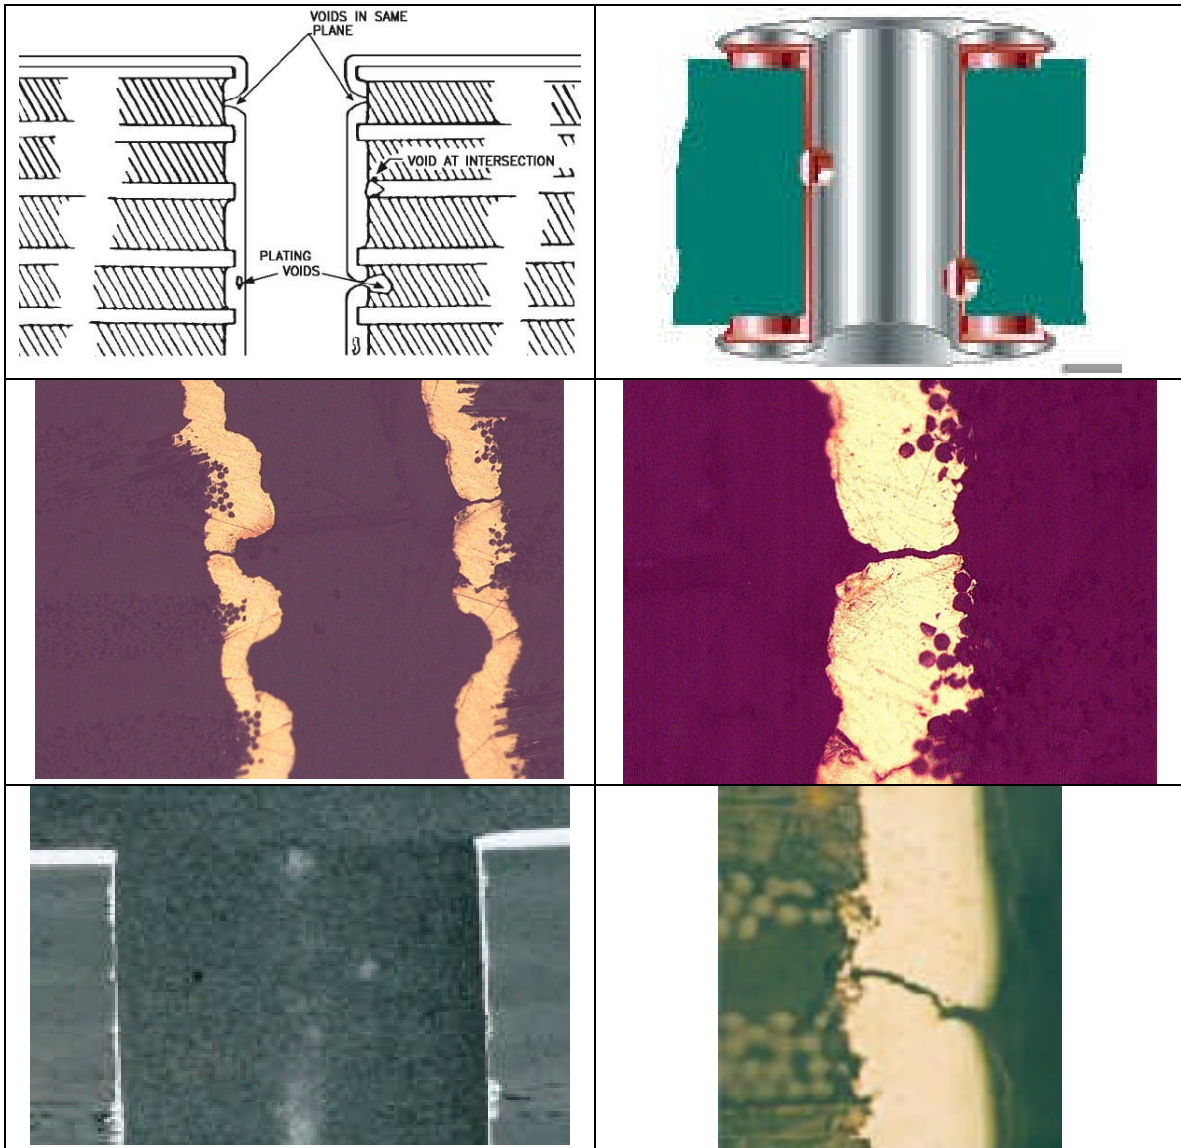
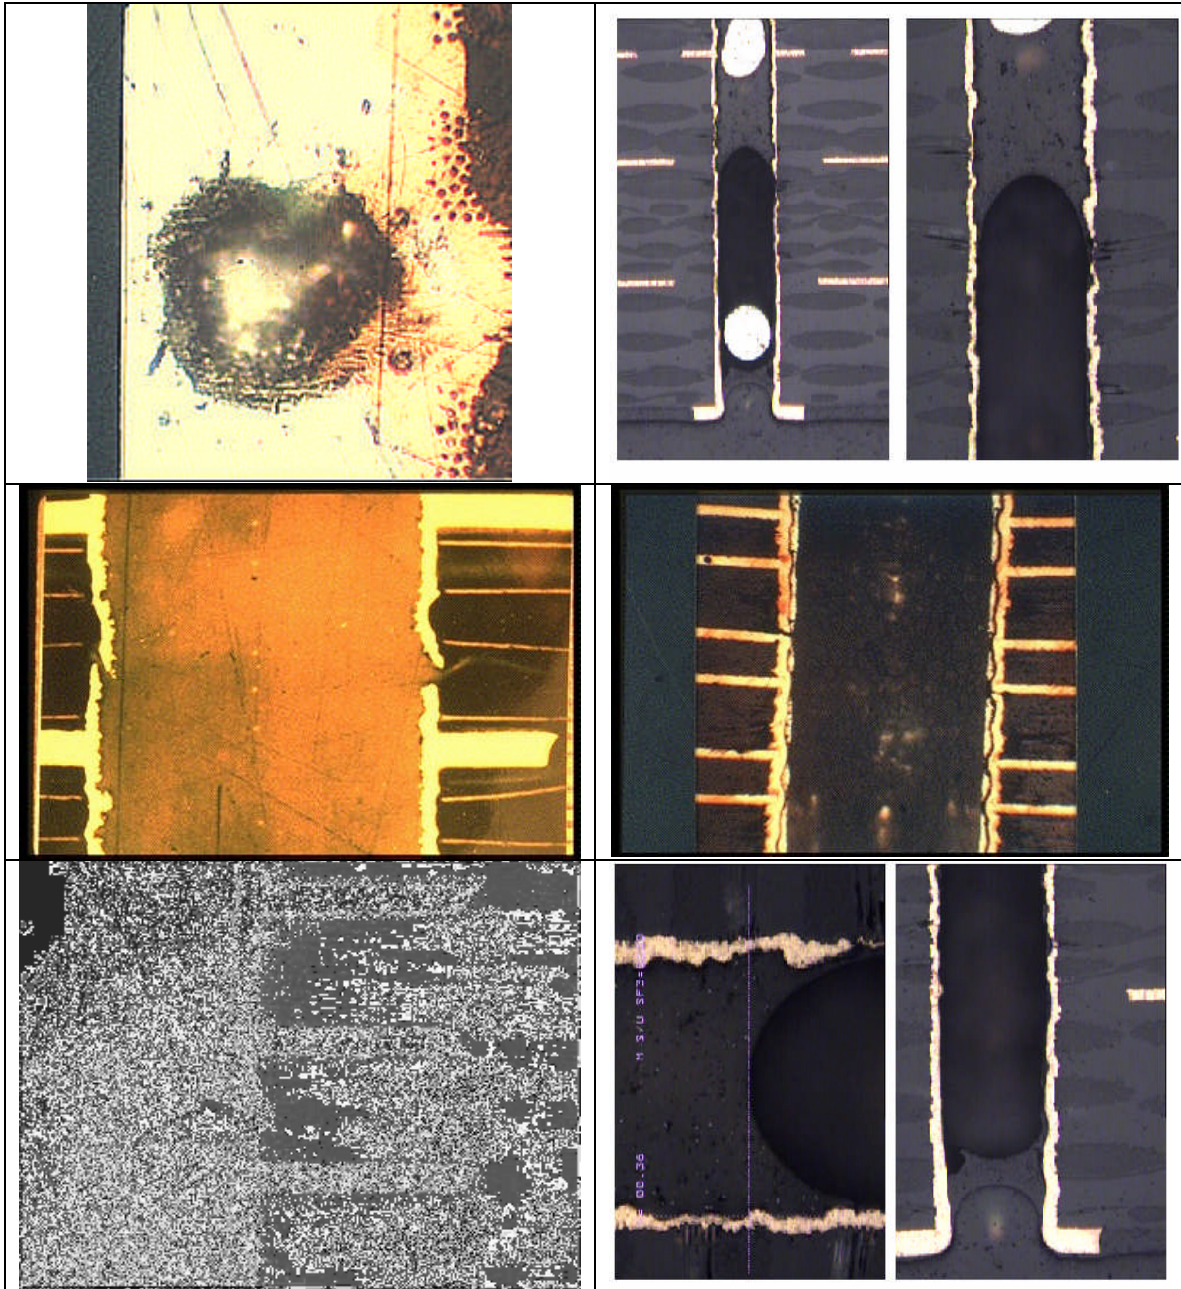
Again, managing plating chemistries prevent plating void occurrences as in the following. Read MoonMan's presentation on printed circuit basics as in the laboratory analytical, maintenance, and prevention section herein to ensure these little beauties do not come into your lives and wreak havoc. Remember what constitutes plating voids as in the first image, in MIL-P-55110, and the second in IPC - 600.
