# Reliability and Failure Mechanisms of Laminate Substrates in a Pb-free World

Kevin Knadle  
Endicott Interconnect Technologies, Inc.  
Endicott, NY

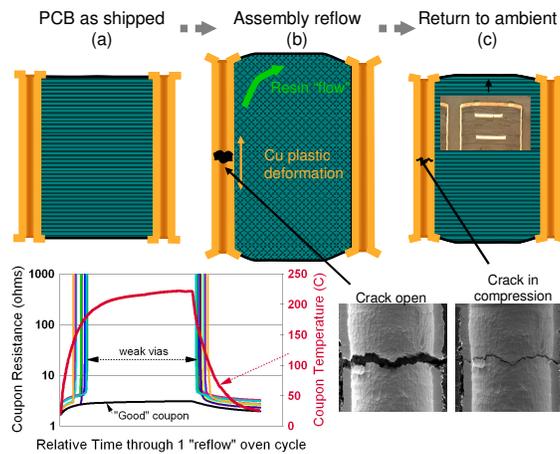
While Figure 3 shows the reason for assembly driven failed vias, Figure 4 illustrates why they can be a serious reliability concern as latent opens in the field. At reflow temperatures above the Tg of the laminate material, the z-axis expansion of the laminate is an order of magnitude much greater than that of the copper, which forces the copper in tension where it plastically deforms—i.e., the copper barrel becomes permanently longer than it was. Similarly, the laminate sees significant compressive forces in the zone around the PTH barrel because the barrel acts as a rivet to constrain it from expanding as it would away from the PTH. These considerable compressive forces create a pressure gradient that causes the laminate, now well above Tg, to “flow” away from the barrels. “Flow” is used in quotes because cross-linked thermoset polymers are not supposed to flow as other polymers, but some form of movement or reshaping is indicated by the permanent deformation seen in laminate x-sections after reflow or solder shock—the laminate is now longer between vias than in the zone directly next to them (Figure 4c). The combination of these permanent deformations (longer barrel, shorter laminate) means that any crack formed at the peak temperature will be forced in slight compression on return to room temperature. In addition to the illustration, figure 4 includes 1) ESEM photos of a barrel crack open at 230C and the same crack closed tightly again after cooling to ambient, and 2) electrical measurements of 8 coupons (left axis) with intentionally very weak barrels through a single simulated reflow cycle in a convection oven showing them open completely during heating (temperature, red line and right axis) between T = 140-185C, and close solidly to original resistance value starting between T=175-110C.

**Figure 4-- Illustration, electrical data, and ESEM photos of deformations on a wiring via during assembly cycle.**

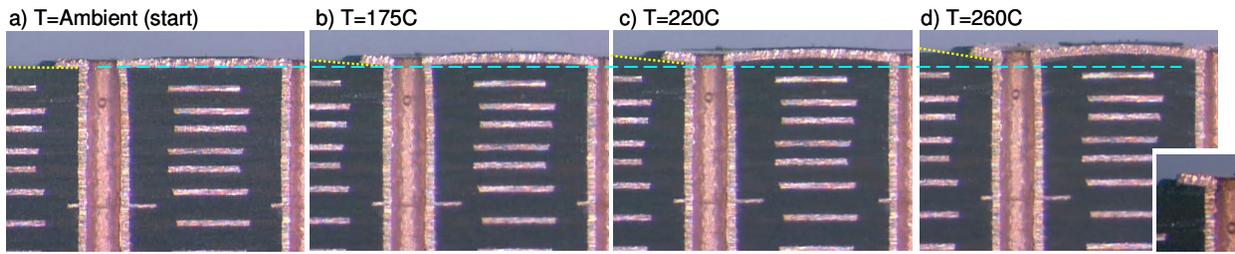
**Figure 6-- Select frames from video of CIRC coupon cycled ambient to 260C, 10mil via/180mil thick PWB.**

The magnitude and slope of the PTH curve at Pb free temperatures, as well as the challenge of Pb free assembly in general, is further portrayed by real time video of a coupon cross-section during a Pb free reflow. Figure 6 shows four select frame captures from the video of a high Tg epoxy coupon similar to that of the blue curve (this one was 10mil via on 180mil thick board) in a simulated single cycle from room temperature to 260C. Sample preparation and procedure was as shown earlier in Figure 2: sample was dry-sectioned to row 1, wired, and placed PTH-up in a glass frame under the camera. For this video, N<sub>2</sub> gas was leaked into the glass enclosure to limit oxidation of the copper during heating. The first observation from the figure is the significant deformation of the laminate, barrel, and lands at 260C. The difference in the two center frames between Pb free 260 and conventional 220C is staggering, but is consistent with the slope of the Figure 3 blue curve as discussed above, let alone general industry experience with Pb free assembly. The yellow dotted lines indicate measurements of the angle of deflection for the external lands: the lands deflected about 10 degrees at 260, 6.5 degrees at 220C and 5 degrees at 175C. The inset photo shows the permanent deflection of that same land (no longer adhered to the laminate) after on return to ambient after only a single 260C cycle, measured at 7.7 degrees, suggestion significant plastic deformation of the rim copper. Additional cycles at 260C are known to exaggerate the angle and/or protrusion of the land even further.

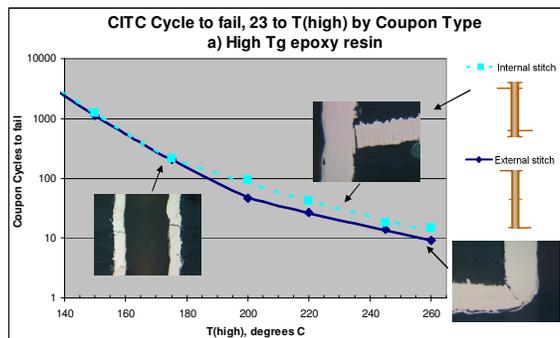
Finally, as if the Pb free situation was not complex enough, the magnitude of deformations at Pb free temperatures are so significant that they often trigger different and competing failure mechanisms along the life curve. While this fact does not invalidate the curves, it could have design implications, and it certainly sheds further light on the Pb free challenge. For example, Figure 7 is a life curve for a high Tg epoxy (more recent build than in Figure 3, though same aspect ratio) constructed with 2 different and independent CIRC coupons—one with the daisy chain stitch external (top and bottom surfaces) and one with the stitch on the nearest 2 internal planes, top and bottom. The two coupon types yield exactly the same cycles to failure at 150C and 175C, and the same failure mode (center barrel crack), but they diverge slightly at higher temperatures—the external coupon with lower life in this case, fails at the external rim, while the internal coupon lasts a little longer but fails at the inner plane connection, at least at 260C. Note that inner plane fails observed at 260C are not related to poor barrel to innerplane connection, but rather appear to be ripped apart in a bending mode due to the same laminate deformation that bends the lands (only a few mils above where the first innerplane connection is located) as seen in Figure 6. Of course, the rim crack mechanism that activates on the external coupon at 260C in Figure 7 is similarly related to the same observations of Figure 6.

**Figure 7—Failure mode shift vs. temperature for a High Tg epoxy resin, 10mil drill on 130mil thick board.**

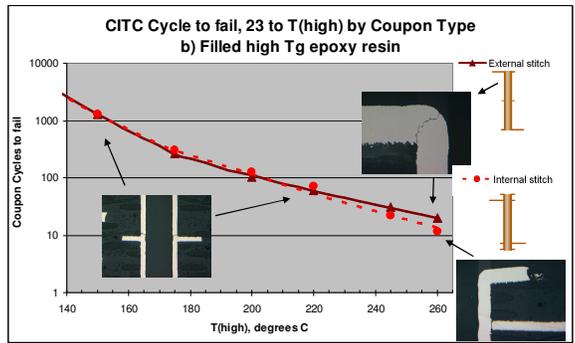
As a second example, Figure 8 compiles the results of the same experiment for a High Tg filled resin. The same 3 failure mechanisms “compete” again, this time with the inner plane failing slightly earlier than the rim at 260C, but both different than the center barrel crack than at conventional reflow temperatures. Note that none of the curves differ significantly, and a repeat of either test could yield a different result by material depending on plating thicknesses, etc, but these examples are otherwise provided as one more case for the complexity of assuring laminate boards for Pb free assembly.

Figure 8—Failure mode shift vs. temperature for a High Tg filled epoxy, 10mil drill on 130mil thick board.

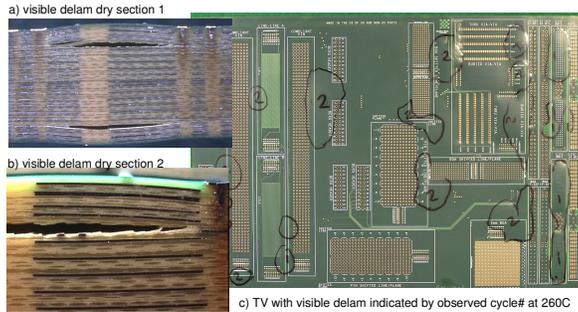
Thermally induced internal delamination is one of the original and ever-present failure mechanisms for laminate substrates and boards. The root cause is generally linked to the “explosive” vaporization of entrapped moisture at high temperatures, especially reflow. The alternate names of blistering or popcorning not only reflect the mechanism but also hint at another fortunate attribute— when they occur within laminates of any thickness they create a measureable opening within the substrate that is almost always visible at the surface as a raised and/or discolored area. “Visible delamination” as such is typically observed in open areas with few vias, and/or in regions surrounding vias such as is shown in Figure 9c for a 130mil thick 10”x7” test vehicle (TV); cases of visible delamination on the TV are circled and numbered during reflow passes at 260C. The number is the pass after which it was observed (i.e., “2” = delamination was observed by inspection immediately upon removing card from reflow pass 2 at 260C). Note how the delamination rarely encroaches on via grids. The (a) and (b) insets show dry-section examples of visible delamination, typically cohesive within laminate material at glass to resin interfaces, near but not into vias seen further back in the section.

Figure 9-- "Visible Delamination" during Pb free reflows on a high Tg resin board.

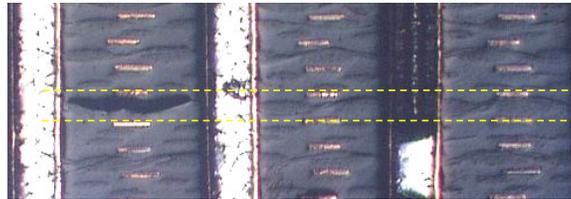
not at glass interfaces, and is highly dependent on the aspect ratio and grid of those vias. That is, for any given board thickness the mechanism would trigger above a certain hole density (below a certain grid), and usually near the center of the board<sup>[13]</sup>. The author prefers to call this new form after its most pragmatic difference and challenge—the significant void or hole it creates in the board, often spanning entire vias, is completely invisible from the surfaces. And except in a specially designed coupon where it can be detected as a capacitance change, it can only be found by x-sectioning. That is, there is no visible difference between a board module site that has this delamination versus one that does not. While most believe that at the very root both mechanisms are due to expansion/vaporization of trapped moisture with temperature, the unique nature of “invisible delamination” is so striking as to demand a greater understanding. Figure 10 shows a unique photo of invisible delamination found by x-section (in this case induced by solder shock, but otherwise the same as that found with oven reflows, and not a time-0 condition) that vividly answers why this mechanism is invisible—despite the large rupture between the two vias, there is otherwise little or no change to the surrounding material, planes, or dimensions. But this answer only raises new questions—how does the material within the rupture disappear as if to violate “conservation of mass”, and how does this happen with little affect to surrounding laminate?

**Figure 10—“Conservation of mass” dilemma with Invisible delamination—where does the material go?**

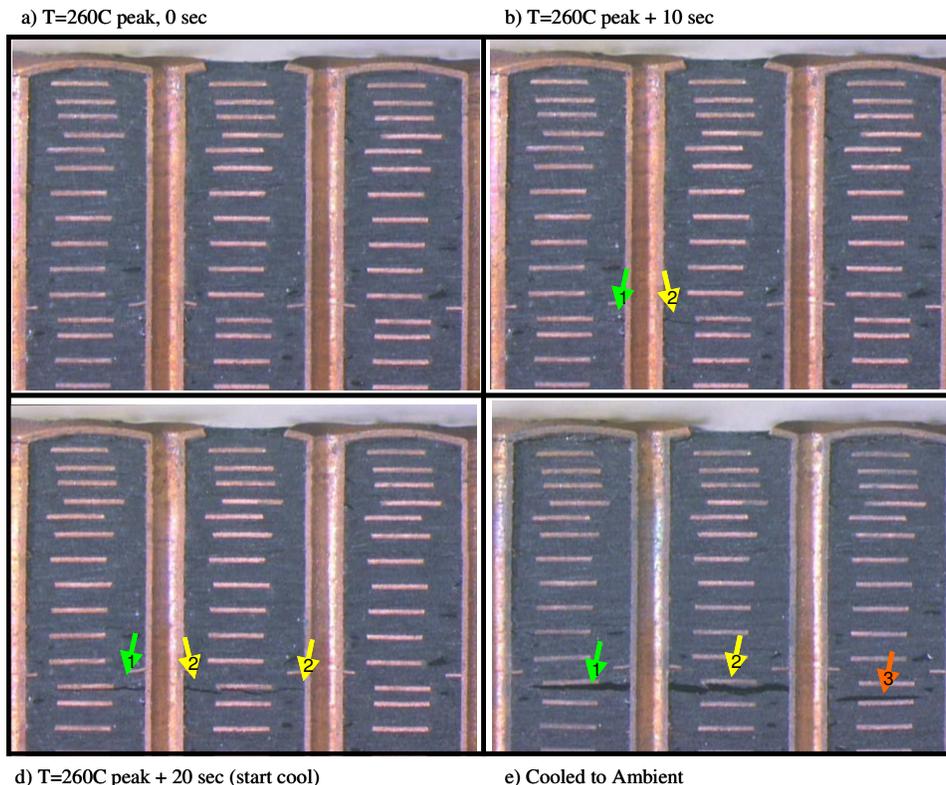
**Figure 11--Frame capture from video showing formation of Invisible delamination.**

as shown in the 4<sup>th</sup> frame of Figure 11. At the same time, a new rupture at point 3 appeared during cooling; apparently it also was created during the dwell, but not visible until cooling. The other randomly shaped small black spots in the laminate are artifacts of the dry section polishing, and should be ignored except that it is interesting to note that they shrink somewhat with cooling, as expected, unlike the cracks formed by this mechanism. Also note the significant permanent deformation of the copper and laminate even after cooling, as discussed in the previous section.

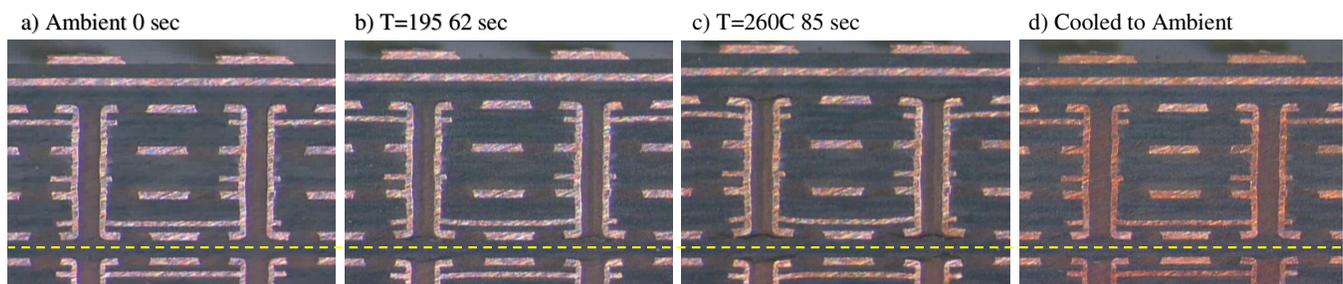
To illustrate, the CITC test is again used to capture with video the formation of eyebrow cracks in a worst case double subcomposite structure with a full grid of top and bottom buried vias. Figure 14 shows a macro view of 4 frame captures starting and ending with ambient; note that N<sub>2</sub> was not used in the glass enclosure, therefore copper will appear oxidized after the peak temperature exposure. Figure 14 includes a frame at 195C when the eyebrow cracks (4 total, above and below yellow center line) were fully formed, and a frame at 260C peak where they are more evident, somewhat longer, and more numerous (note 2 more at the top of the vias). But here, the difference between 260C and 195C is not as striking as with the prior mechanisms, which is consistent with industry experience that eyebrow cracks are by no means exclusively a Pb free problem, but can happen with any reflow. In fact, they may be as much a function of time as of temperature—the author has delaminated an entire module site due to interconnected eyebrow cracks simply by baking for several hours at 195C.

**Figure 14-- Frame captures from video of eyebrow crack formation in a double subcomposite board.**

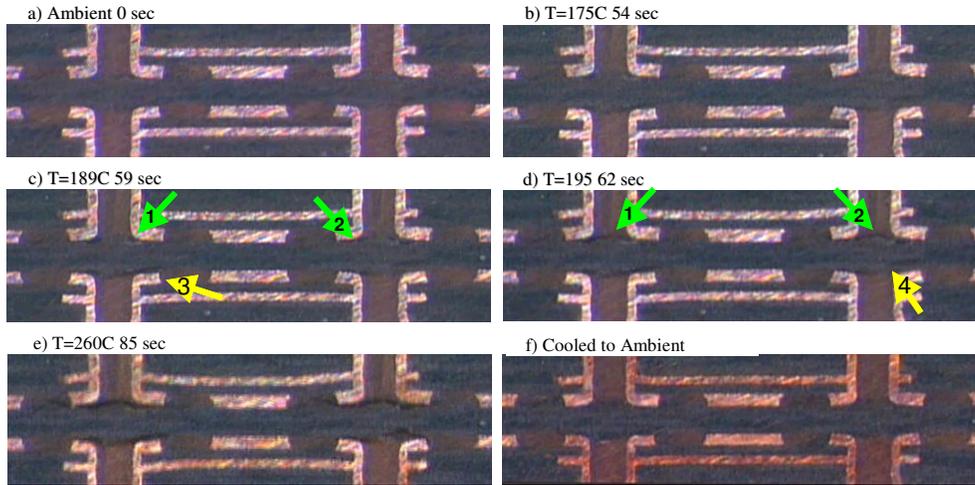
To better depict the formation of these cracks, additional frames focusing on the critical zone are shown in Figure 15. The first hint of the cracks or at least their eventual path is seen at T=175C (b). At T=189C, note the small eyebrow shaped start of cracks at points 1 and 2. Within a few seconds, by T=195C, these have propagated fully across the land diameters. Cracks

**Figure 15-- Close-up of eyebrow crack formation in previous figure.**

3 and 4 show a somewhat different formation path and look. Crack 3 simply becomes more visible with temperature, without the propagation of 1 and 2. Crack 4 starts as two separate cracks which apparently start far enough apart that, though they grow toward the center, they never join together. All the cracks close back up on return to ambient and are no longer visible, at least at this magnification.

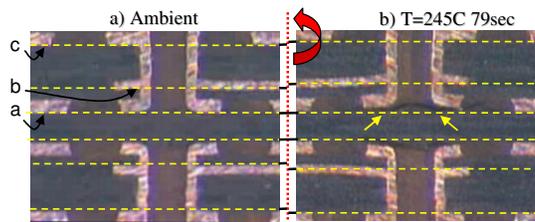
Note the thermal induced deformation of the vias, lands, traces, and laminate in the middle 2 frames of Figure 14, compared to the ambient frames— the magnitude of the deformation is scaled down with aspect ratio, but the same shape as is observed as with thru-vias of Figure 6. But in the case of buried vias observe how the deformed shape, especially the land deflection, would create a tensile zone in the joining resin just above the lands and vias. Resins can withstand reasonable tensile forces below  $T_g$ , but above their  $T_g$  they tear easily when pulled in tension. This root cause of the eyebrow crack is further illustrated in Figure 16, which is a close-up of the left most via pair in the above Figures at ambient, and at a peak of 245C. To better compare relative shape and deformation, the 245C image is shown flipped 180 degrees vertically. Dotted reference lines are drawn at the indicated locations a, b, and c for both temperatures. Note the distinct tensile zone visible in the region of the via rims (at arrows), exactly where the eyebrow cracks were seen to start and grow in the above Figures.

**Figure 16— Comparison of T=245C versus ambient frames to illustrate tensile zone that causes eyebrow cracks.**

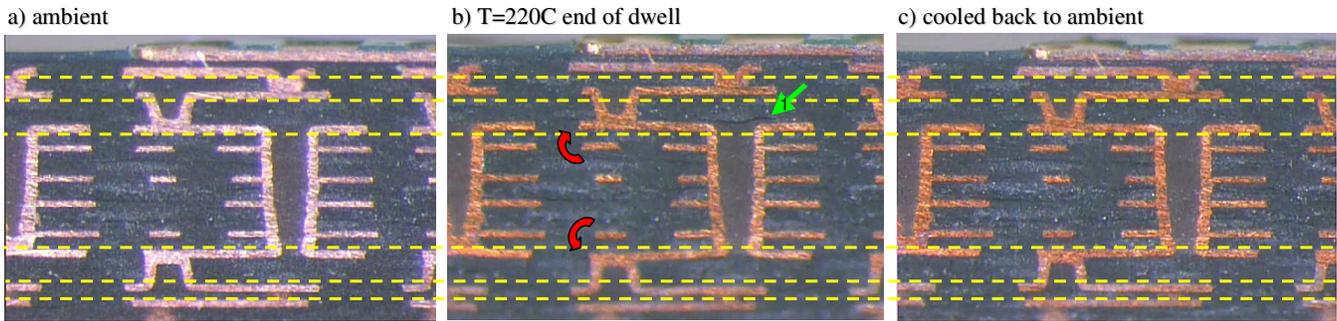
**Figure 18-- Frame captures from HDI reflow cycle video**
