THE PROXIMITY OF MICROVIAS TO PTHs AND ITS IMPACT ON THE RELIABILITY OF THESE MICROVIAS

Jaydutt Joshi
Principle Program Manager
RF Module Technology Development
Skyworks Solutions, Inc.
Irvine, California 92617.

Anthony Primavera, Ph.D.
Manager - CSP Consortium
Universal Instruments Corporation
Binghamton, New York 13902-0825.

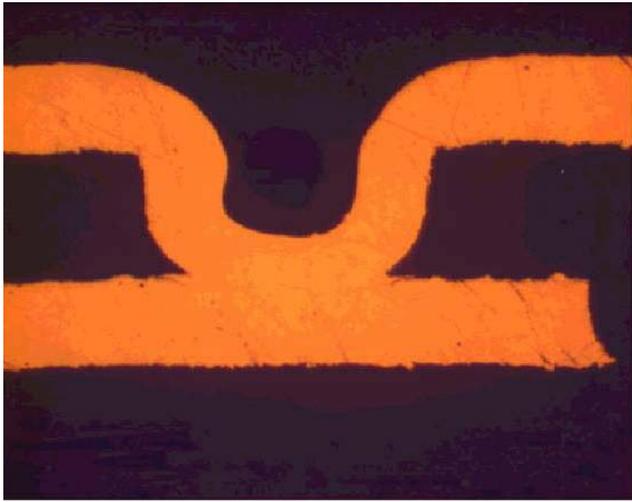
Figure 2a shows a cross section of a YAG drilled microvia fabricated by Vendor D. Vendor D used only the YAG laser to fabricate vias. The build-up dielectric layer in the boards from Vendor D was non-reinforced (no glass fibers in the epoxy dielectric). The observed effect of the dielectric material used and the via formation technology on the failure mechanism in this particular experiment is summarized in the Table 1.

a. Cross Section of a YAG Laser Drilled Microvia from Vendor D

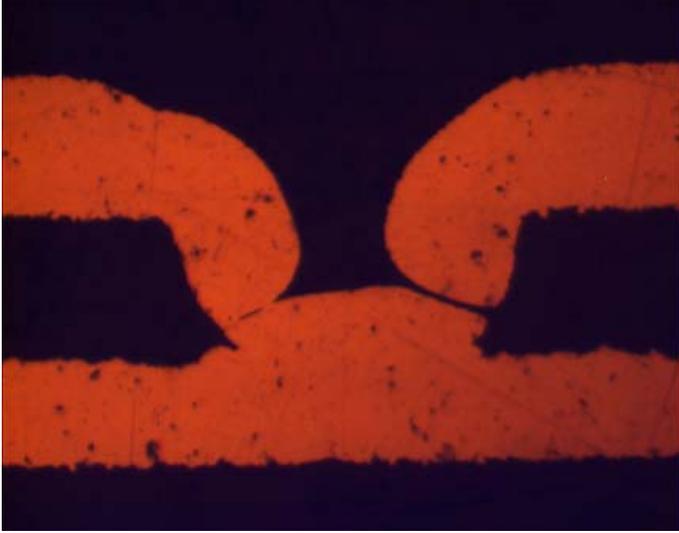
[Figure 3a](#) shows the cross section of a time zero via failure that had a break in the hole wall by Vendor D. This could be due to the entrapment of air bubbles during plating or the improper cleaning of plating resist residue. [Figure 3b](#) shows the cross section of an improperly plated via that resulted in a time zero failure in a board from Vendor D.

a. Cross Section of a Via with a Break in the Hole Wall (Time Zero Cross Section)

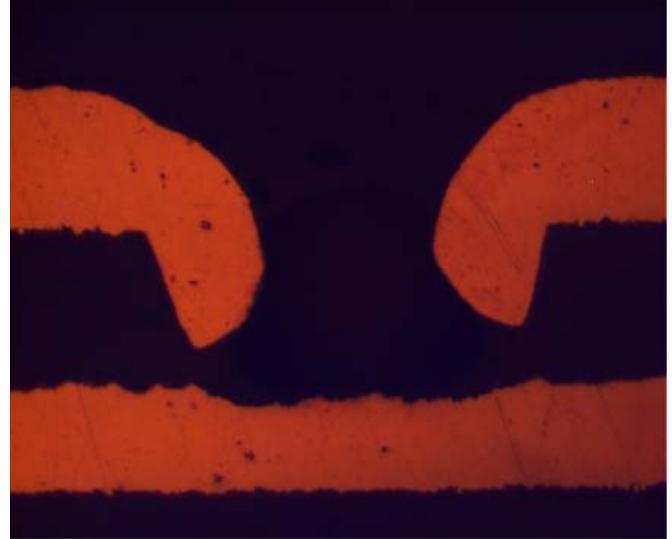
b. Cross Section of an Improperly Plated YAG Laser Drilled Via from Vendor D (Time Zero Cross Section)

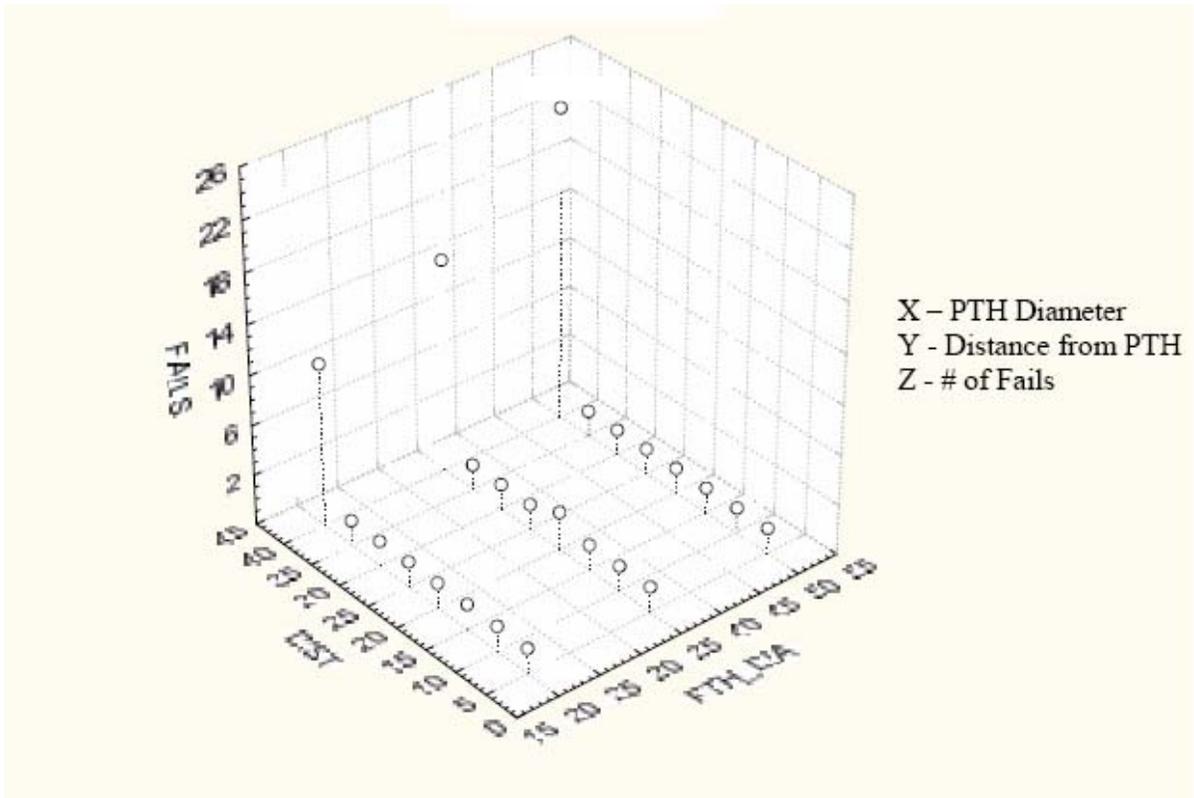
Figure 4. Failure Frequency Plot for the Vendor M

This section of the report presents the via reliability evaluation and the failure analysis. [Table 2](#) shows the number of failed vias at different distances from a PTH for Vendor M. The first failure was reported after 1100 LLTS cycles. [Figure 4](#) shows the 3-dimensional plot for the PTH diameter (X-variable), via distance from PTH (Y-variable), and number of failed vias (Z-variable) for Vendor M. It can be observed that the failure frequency of the vias at a distance of 40 mils, the farthest distance from a PTH was found to be the greatest.

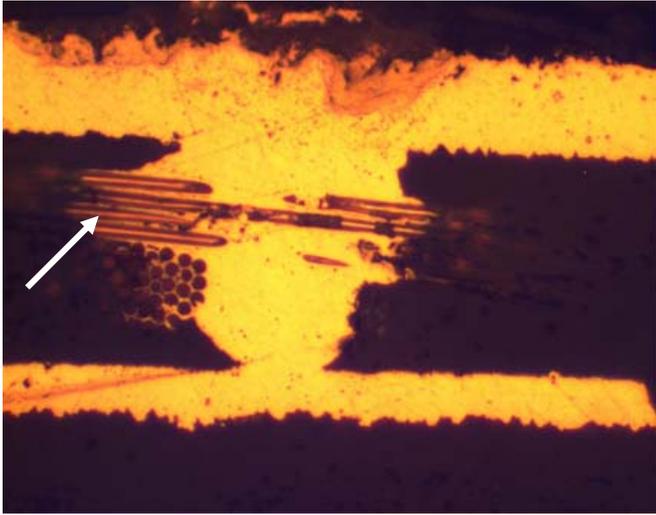
To understand the failure mechanisms, cross sections of the failed samples are presented in the following sections. [Figure 5](#) shows the cross section of a failed microvias after different stages of LLTS cycles. [Figure 5a](#) shows the cross section of a failed microvia after 1100 LLTS cycles. This via was at a distance of 40 mils from a 20 mil PTH. It should be recalled that Vendor M used a YAG and a CO₂ laser to fabricate microvias. The CO₂ laser possesses high energy that debonds the glass fibers from the glass reinforced composite. The presence of fibers debonded in the via area has plating along the fibers. The via structure at a distance of 5 mils (center to center distance of 27 mils from 20 mil diameter PTH) from a PTH was examined to check for possible plating ingress along the debonded glass fibers. Although bias testing had not been performed, no cases of migration or bridging was observed in cross-sectional analysis.

a. Failed Microvia at a Distance of 40 mils from a 20 mil PTH after 1100 LLTS Cycles

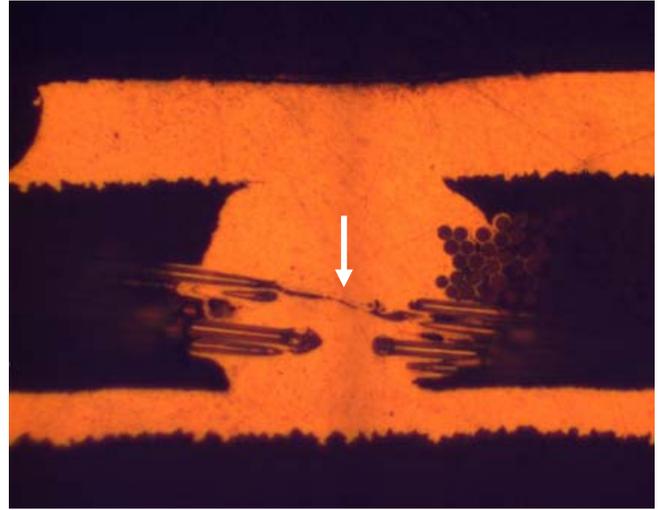
To determine the failure mode after 2000 LLTS cycles, failed samples were cross sectioned and analyzed. [Figure 5b](#) shows the cross section of a via at a distance of 40 mils from a 50 mil PTH that failed after 2000 LLTS cycles. A crack can be seen through the via that caused the high resistance value. It is important to note that vias at a distance of 40 mils failed earliest. In addition, cracks can be seen in the cross section. As the testing progresses, these cracks propagate and lead to failures as shown in [Figure 5c](#), which shows the cross section of a via at a distance of 40 mils from a 50 mil PTH. A void in

b. Failed Microvia at a Distance of 40 mils from a 50 mil PTH after 2000 LLTS Cycles

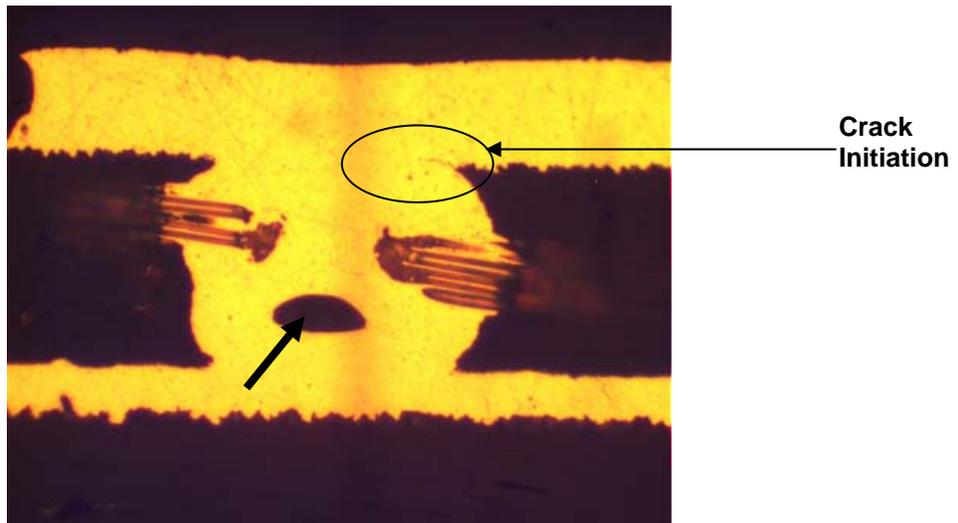
the plating can be seen in the cross section. Presumably, LLTS did not cause this void. In addition, cracks propagating from the periphery can be seen in the cross section, which leads to high value of resistance.

c. Cross Section of a Via Showing a Void in the Copper Plating

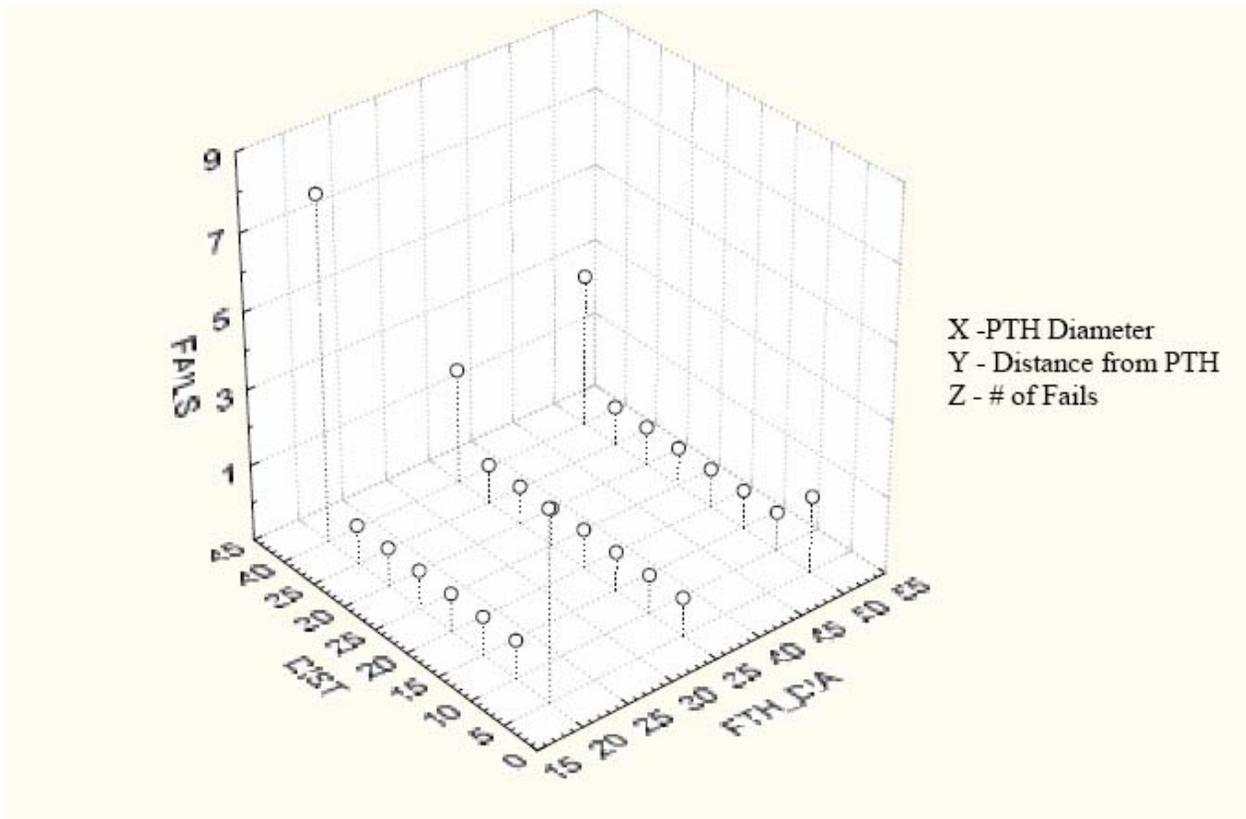
Figure 6. Failure Frequency Plot for Vendor L

[Table 3](#) shows the number of failed vias at different distances from a PTH (Vendor L). It can be seen that the failure frequency of vias at a distance of 40 mils from a 50 mil PTH is higher than vias at a distance of 5 mils from PTH, i.e. vias farthest from a PTH fails faster than vias closest to a PTH. Similar trends were observed in the vias near 20 mil diameter PTHs. [Figure 6](#) shows the 3-dimensional failure frequency plot for Vendor L. It shows that the failures were found both at a distance of 40 mils and 5 mils from the PTH. However, the failures frequency of a vias at a distance of 40 mils from the PTH was more than that of vias at a distance of 5 mils.

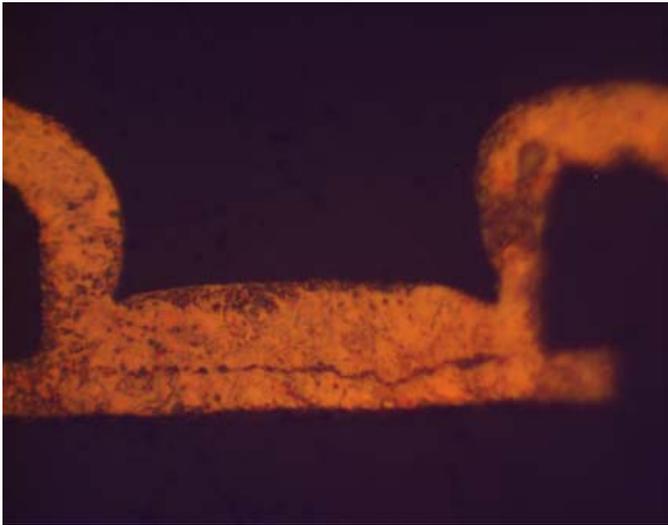
[Figure 7](#) shows cross sections of a microvias from Vendor L after different stages of LLTS testing. [Figure 7a](#) shows a failure in a via at 40 mils from a PTH. The cause of failure was found to be a crack at the via-pad interface. Microetching of the cross sectioned sample was carried out to make the crack more visible. It was observed that the crack was initiated at the via-pad interface. Due to a sharp corner at the via-pad interface, it becomes a high stress concentration region and is susceptible to crack initiation. It can be seen that via wall angles are straight, which is characteristic of a photo defined via. It can be observed from [Figure 7a](#) that the plating thickness at the bottom of the via wall edge and via pad is slightly less than the plating thickness at the top. A similar failure was observed in the via at a distance of 5 mils from 50 mil PTH after 1100 LLTS cycles. [Figure 7b](#) shows the cross section of a functional via at a distance of 5 mils from a 35 mil PTH after 2000 LLTS cycles. Uniform plating thickness can be seen from the cross section.

**a. Failed Microvia after 1100 LLTS Cycles
at the Distance of 40 mils from a PTH**

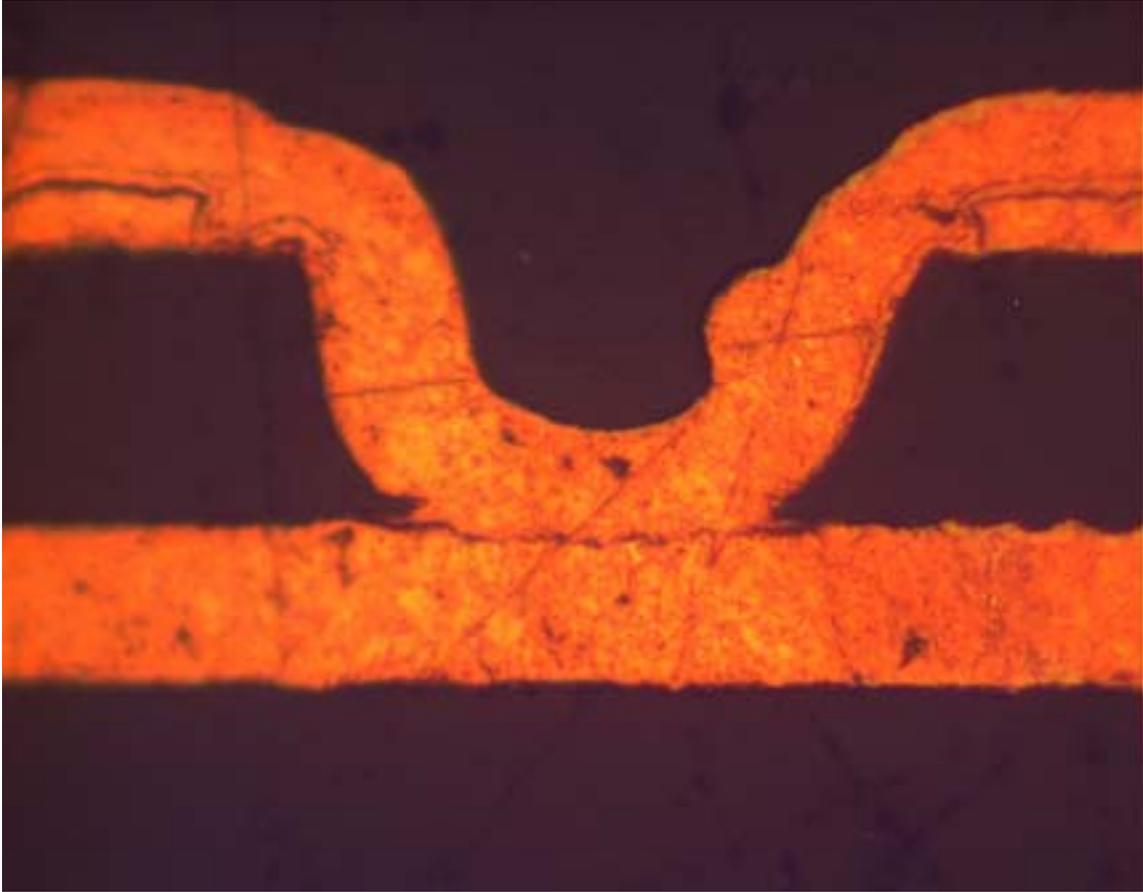
Figure 8. Cross Section of a Failed Via after 1100 LLTS Cycles

[Table 4](#) shows the number of failed vias in samples provided by Vendor D. It can be observed from the table that only 5 failures were reported. The samples were tested for 2000 LLTS cycles. Microetching of the cross sectioned sample was carried out to make the crack more visible as shown in the [Figure 8](#). Again, it was observed that the crack was initiated at the via-pad interface.

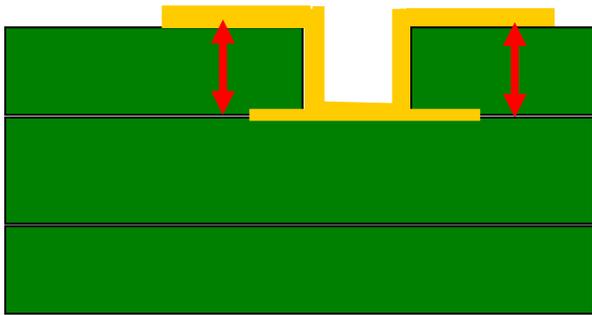
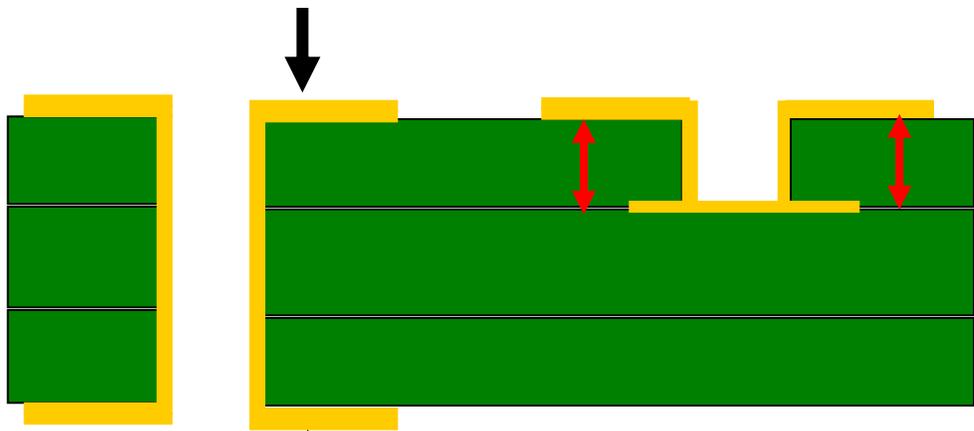
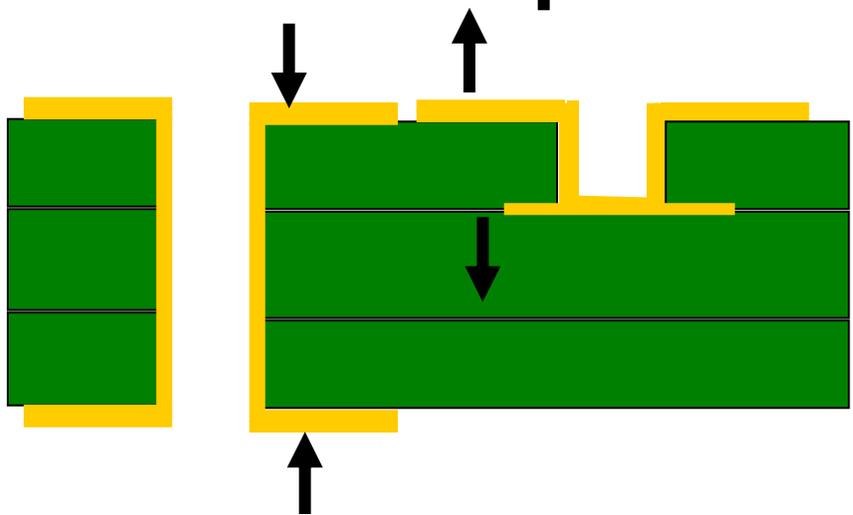
Figure 9. Failure Mechanism for the Higher Frequency of the Failures of Vias at the Distance of 40 mils from the PTH

It was observed that the vias at a distance of 40 mils from PTHs showed greater number of failures as compared to other vias. It should be remembered here that via size was held constant at 5 mils. [Figure 9](#) describes the mechanism behind higher frequency of failures observed in vias at the distance of 40 mils from PTH. It is proposed that the mechanical interlocking and Z-axis CTE of the copper PTH prevent the high CTE of the epoxy/glass layers from expanding. This in turn causes a local 'Z' axis constraint on the outer dielectric layers around the PTH. This reduces the occurrence of the failure mode for microvia technology that is separation of via from the stop pad in case of vias at the distance of 5 mils from the PTH.
