Surface Finish Issues Affecting Solderability and Reliability

ACI Technologies was contacted in regards to poor solder joint reliability. The customer submitted an assembly that was exhibiting intermittent opens at multiple locations on a ball grid array (BGA) component. The assembly's functionality did not survive international shipping, essentially shock and vibration failures, immediately making the quality of the solder joints suspect. The customer was asked about the contract manufacturer and the reflow oven profile as well as the solder paste and surface finish used. The ACI engineering staff evaluated the contract manufacturer's technique and determined that they were competent in the methods they used for placing thermocouples in the proper locations and developing the reflow oven profile. The surface finish was unusual, but not unheard of, in that it was hard gold over hard nickel, rather than electroless nickel immersion gold (ENIG). The customer was able to supply boundary scan testing data which showed a diagonal row of troublesome BGA pins.

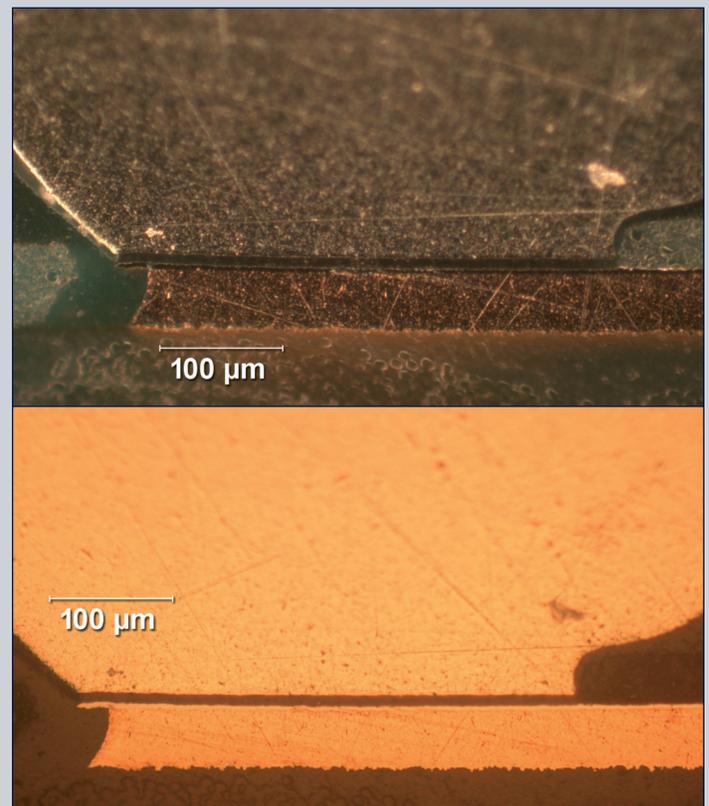
A position halfway through the BGA solder balls along a diagonal through the BGA component was selected as the area of interest to examine the solder joints, surface plating, and foil thickness as well as any anomalies from internal observations. The microsectioning was performed in accordance with IPC-TM-650 2.1.1 - Microsectioning, Manual Method. In Figure 1, images of one of the suspect solder joints are shown with a clean break along the board pad to solder ball interface.

The clean breaks at the nickel layer of some of the BGA solder joints, especially from the outside towards the inside of the component,

Figure 1: Optical images of a broken solder joint along the board pad to solder ball interface. Dark field image on top; bright field image below.

indicated that it was less likely the assembly manufacturing process was the cause and more likely the bare board. During the reflow process, the corners of the component are the hottest and the center should be coldest. The center would most likely fail if the process was too cold while dewetting and excessive intermetallics would be observed if the process was too hot. This points to surface finish as the likely problem since low intermetallic formation was observed and the solder joints weren't broken near the center of the BGA.

ACI recommended evaluating the plating process of the bare board and the hard gold over hard nickel surface finish to see if they met the recommended thicknesses for the nickel and especially the gold layers. Also, removal of any storage or processing step that would have led to the oxidation or fouling of the nickel surface should increase the solder joint reliability.

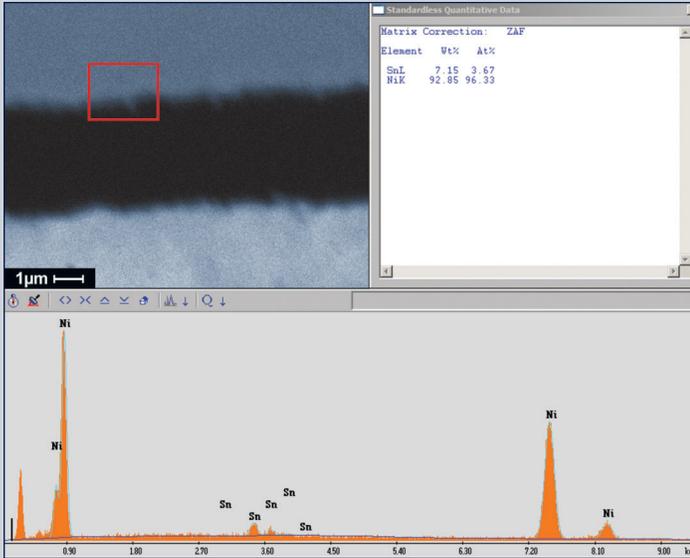
After examining similar solder joint cracks under optical microscopy, the cross-section was analyzed using SEM-EDS. Figure 2 shows the pad interface of the cracked joint of an outer BGA solder ball in which nickel (Ni) was predominant with a minor contribution of tin (Sn). Figure 3 shows the solder ball interface of the same cracked joint of an outer BGA solder ball with copper (Cu) from the SAC (Sn-Ag-Cu) solder paste, nickel (Ni) from the pad, gold (Au) from the pad, and tin-silver (Sn-Ag) from the solder ball.

The low levels of gold observed at the interface, especially with no line of demarcation, and few intermetallics at the pad interface (with the hard gold over hard nickel plating) suggested that there was an issue with the bare board. Oxidation of the nickel plating, either during the surface finish deposition or through an insufficient layer of gold, could prevent solder from adhering to the pad to form a strong solder joint. The patchy intermetallic layer observed at the interface also suggested a blocking of the nickel interface.

Figure 2: SEM-EDS data for the pad side of an outer solder joint that cracked.

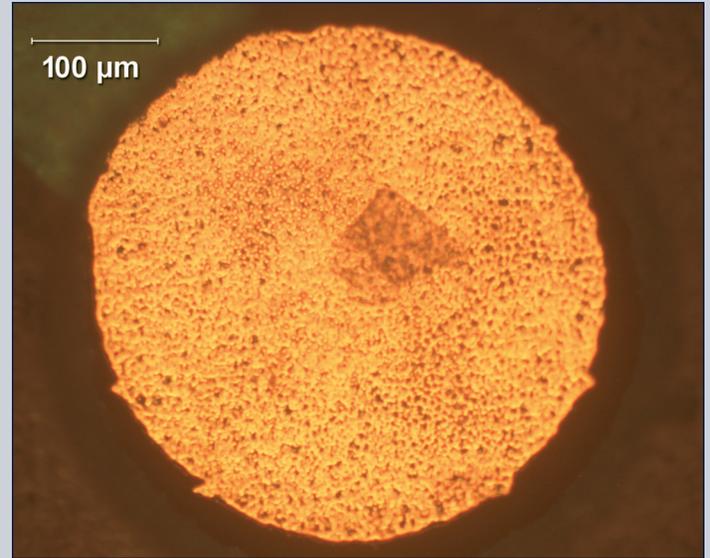
Figure 4: Optical image of the rough surface of a pad.

Optical microscopy, X-ray fluorescence (XRF) spectroscopy, and/or SEM-EDS techniques were recommended to determine the plating thickness and porosity. The customer was able to provide a bare board from a similar lot to the previously examined assembly. Figure 4 shows the uneven and apparently porous gold surface of a representative BGA pad location. Figure 5 shows the SEM-EDS elemental mapping for a BGA pad where nickel appears to be visible through thin patches of the gold plating.

Optical microscopy showed uneven gold plating on the pads throughout the board. The SEM-EDS data also showed patchy gold plating with nickel apparently being exposed through the gold. All of this data indicates that the process producing these boards was not properly controlled.

ACI recommended that the customer speak with their bare board manufacturer about improving the hard gold over hard nickel plating process or switching to other surface finishes, such as soft gold over nickel plating, electroless nickel immersion gold (ENIG), or immersion silver (IAG).

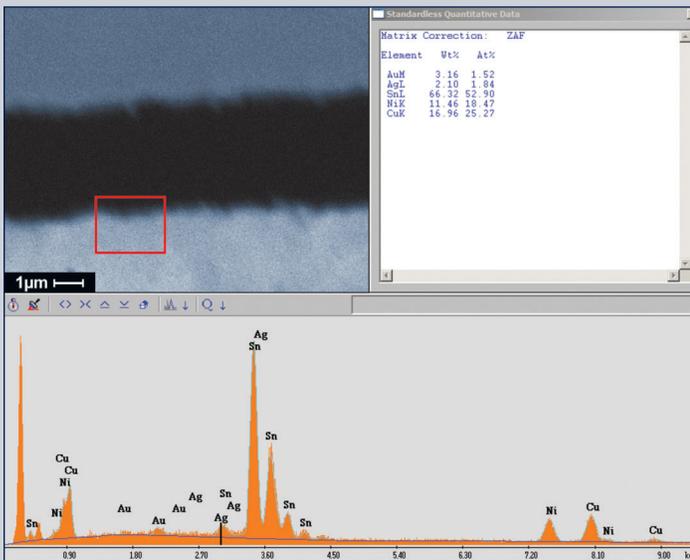
Figure 3: SEM-EDS data for the solder ball side of an outer solder joint that cracked.

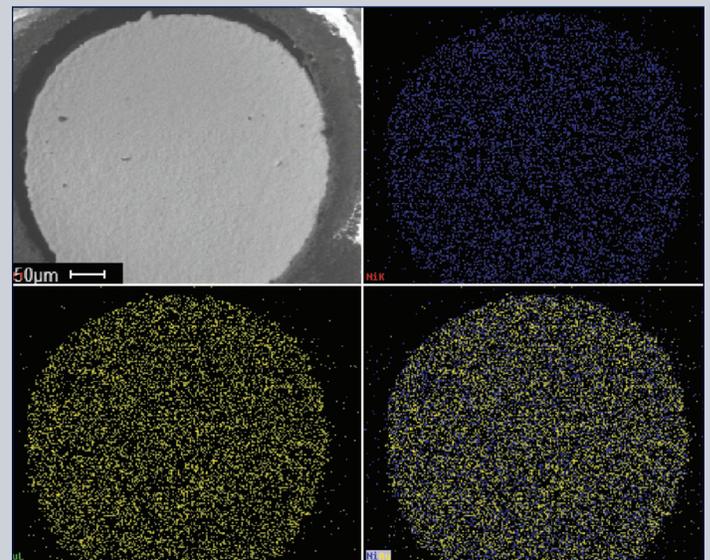
Figure 5: SEM-EDS elemental map of a pad. [Top left - image, top right - nickel (blue), bottom left - gold (yellow), bottom right - overlay of both.] The overlay map shows patches where the nickel may be exposed through the gold.

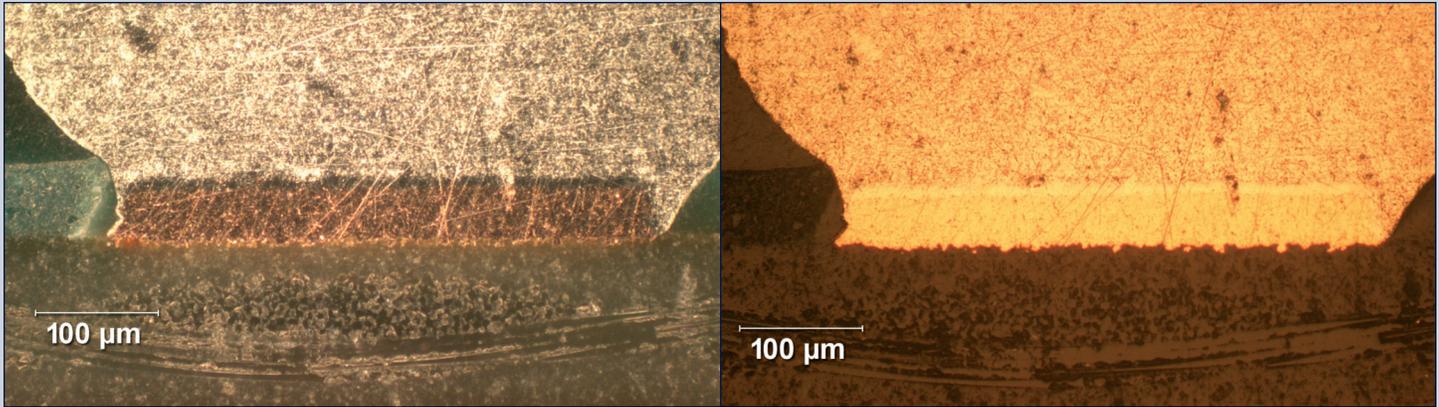
Figure 6: Optical image of a good solder joint along the board pad to solder ball interface. Dark field image on left; bright field image on right.

The customer made a new set of boards with an IAG surface finish and provided them to ACI in the bare board and finished assembly states. Figure 6 shows images of a representative solder joint in which good bonding along the board pad to solder ball interface was observed.
