## Component Failure Analysis - Hermetic Packaging

Recently ACI Technologies was asked to perform failure analysis on a hermetically sealed transistor for potential electrostatic discharge (ESD) or electrostatic overstress (EOS).

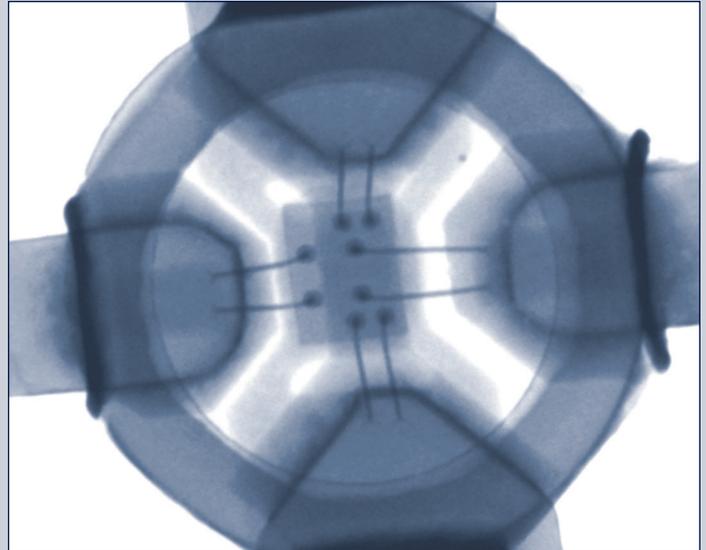
Before delidding, non-destructive testing by x-ray inspection was performed to provide a baseline for the as-received device (Figure 1). This will be used later to determine if any damage resulted from the delidding process.

Figure 1: X-ray image of field-failed transistor prior to delidding.

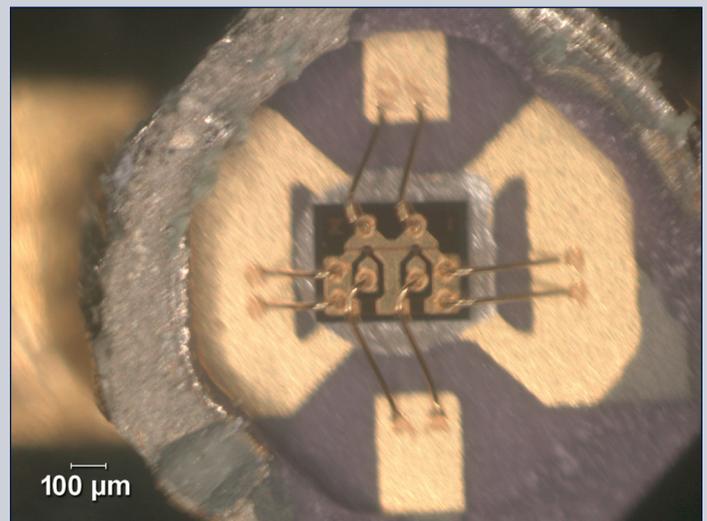
Figure 2: Optical image of field-failed transistor.

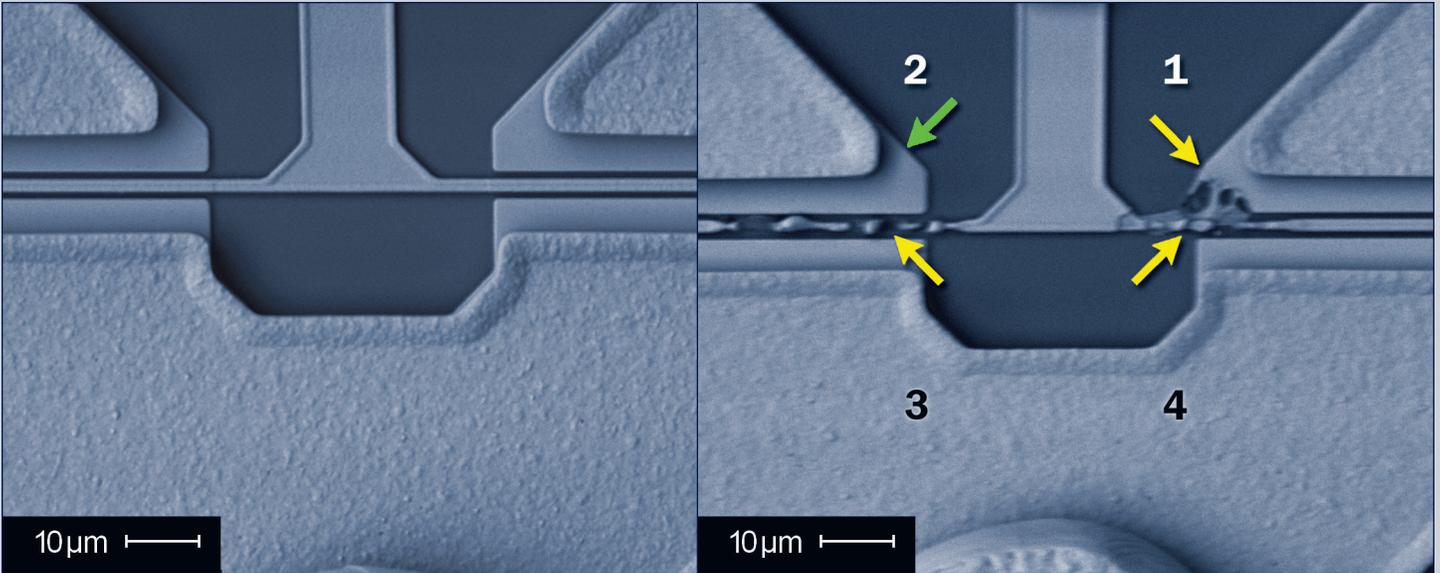
Figure 3: Shown on the left is a SEM image of good transistor. To the right is a SEM image showing EOS damage (indicated by yellow arrows).

Figure 3 shows that higher magnification with a scanning electron microscope (SEM) is necessary for a closer examination of die, wire bonds, and traces. Melted traces were clearly observed at the higher magnification which typically indicated EOS damage. The large current caused by the electrical overstress was high enough to melt pad #1 and traces #3 and #4.
