# GOLD EMBRITTLEMENT IN LEADFREE SOLDER

Craig Hillman, Nathan Blattau, Joelle Arnold, Thomas Johnston, Stephanie Gulbrandsen  
DfR Solutions  
Beltsville, MD, USA  
chillman@dfrsolutions.com

## ABSTRACT

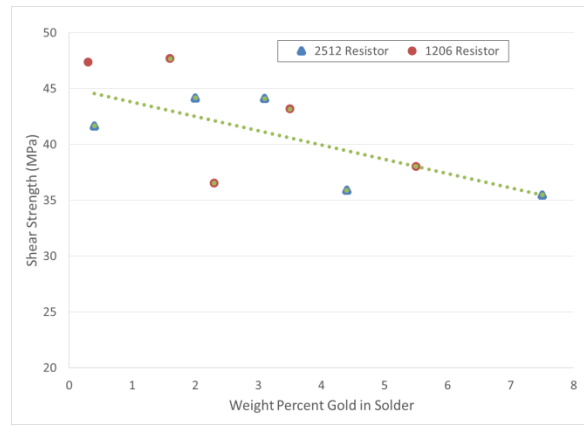
Low speed shear was performed to determine if gold content induced measurable changes in solder strength. The test was performed using the die shear tool at a speed of 2.5 mm/s and a shear height 0.2mm. Shear force measurements were normalized by bond pad dimensions to acquire shear strength values for both 2512 and 1206 resistors. The results as a function of weight percent gold and aging times are displayed in Figure 11 through Figure 13. The dotted green lines are a linear extrapolation of the data.

Figure 11: Low Speed Shear Test Results, SAC305 – 0 hr Aging

It is this duality of failure locations, fracture of the intermetallic in the bulk and separation along a gold-rich layer at the interface, that may explain the shear strength trends observed in Figure 11 through Figure 13. Shear strengths at time zero are dominated by the amount of  $\text{AuSn}_4$  within the bulk SAC305 solder. Initial aging of the SAC305 solder allows the gold in the immediate vicinity of the interface to diffuse towards the  $\text{SnNi}$  intermetallic. This migration weakens the interface and the surrounding solder (discussed as a denuded region in the paragraph below). For SAC305 solder with low gold content, the interfacial region becomes the weak link. For SAC305 with high gold content, the bulk solder with fractured  $\text{SnAu}_4$  intermetallics remains the failure site.

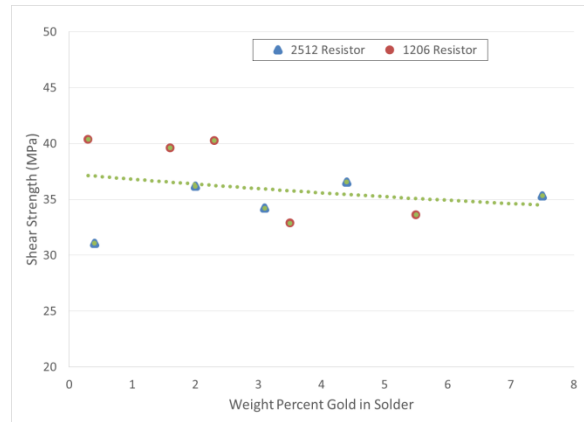
Figure 12: Low Speed Shear Test Results, SAC305 – 168 hr Aging

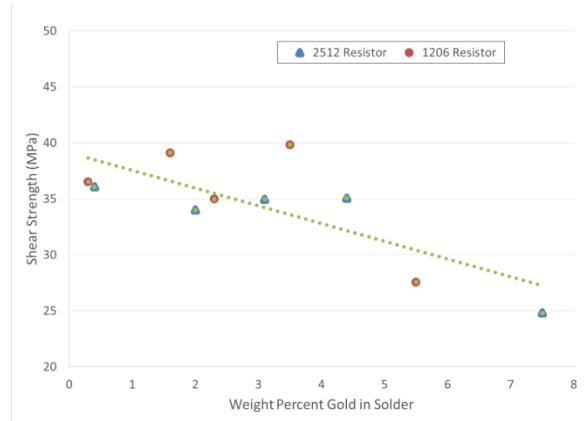
Figure 13: Low Speed Shear Test Results, SAC305 – 1000 hr Aging

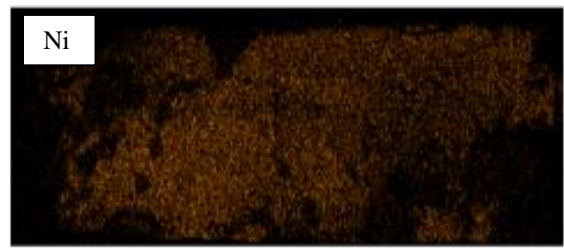
Reviewing the elemental maps in Figure 24, the crack path is seen to have primarily propagated between the AuSn<sub>4</sub> and the SnNi intermetallic layers. In some areas, crack seems to have deviated into the interface between the SnNi intermetallic and the underlying nickel plating.

Figure 24: Elemental map of SAC305 solder with 5.5wt% Gold and Aged for 1000 hrs at 125C

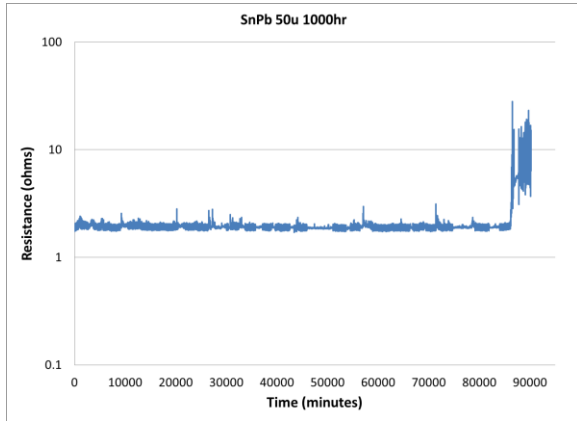
To minimize false detection error, the failure criteria was defined as when resistance increased by 10 times (10X) the range of variation in resistance [7]. Using this approach avoided false detection errors and response to variations driven by channels, wiring, and board level connections. Examples of the resistance variation are shown in Figure 26 and Figure 27.

Figure 26: Resistance vs. Time, Thermal Cycling of SnPb with 6.0% Gold and Aged for 1000 hours at 125C

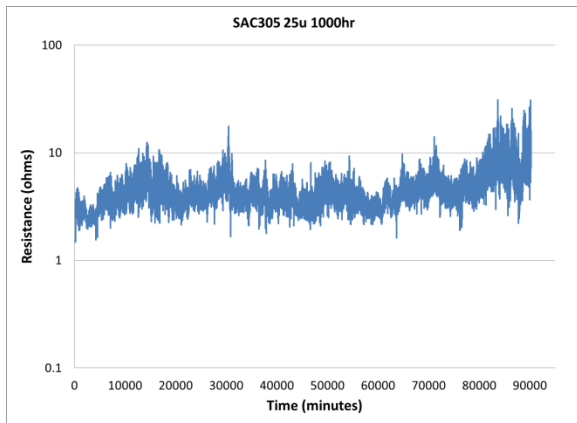
Figure 27: Resistance vs. Time, Thermal Cycling of SAC305 with 3.1% Gold and Aged for 1000 hours at 125C

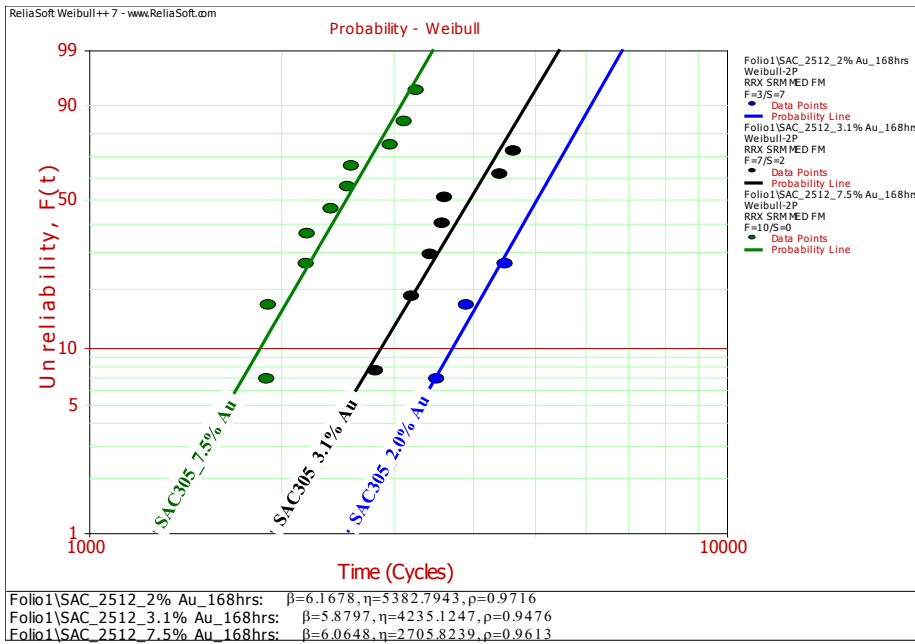
A Weibull plot of thermal cycling failures as a function of gold content, after 168 hours of aging, is shown in Figure 28. There seems to be a strong influence of gold content, with increasing gold content resulting in measurable reduction in time to failure.

Figure 28: Weibull plots of thermal cycling failures (0 to 100C) as a function of gold content (2512 Resistors, Aged for 168 hours at 125C)

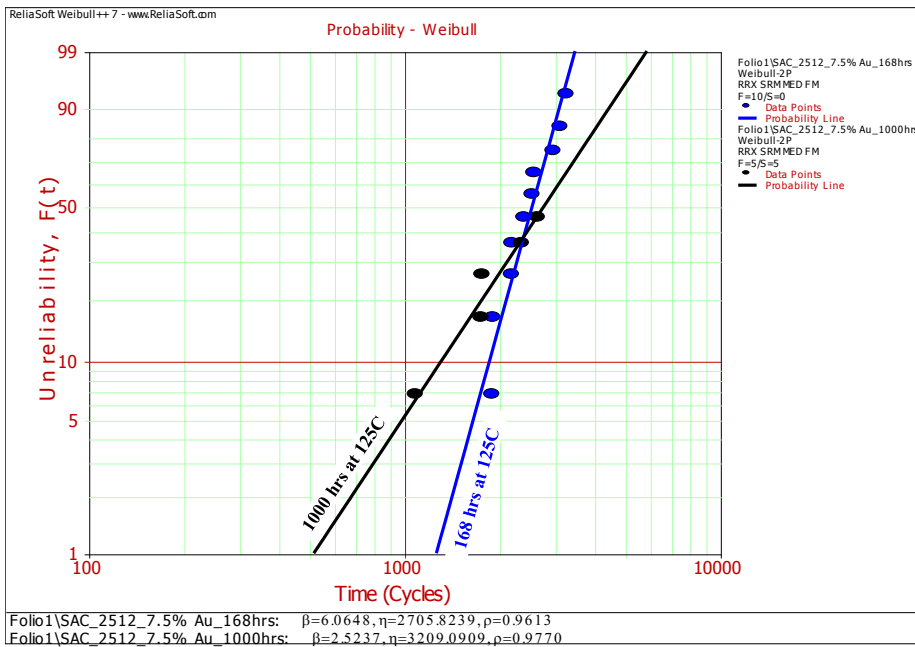
Weibull plots showing the influence of aging time (168 vs. 1000 hours) and solder alloy (SAC305 vs. SnPb) are shown in Figure 29 and Figure 30.

Figure 29: Weibull plots of thermal cycling failures (0 to 100C) as a function of aging time (2512 Resistors, SAC305 with 7.5% Gold)

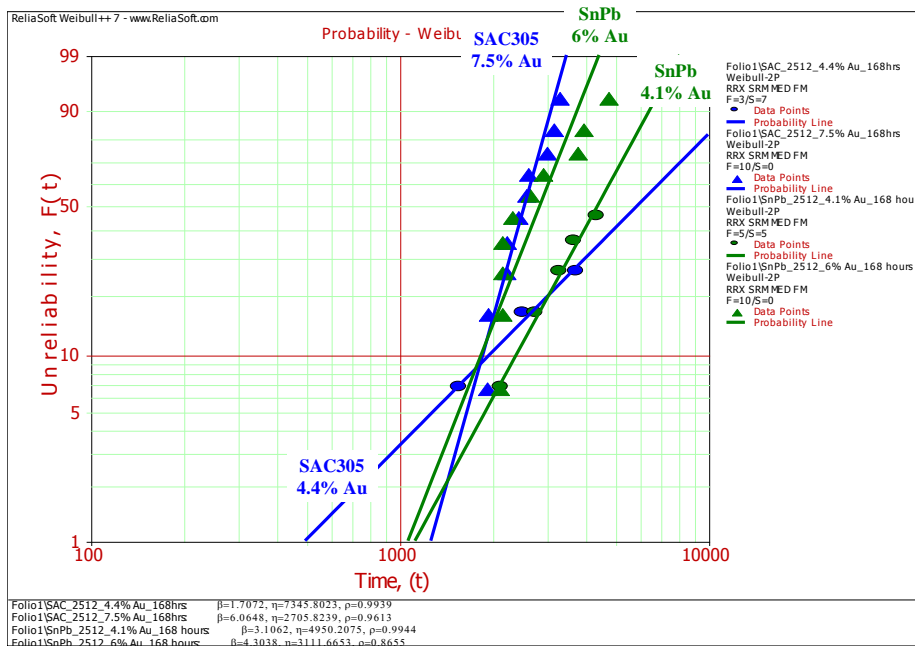
Figure 30: Weibull plots of thermal cycling failures as a function of solder alloy (2512 Resistors, Aged for 168 hours at 125C)

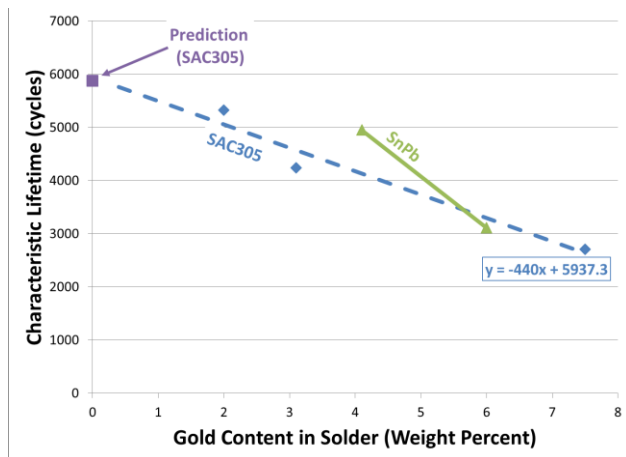
A plot of time to failure under temperature cycling as a function of gold content can be seen in Figure 31. All samples in Figure 31 were aged for 168 hours. A clear trend can be observed, with increasing gold content decreasing characteristic lifetimes by approximately 500 cycles / 1% Au for SAC305 solder.
