PCB SURFACE FINISHES & THE CLEANING PROCESS - A COMPATIBILITY STUDY

Umut Tosun, M.S.Ch.E., Naveen Ravindran, M.S.Ch.E.
ZESTRON Americas
Manassas, VA USA
u.tosun@zestronusa.com

Originally published in the Proceedings of SMTA International, Rosemont, IL, September 17 - 21, 2017

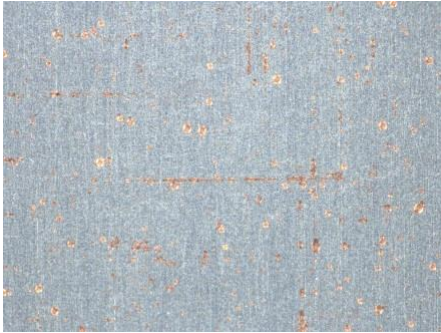
Figure 7B. Visual Inspection, Cleaning Agent A – Trial 4: Reflow, 6 Passes

- Cleaning Agent A (dynamic surfactant, uninhibited) adversely affected the Immersion Silver plating. The plating removal was most severe for trials 2 (no reflow - 6 passes) and 4 (reflow - 6 passes). Reference Figures 7A and 7B.
- Cleaning Agent C (dynamic surfactant, inhibited) had no affect under all conditions. Reference Figures 8A and 8B.
- Cleaning Agent D (pH neutral, inhibited) had no affect under all conditions. Reference Figures 8C and 8D.
- Cleaning Agent B (micro phase, uninhibited) had a slight affect for Trial 14 (no reflow - 6 passes). Reference Figure 9.

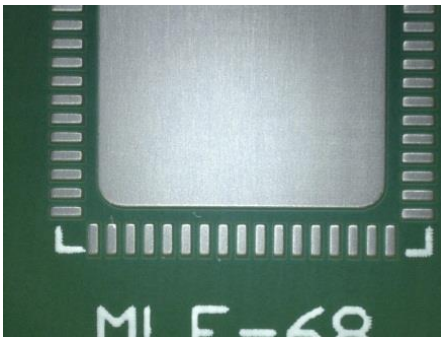
Figure 8A. Visual Inspection, Cleaning Agent C – Trial 26: No Reflow, 6 Passes

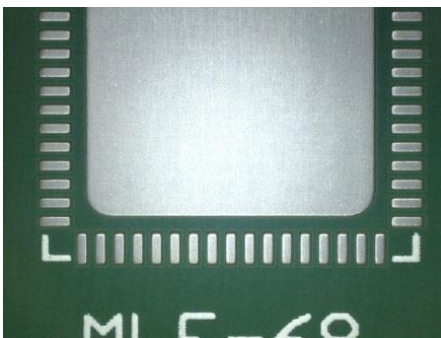
Figure 8B. Visual Inspection, Cleaning Agent C – Trial 28: Reflow, 6 Passes

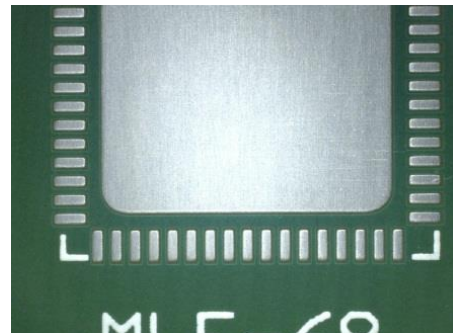
Figure 8D. Visual Inspection, Cleaning Agent D – Trial 40: Reflow, 6 Passes

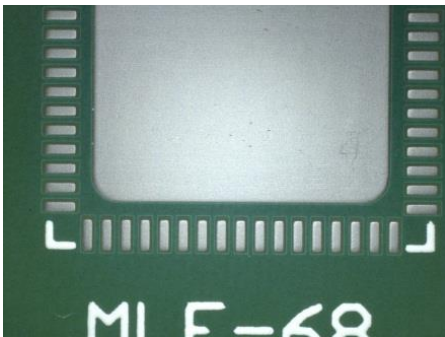
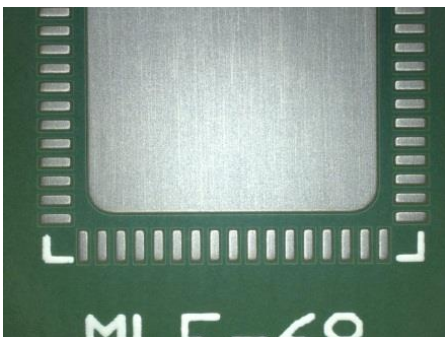
Figure 10A. Visual Inspection, Cleaning Agent A – Trial 10: No Reflow, 6 Passes

Figure 10B. Visual Inspection, Cleaning Agent A – Trial 12: Reflow, 6 Passes

As the results were consistent for all variables evaluated, representative pictures from the most challenging process variables, 6 (six) passes, reflow and Cleaning Agent A (dynamic surfactant, uninhibited) are detailed in Figures 10A and 10B.

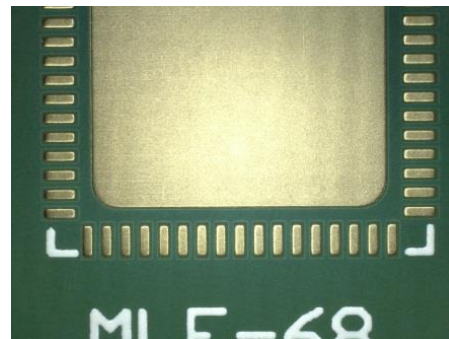
Figure 11A. Visual Inspection, Cleaning Agent A – Trial 6: No Reflow, 6 Passes

Figure 11B. Visual Inspection, Cleaning Agent A – Trial 8: Reflow, 6 Passes

As the results were consistent for all variables evaluated, representative pictures from the most challenging process variables, six (6) passes, reflow and Cleaning Agent A (dynamic surfactant, uninhibited) are detailed in Figure 11A and 11B.

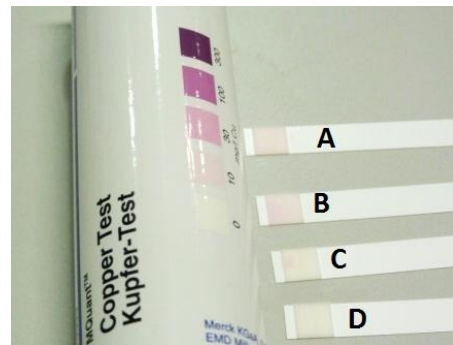
Figure 14A. Copper Test, Cleaning Agent C – Trial 26: No Reflow, 6 passes

Figure 14B. Copper Test, Cleaning Agent D – Trial 38: Reflow, 6 passes

Cleaning Agent B (micro phase, uninhibited), Cleaning Agent C (dynamic surfactant, inhibited) and Cleaning Agent D (pH neutral micro phase, inhibited) had no affect on the Immersion Silver plating. Reference Table 11. It was further noted that the inhibited cleaning agents, that is Cleaning Agent C and Cleaning Agent D, seemed to protect the exposed copper on the boards. This conclusion is derived from the results of the copper test wherein the boards cleaned using these cleaning agents showed a lower concentration of exposed copper than unprocessed control boards (reference Figures 14A and 14B).

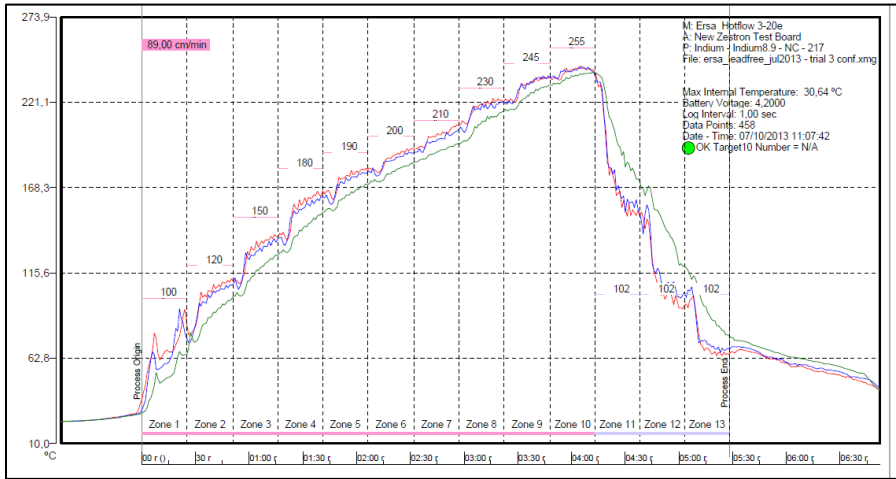
Reflow Profile:

Recommended Lead-free Reflow Oven Settings (°C)											
	Zone 1	Zone 2	Zone 3	Zone 4	Zone 5	Zone 6	Zone 7	Zone 8	Zone 9	Zone 10	Cooling
Top	100	120	150	180	190	200	210	230	245	255	3 Zones
Bottom	100	120	150	180	190	200	210	230	245	255	3 Zones
	Fan Speed at 50%							Fan Speed at 60%

The DOE was developed to challenge the evaluation. Thus, with regard to reflow, a lead-free profile was selected due to its higher peak temperature, thereby increasing potential impact on the surface finishes. However, to fully understand the impact of the reflow process as it relates to the cleaning process, boards that were and were not reflowed were each subjected to the cleaning process. Reference Table 2 in the Appendix for the reflow oven zone temperatures and the profile curve.
