# RELIABILITY TESTING FOR MICROVIAS IN PRINTED WIRE BOARDS

Bill Birch  
PWB Interconnect Solutions Inc.  
Nepean, Ontario, Canada  
bill.birch@pwbcorp.com

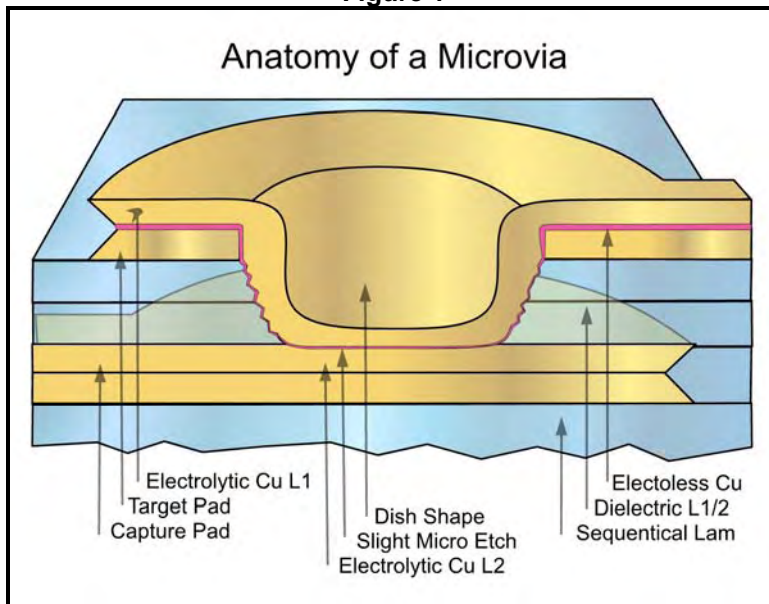
Figure 1

The anatomy of a well produced microvia is processed with a dish shaped profile (see figure 1), rather than a straight or angle sidewall. Processing should achieve an even distribution of electroless copper and electrolytic copper, from the surface foil capture pad down to the target pad. The side wall of the microvia should be relatively smooth, with minimal glass fibers protruding into the microvia, which has proven to inhibit the ability of chemistries to penetrate down onto the target pad.

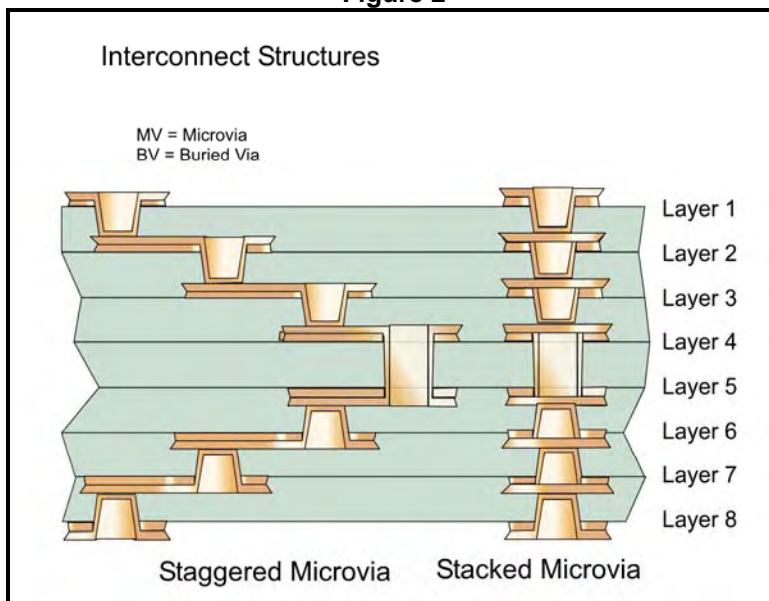
Figure 2

Microvia produced over the past 5 to 10 years are commonly created between two adjacent layers, but the advent of products requiring HDI technology, especially hand-held computers necessitate multi-level microvias that traverse sequential layers. Each level of microvias may be staggered in an offset arrangement or stacked on top of each other in the same x/y location (See Figure 2).

Graph 5 compares 3 stacked microvias attached to a buried via versus 3 staggered microvias, with the lowest microvia being attached to the buried via (see figure 2 for illustration of stacked and staggered).

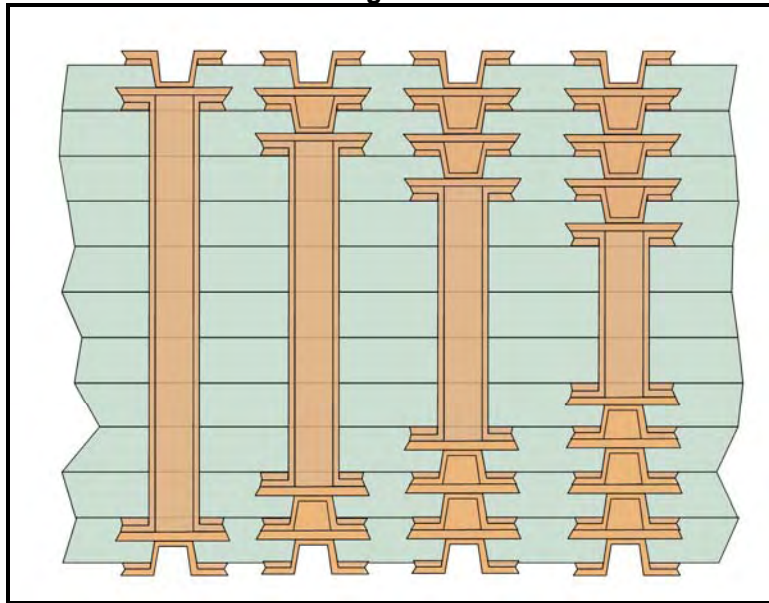
Figure 3

Stacked microvia require duplicating and/or additional process steps in fabrication, including the filling of the microvia which establishes an ability to sequentially ablate additional vias into a structure containing 2, 3 or 4 microvias stacked on both sides of the substrate (See Figure 3).

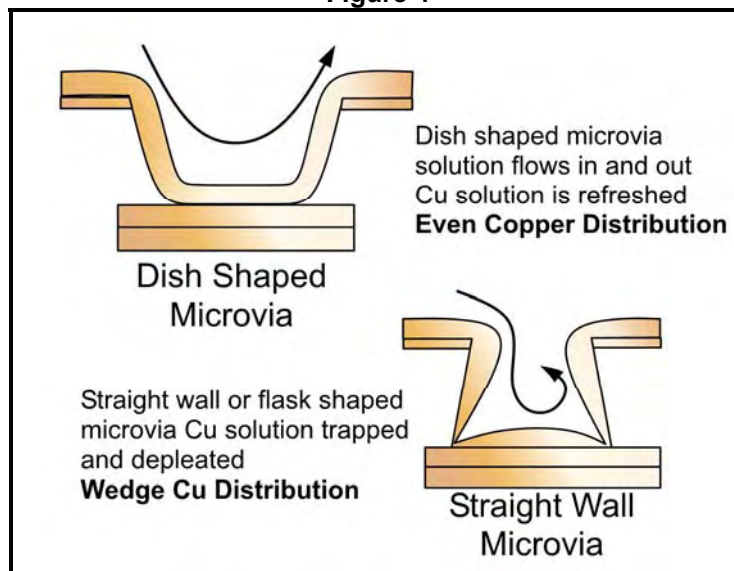
Figure 4

The critical processing steps involved in producing a reliable conductive structure capable of carrying an electrical current between two or more layers includes; laser ablation, chemical cleaning, “desmearing” (chemical removal of excess resin), micro-etching, electroless copper or direct metallization, electrolytic copper plating and possibly hole filling. The small geometries of the microvia features create a number of complex manufacturing challenges, requiring excellent process controls in both equipment and in the processing lines that most affect the capability to produce consistent conditions (laser ablation, metallization line and electroplating line). The fundamental considerations are relative to the surface tension and that fluid viscosity limits the numerous process chemistries ability to remove spent solutions and replace it with fresh chemistry (See Figure 4).

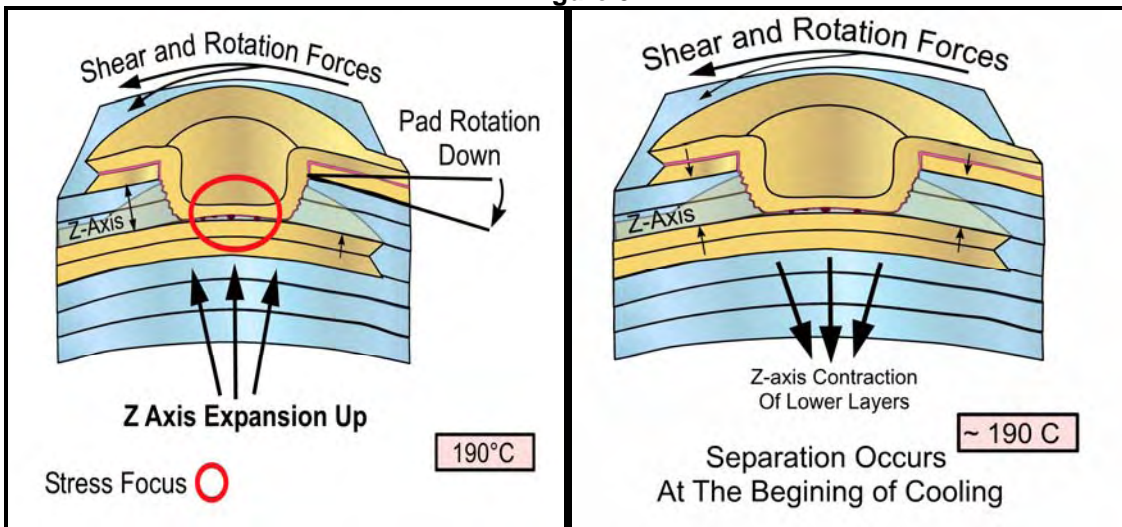
Figure 5

**THE PHYSICS OF MICROVIA FAILURE** - The majority of the strain exerted on a microvia is from the Z-axis expansion of the dielectric. As the dielectric is heated it expands. The coefficient of thermal expansion (CTE) is the change in thickness of the dielectric per degree centigrade. The CTE of dielectric materials used in PWB fabrication are measured in part per million per degree centigrade (ppm/C). Thermal analysis of the FR4 epoxy glass laminate show a CTE that is constant until the glass transition temperature (Tg). At the glass transition temperature the CTE increases by a factor of 8 to 10. A typical CTE of a multilayer PWB is around 30 ppm/C before Tg and then increase to 250 to 300 ppm/C after Tg. Tg is usually found to be between 150°C and 180°C. at temperatures above Tg the amount of strain exerted on the system is significantly increased (See Figure 5) .

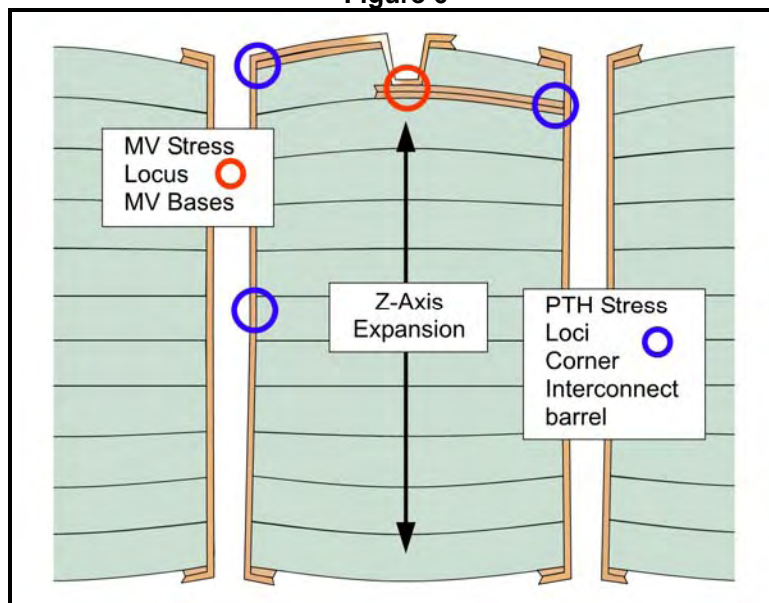
Because the microvia dielectric is very thin (0.05mm/.002" to 0.15mm/.006"), the amount of strain in the microvia structure is low as compared to a PTH or other interconnect structures. Figure 6 illustrate the most common location where stain is applied to PTH and microvia structures. Considering is the PWB is correctly fabricated, the hierarchy of influence for stain distributions is as follows; PTH barrel (central zone), corner/knee, internal interconnect, followed lastly by the microvia. In the typical HDI board construction the microvias are frequently found only on the outer layers of the board, the surface layers are not inhibited and move in unison with the z axis expansion, creating a movement like a "springboard", literally moving freely without constraint

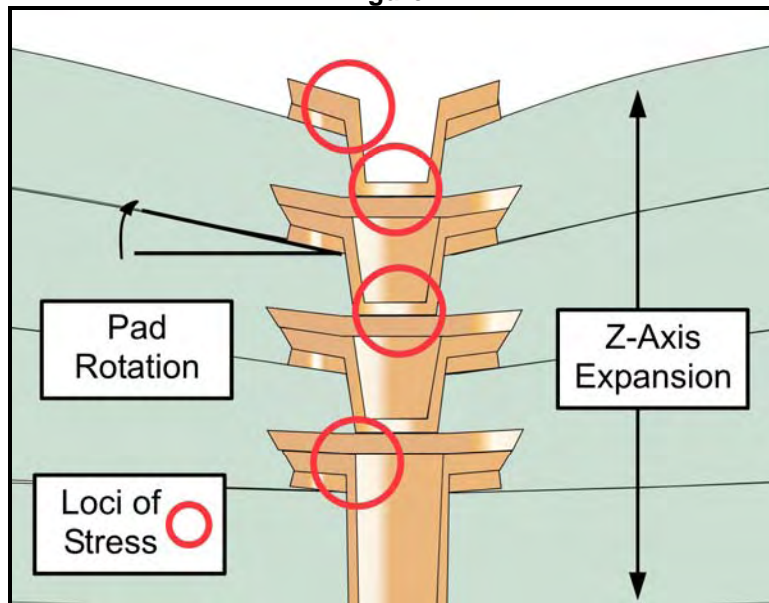
Figure 7

Obviously, as additional vias are added to the structure the stress levels are increased relative to the increased dielectric distance between the upper capture pad and lower target pad. The focus of the stress concentrations are now distributed over a wider range of interconnections, primarily any interface between each two levels of microvias (See figure 7).

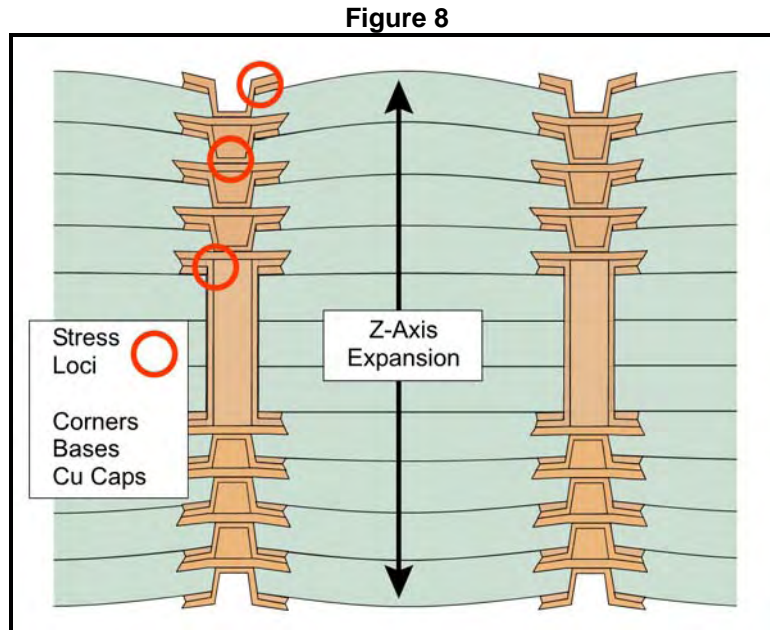
Figure 8 describes the appearance of a “4 n 4” construction, where a PTH is not used in the product to create an interconnection. For this type of build the hierarchy of influence for failure are relatively equally divided across the lower attachment to the buried via, corner/knee and central zone of the via stack. The buried via is generally created on a thin dielectric material and is not usually affected by x, y axis expansion . The exception to this rule is when a plated cap is applied on either side of the buried via, the buried via can experience higher level of z axis being applied by the stacked via “pulling away” from either side (see failure modes for more details).

The hierarchy of failure would normally be applied equally on both sides of the construction, although the deciding factor would be the component placement used in the actual product. If a large device (BGA etc.) was attached on the top side, the additional detrimental influence of the CTE mis-match between the FR4 and package material would bias the hierarchy toward the device side of the substrate. The resulting loads would be a combination of thermal (x, y and z axis) and mechanical stresses applied (device moving upwards and away) to the structure.

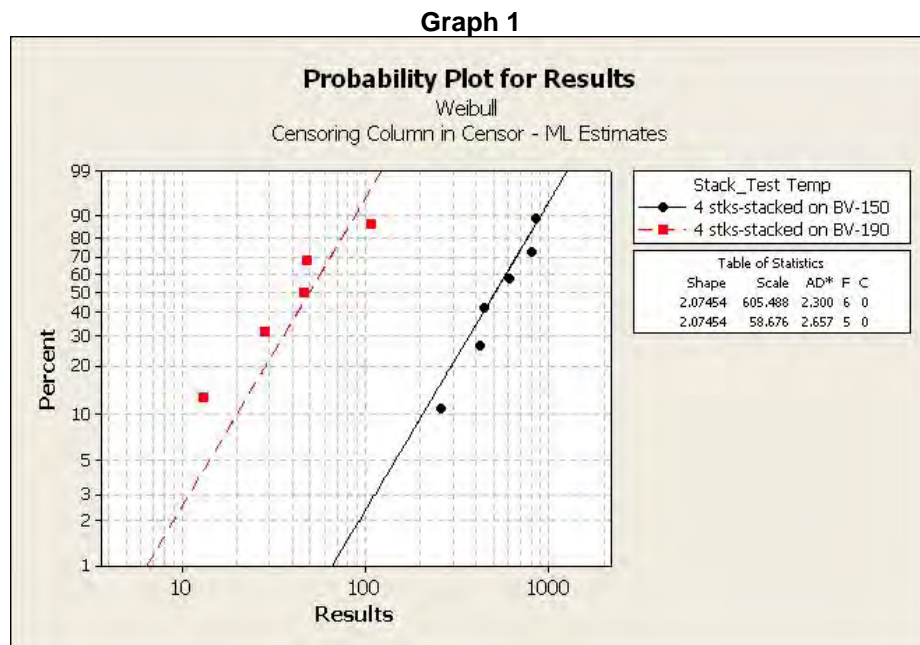
Graph 1 is critical to the importance of understanding why higher test temperatures are required to discern acceptable from questionable results from microvia testing. Identical coupons produced on the same test panel with 170°C Tg material, constructed with 4 stack microvias on either side of a buried via, were tested without assembly stresses at temperatures of 150°C and 190°C. The mean cycles to failure ranged from approximately 600 to 60 respectively, a 10X acceleration. From a test time perspective this equates from 3 days to 5 hours on IST, the equivalent cycles in the thermal shock oven would be 24 days (probably even longer because of the lower test temperature). The performance achieved in the 150°C testing would have been considered acceptable to virtually all documented customer specifications.

The shape of the lines are virtually the same, this indicates that the failure mode is expected to be the same. The results in graph 1 do not appear that unusual until the performance of the 4 stack microvias are compared to similar products (built on the same test panel) constructed with fewer levels within the stacked microvias. Graph 2 compares 2, 3 and 4 stack structures, not on a buried via, tested at 190°C. The shape of the lines again confirm similar failure modes should be expected, despite the differences in constructions.

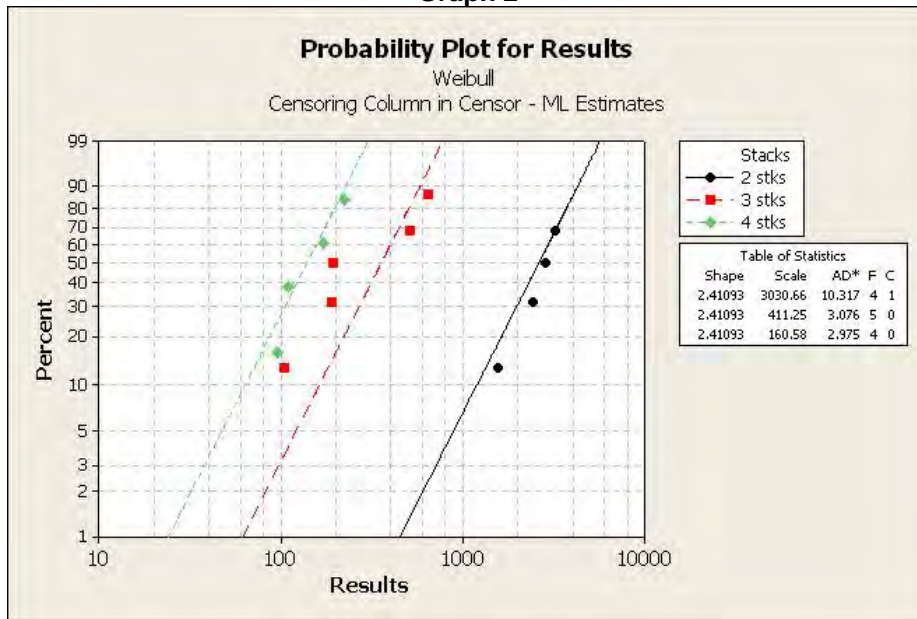
**Graph 2**

The mean cycles to failure range from approximately 3000 (2 stack), 400 (3 stack) and 160 (4 stack). It is now possible to establish a relative performance between the different structures, clearly the migration from 2 stack to 4 stack demonstrates a potential for a 20X reduction in cycles to failure. What is also important to consider is that the 2 stack construction achieved a mean of 3000 cycles when tested at 190°C, subsequent failure analysis confirmed the material was not severely degraded by the excessive cycling at relative high temperature. From a test time perspective duration ranged from 12 days, 2 days to 17 hours respectively. Thermal shock ovens would take approximately 120 days to complete 3000 cycles.

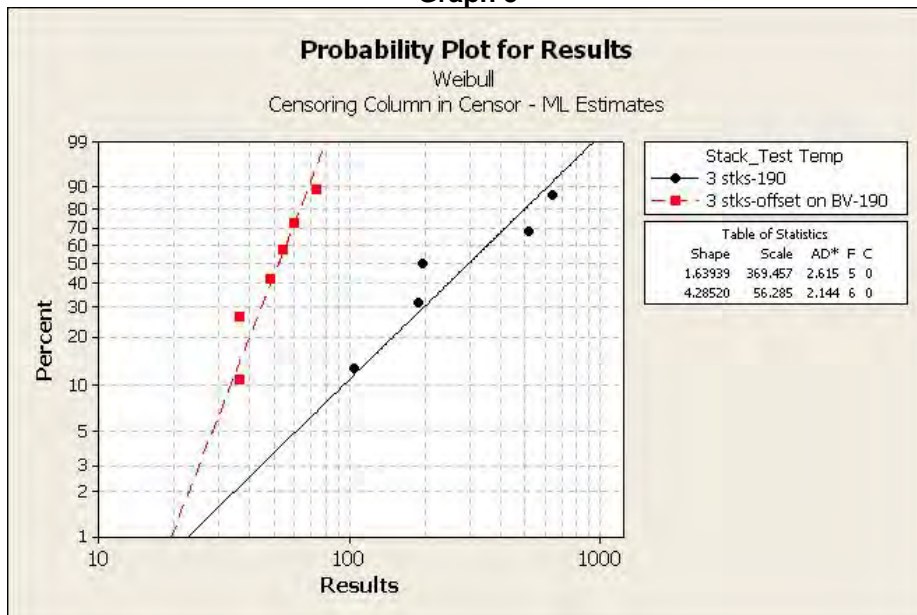
**Graph 3**

Graph 3 compares 3 stack microvias with and without attachment to a buried via. Firstly, the line shapes are different, indicating that the two configurations failed in different ways. Although the 3 stack on buried via failed relative early (mean 56 cycles), the shape of the data is consistent, meaning that predicting the performance can be completed with high confidence. The 3 stack without buried via attachment is quite scattered, indicating that more than one mechanism is responsible for the failure

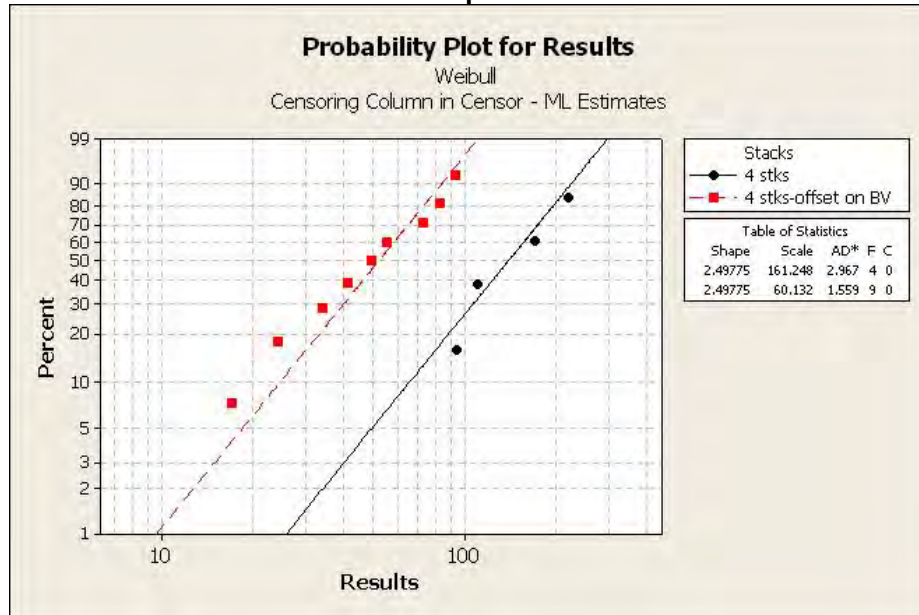
**Graph 4**

Four stack with and without attachment to a buried via are compared in graph 4. The cycles to failure are dramatically reduced, the mean without buried via attachment was approximately 160 cycles, with buried via 60 cycles. The trend is consistent to the 3 stack results confirming the attachment to the buried via is detrimental to the performance of the stack via structures. The line shapes are similar, so the expectation is that the failure is occurring in the same location within the stack structure

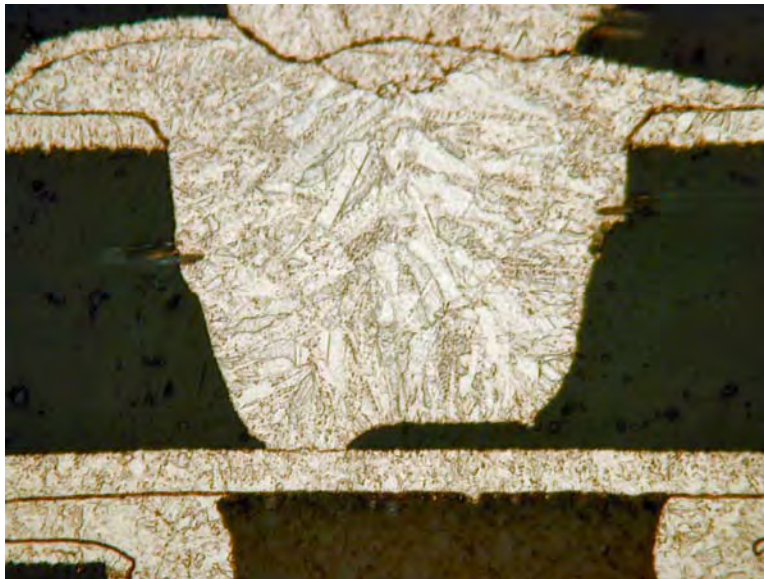
**Photo 1**

**INTERFACE SEPARATIONS** – The most common failure mode for microvias is a separation between the base of the microvia and the target pad. This failure mode presents itself as a catastrophic failure that is usually observed as the structure enters into a cooling phase. The condition is created by a number of factors, but the most common root causes are; Under-ablation, where resins are not sufficiently removed due to incorrect energy levels or poor trepanning techniques, creating a non-conductive barrier between the target pad and subsequent metallization (See Photo 1).

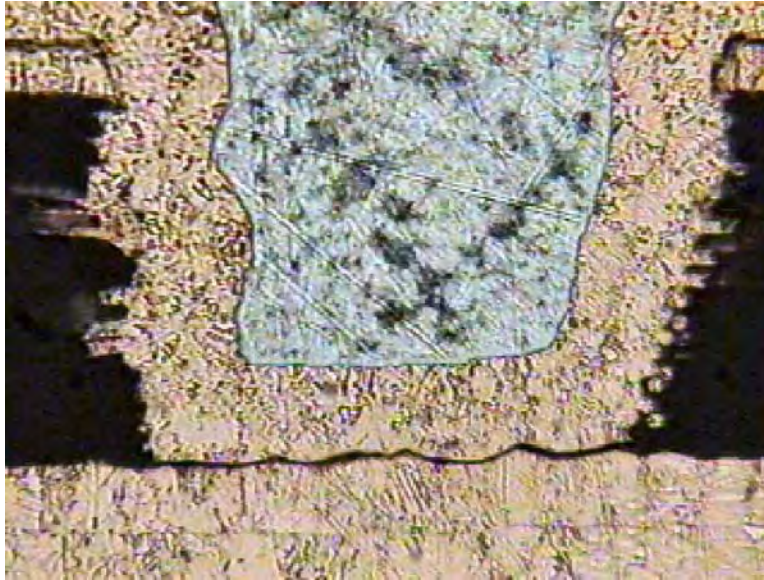
**Photo 2**

Poor/Limited micro-etching of the target pad, preventing a strong chemical bond from being established, the area below the microvia should exhibit a slight micro-etch, this confirms the target pad was chemically cleaned before the copper plating was deposited into the via.

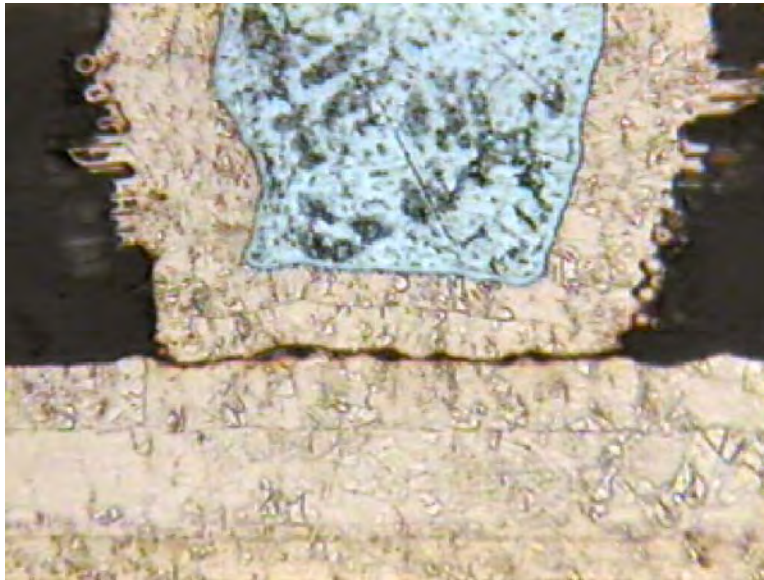
**Photo 3**

Insufficient desmear causing the by-product from the ablation process (ash) to become entrapped at the interface between different metal layers, this residue creates perforations (small spherical matter) between the metals and weakens the critical chemical bond.

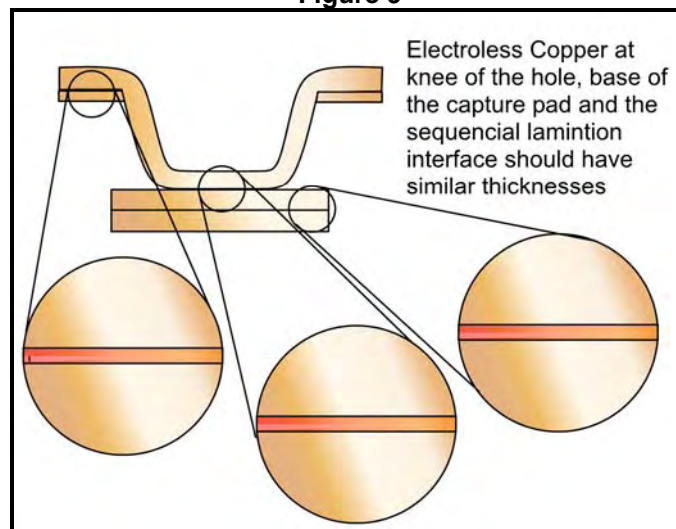
**Figure 9**

Confirming the presence of evenly deposited electroless copper is an important function during failure analysis. In some PWB manufacturing facilities the electroless copper is followed with a thin electrolytic copper flash, designed to “protect” the electroless in subsequent processing. Figure 9 is designed to indicate the areas that should be visually compared for determining the consistency of the electroless deposit.

Note: If the PWB supplier is using a direct metallization (palladium, carbon, conductive polymer, etc.) plating line there will/should not be a demarcation line between the different copper deposits. This situation makes the failure analysis more complicated when attempting to determine the root cause within the manufacturing process. When completing any reliability testing on microvia structures it is important to understand the method of metallization used and convey this information to the individuals or companies responsible for completing the failure analysis.

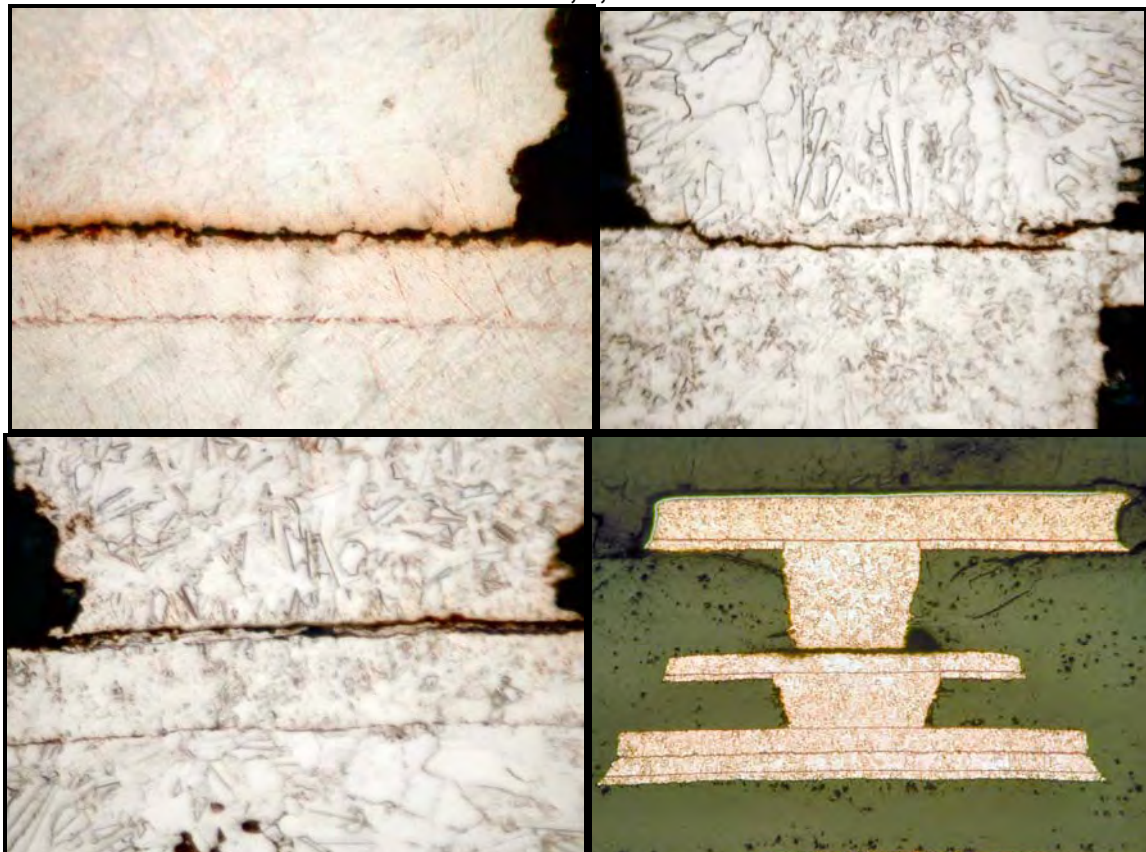
**Photo's 4, 5, 6 and 7**

Photo's 4 through 7 are associated to different types of interface failures, they are not intended to be inclusive, but give illustrations of the many diverse appearances that are commonly found with microvia failures.

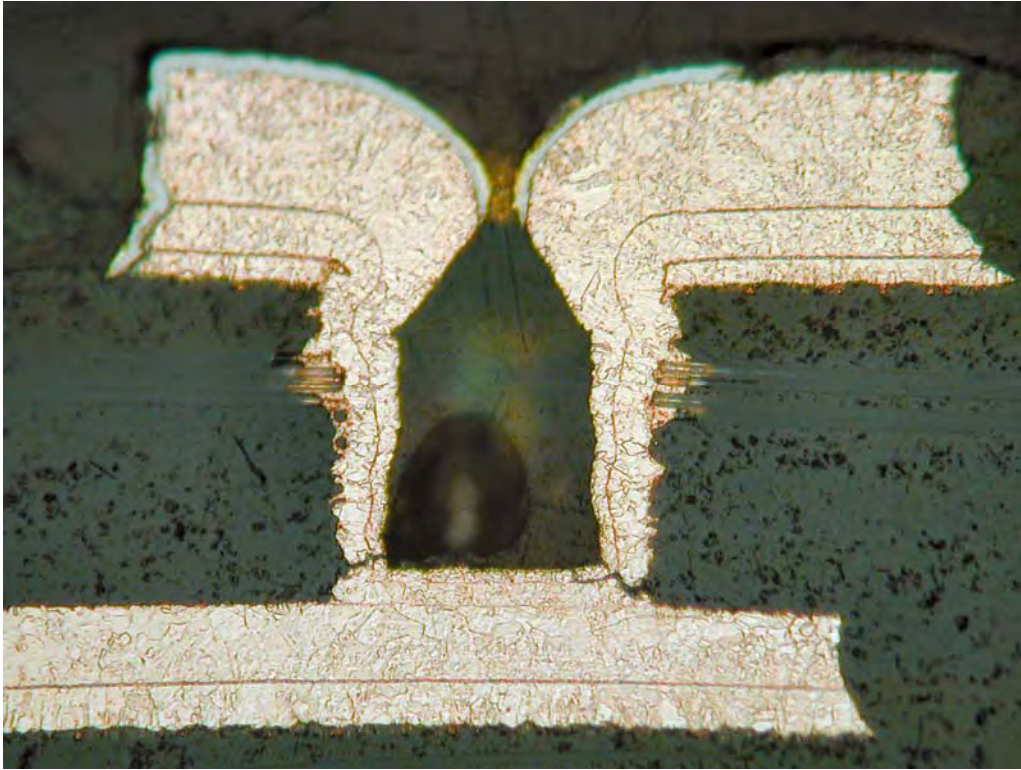
**Photo 8**

**MICROVIA BARREL CRACK** – A barrel crack is associated with thin (often localized) electrolytic copper plating, usually found with a taper toward the base of the microvia. It is common to see a thick copper deposit near the surface, reducing down to very thin at the point of attachment to the target pad.

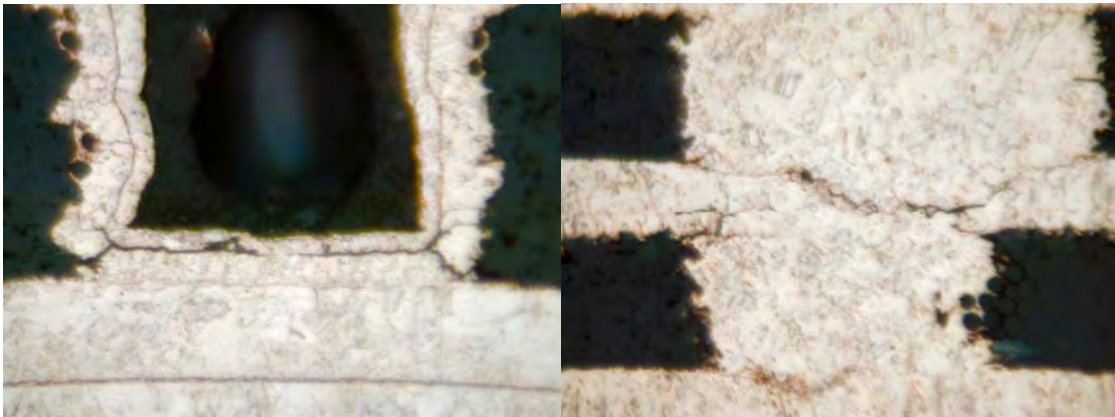
**Photo's 9 and 10**

All plating irregularities/problems are principally related to a dysfunctional combination of chemistry and equipment. In many cases PWB manufacturers use different suppliers for various chemical components within the metallization line; this can create chemical incompatibilities between critical preparation steps (cleaning, desmearing, micro-etching, glass-fibre etching, conditioning, activation, etc.) The type of equipment used must be considered of primary importance to the success of achieving an overall capability and compatibility, the chemical supplier and equipment supplier should be working in concert, as a single entity to assure the ability to produce consistent and robust microvia structures. Reliability testing confirms that a crack in the barrel of a microvia is a wear out type failure mode. The via can withstand the high stress associated with assembly, without creating an intermittent connection, over time the conductive path will degrade and result in a high resistance, or open state.

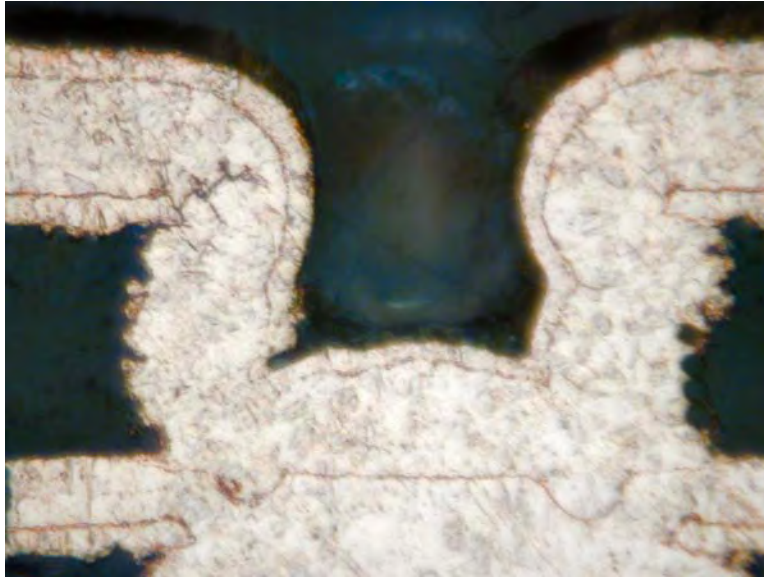
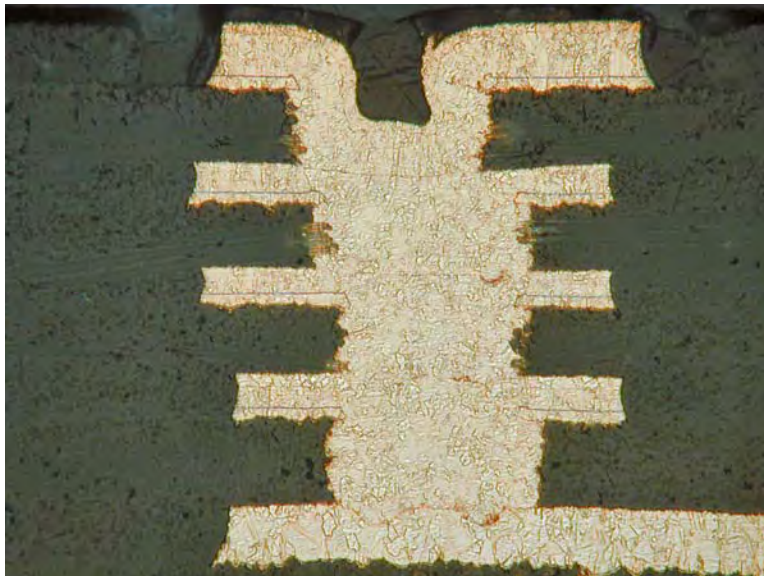
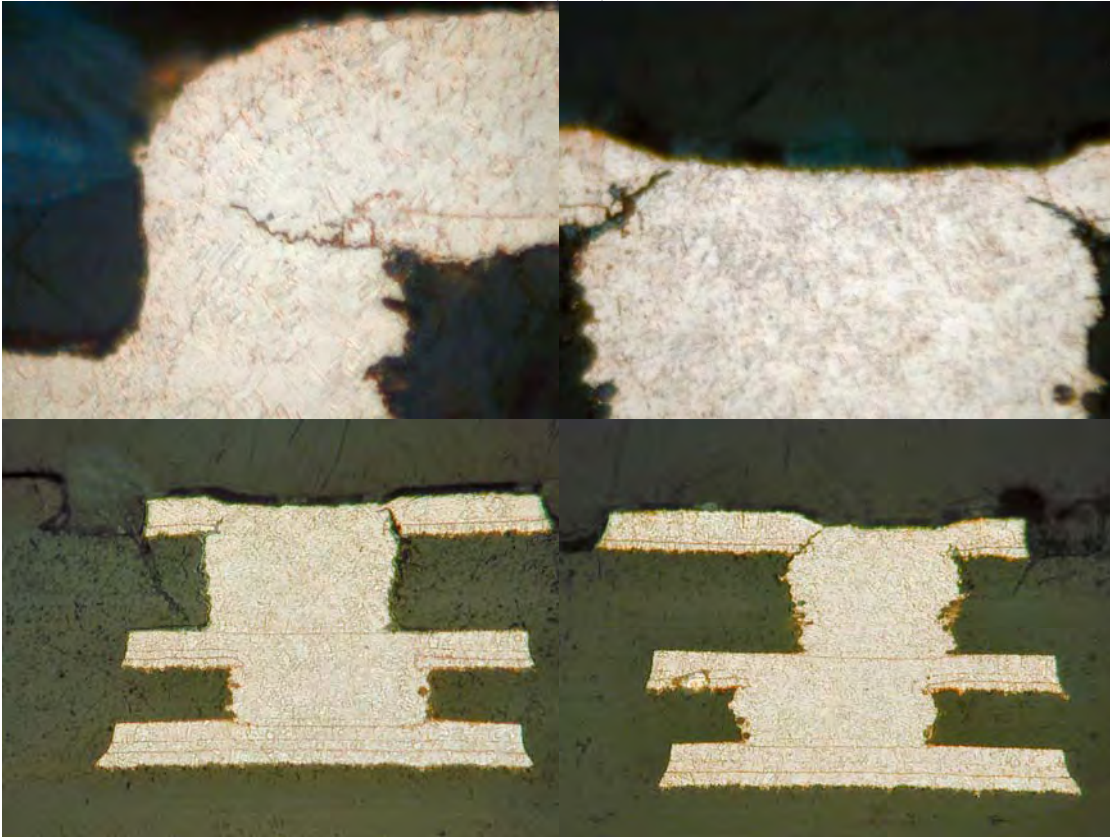
**MICROVIA KNEE/CORNER CRACK** – A crack that occurs at the junction between the microvia knee/corner and the capture pad, The cracks are often present in products that experience an overly aggressive copper removal operation (planarization), resulting in very thin pads, usually only copper foil remains, with all microvia electrolytic copper plating being removed.

When the knee/corner plating is removed it creates a “butt-joint” junction between the pad and via plating, during pad rotation this junction is compromised. The damage is initiated by high z-axis expansion of the dielectric between the capture pad and the target pad, commonly during component assembly, or more probably a local rework procedure. Considering that conventional operating temperature and the dielectric spacing between the two layers, which is commonly between 0.05mm (.002”) and 0.15 mm (.006”), it is unlikely that enough CTE can be generated to initiate damage, or propagate a crack. The concern for this failure mode would be the CTE mismatch between the PWB and the device, which would result in increased pad rotation caused by the mechanical stress “pulling” the pad off of the upper section of the microvia. An analogy to this condition would be pad-cratering, where the surface pad is literally torn away from the outer surface resin. If the junction between the microvia and surface pad are compromised this failure mode could materialize. Following crack initiation a microvia knee/corner crack is a wear out type failure.

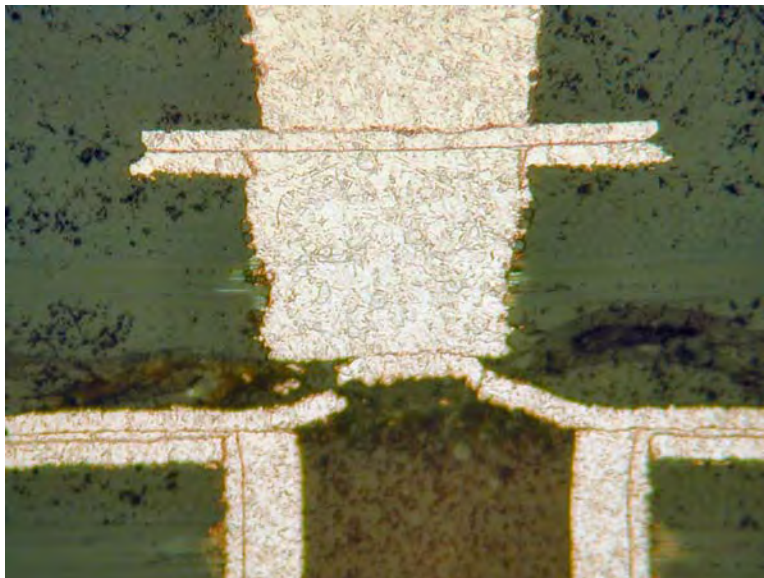
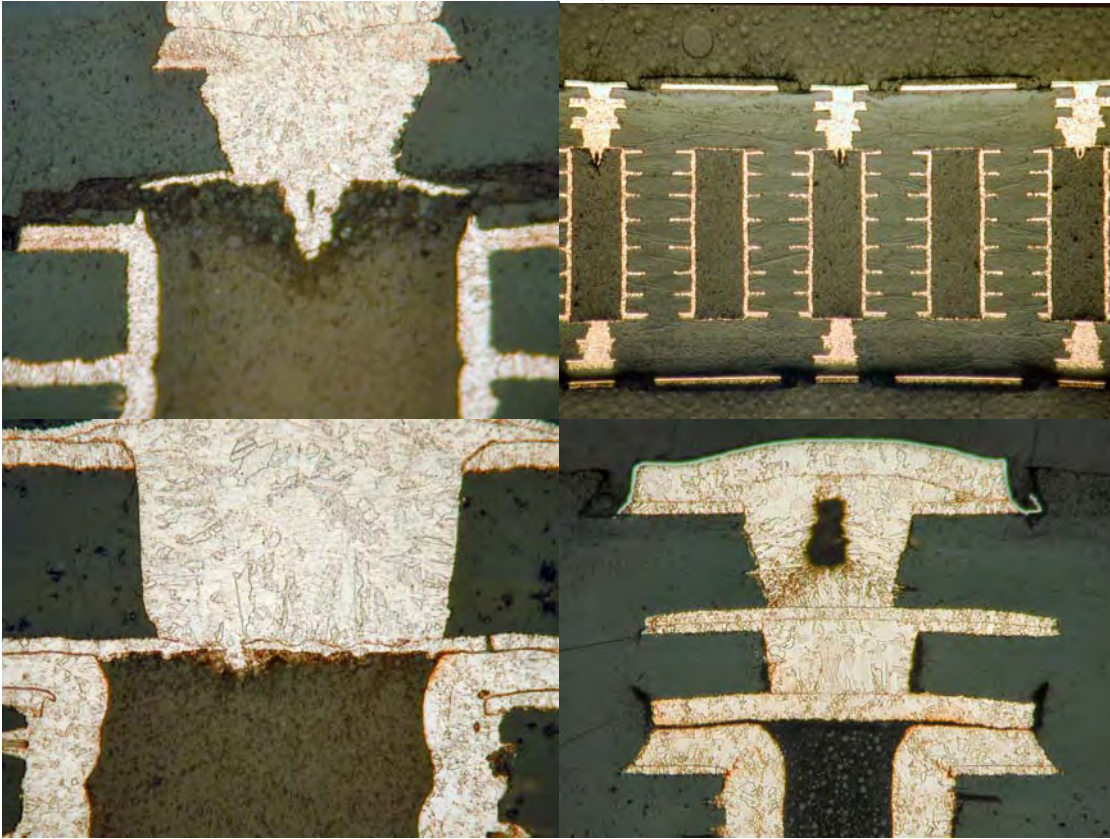
**TARGET PAD CRACKS** – Like knee/corner cracks microvia target pads can cracks, they sometimes referred to as ‘microvia pull out”, they occurs in response to the z-axis expansion or CTE mis-match creating stresses between the capture pad and the target pad. This failure mode is more often observed in thin substrate and flex circuits, especially those with an acrylic adhesive which usually have a higher CTE and lower Tg. If a stacked microvia structure use a non-copper fill material the via is required to have a conductive cap plated. The copper cap creates two secondary concerns; a) low adhesion strength between the electrolytic copper and the fill material, b) the relatively low ductility, elongation, tensile and peel strength of the plated copper compared to traditional copper foil.

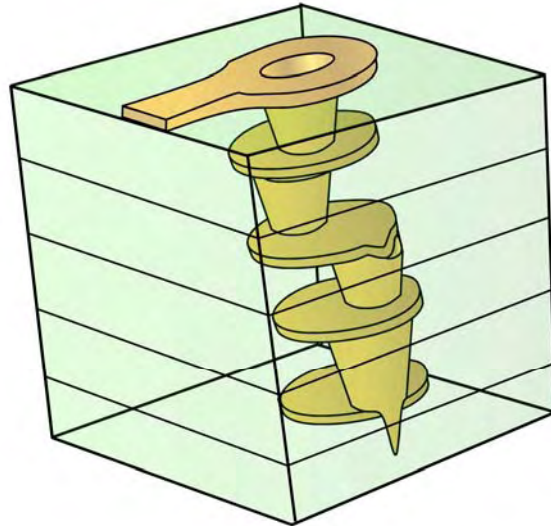
**Figure 10**

The combined influence of all manufacturing tolerances must be applied to each sequential lamination cycle, creating diverse registration concerns for stacked micro via structures. Registration systems must accommodate the increasingly challenging influences of tolerances associated to the primary collective effects of inter-layer material movement, laser ablation to feature alignment and direct or photo imaging registration. Each of these critical manufacturing process steps must be tightly controlled to avoid the risk of via to pad breakout, this requirement is further complicated by the multiplication of each individual tolerance level must be factored into a stacked micro via structure.

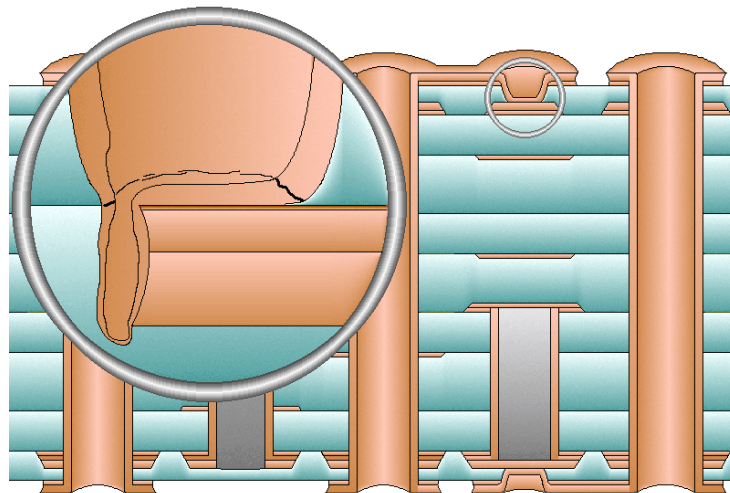
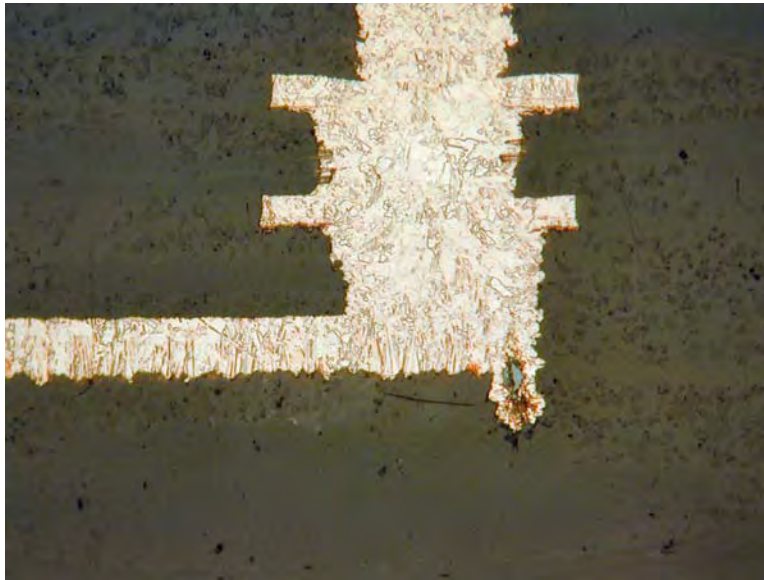
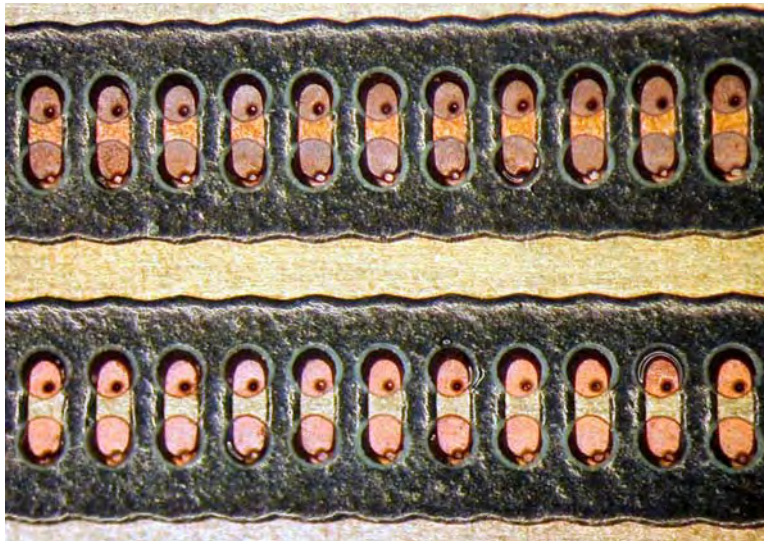
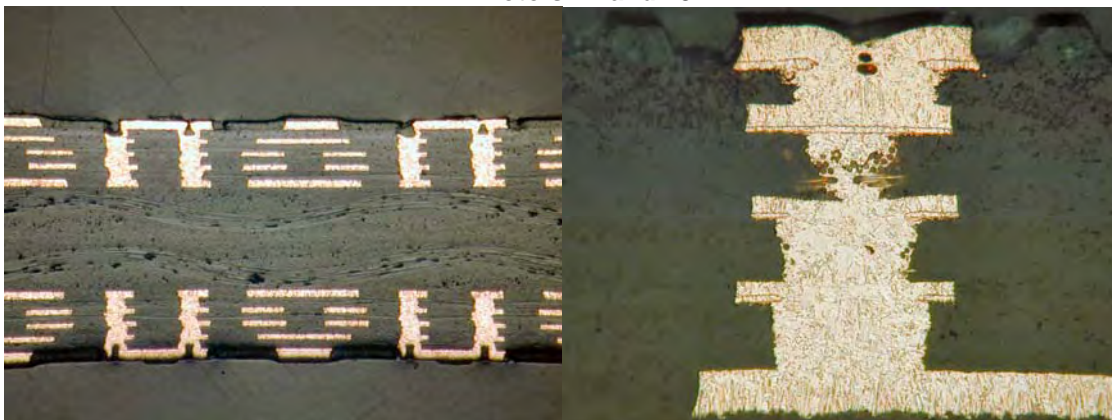
When considering the extreme complexities involved in assuring perfect registration in the build-up of a multi-level micro via structure it becomes statistically inevitable that misalignment will occur at one or more levels. This reality is realized during the micro-section analysis, although quantifying the extent of the condition is very difficult to determine. A traditional vertically ground and polished micro-section is capable of only exposing 1 degree of the via structures circumference, resulting in the remaining 359 degrees not being available to complete visible assessment. Figure 10 illustrates a condition where the surface microvia appears perfectly registered, the three lower levels of interconnection can misalign to the point of via to pad breakout.

**MICROVIA MIS-REGISTRATION** – There are two types of microvia mis-registration for single level structures; a) ablated hole to the capture pad, b) ablated hole to the target pad. In both cases these condition can result in opens or shorts that are detected by the PWB manufacturers automatic test equipment (ATE). Short circuits can be created in both the x/y and z directions; the z direction is due to the laser ablating through dielectric material adjacent to the edge of the pad, potentially penetrating down to an under-lying feature. The reliability concern would be the compromised/reduced dielectric spacing which would be vulnerable to a conductive anodic filament (CAF) type failure mode. The fact that a microvia is mis-registered does not necessarily signify a reduction in thermal cycles to failure, unless the reduced contact area is combined with a condition where the adhesion to the target pad has been compromised

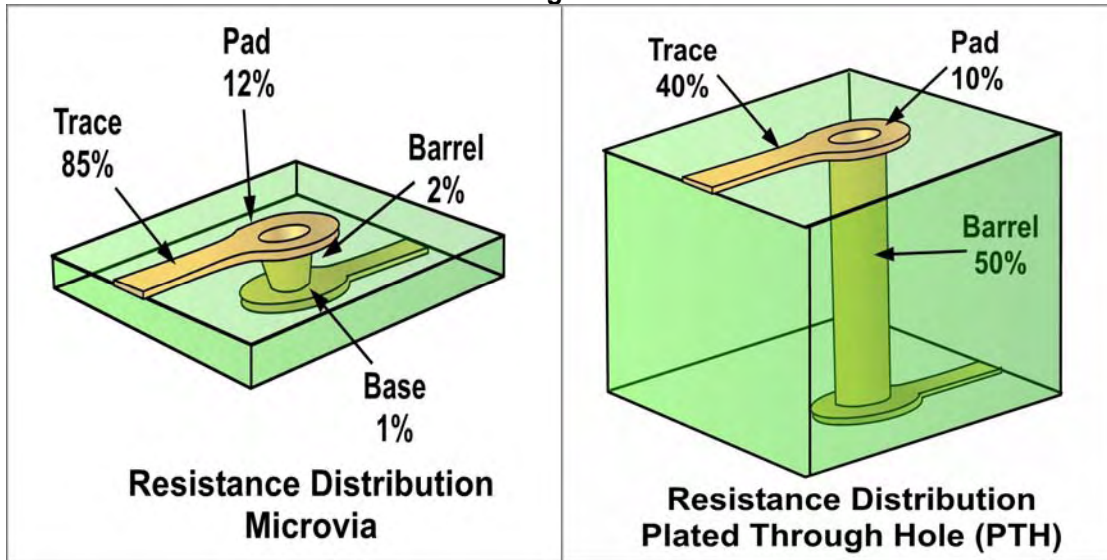
Each individual area is configured to achieve the highest level of sensitivity for measuring the slight changes that signify material degradation (delamination), moisture removal, Tg, Dk (Dielectric constant), dielectric thickness, temperature distribution (both across the surface and from the surface to the centre of the construction) and fatigue or failure to the interconnect structures. Additional information is available from the author that details each of the sections associated to an HDI coupon design. Refer to Figure 12 for an illustration of how the resistance distribution changes between a microvia and PTH structure, understanding these realities is key to successful coupon design.

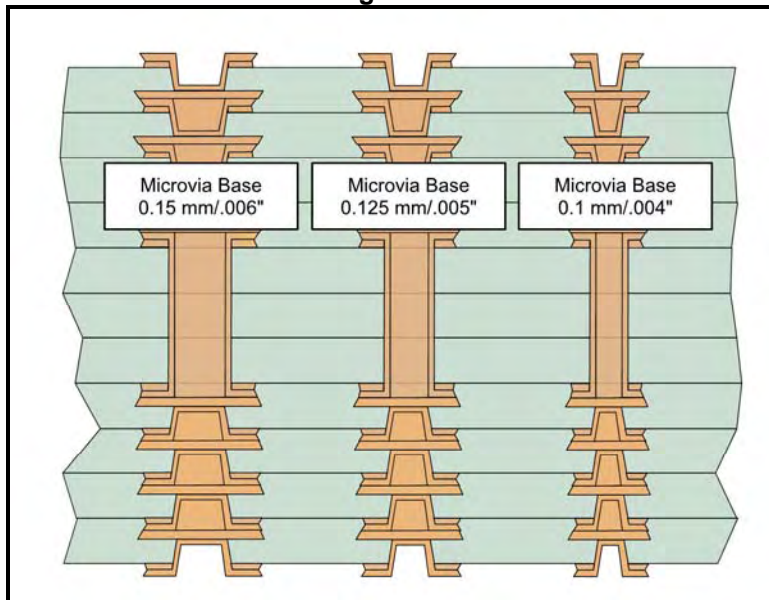
**Figure 13**

Figure 13 illustrates the relative appearance of 4 + 4 construction with microvia ablated at 3 different diameters.

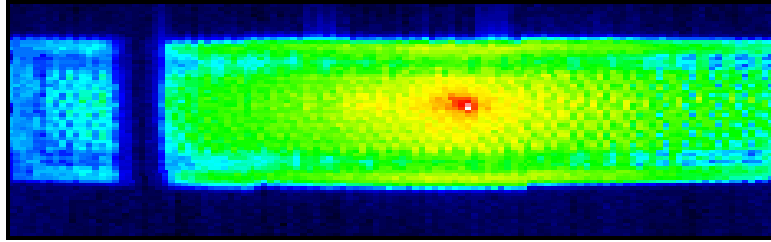
**Thermograph of a Failing Via  
Photo 26**

**MICROVIA FAILURE LOCATION** - In an IST evaluation testing automatically stops when a circuit reaches a 10% increase in resistance. The failing coupons have circuits that are still electrically conductive but have a modest increase in resistance. Because the test stopped well before catastrophic failure (open), it is possible to identify the exact microvia that is contributing the highest resistance to the circuit using thermo-graphic techniques. The worst-case microvia, in the coupon, may be identified using thermal imaging cameras in a technique called "failure location". Since the failed circuit has experienced only a 10% increase in resistance, a low level DC current can be applied, permitting the failing interconnection to heat locally. The compromised microvia has a higher resistance, compared to other (robust) microvias, and it will become the hottest structure in the coupon, and easily found using a thermographic camera. The thermographic camera allows direct visualization of the exact location of the weakest microvia (See Photo's 26 and 27). The worst case failing microvia is seen as a high temperature hot spot on the surface of the coupon. This is a powerful tool for finding failure locations for subsequent microsection analysis.

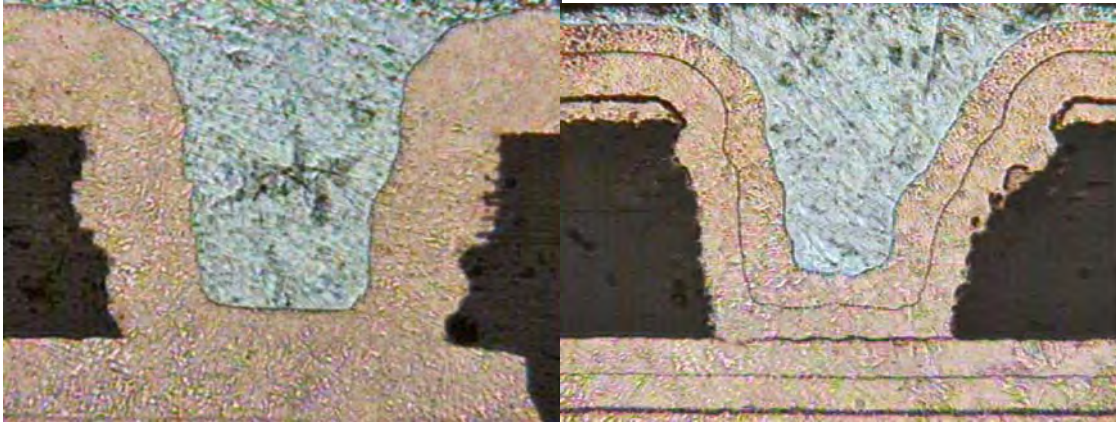
## An Un-Etched and Etched Microvia

In photos 28 and 29 a good microvia was photographed before and after etching to demonstrate the degree of detail that may be achieved. In photo 29 the layer one foil, electroless copper, interfaces between the bottom of the microvia and the target pad and the plating on the top of the target pad are easily visualized after a microetch. In photo 28 all internal detail is not visible. It was demonstrated that a well-controlled micro etch, using hydrogen peroxide and ammonium hydroxide, greatly enhances the physical details of the failing interconnect and improves the ability to objectively evaluate the causative mechanisms. Armed with these tools a comprehensive failure analysis can be achieved.
