# CREEP CORROSION ON LEAD-FREE PRINTED CIRCUIT BOARDS IN HIGH SULFUR ENVIRONMENTS

**Randy Schueller, Ph.D.**  
**Dell Inc., Austin, Texas**  
**randy\_schueller@dell.com**

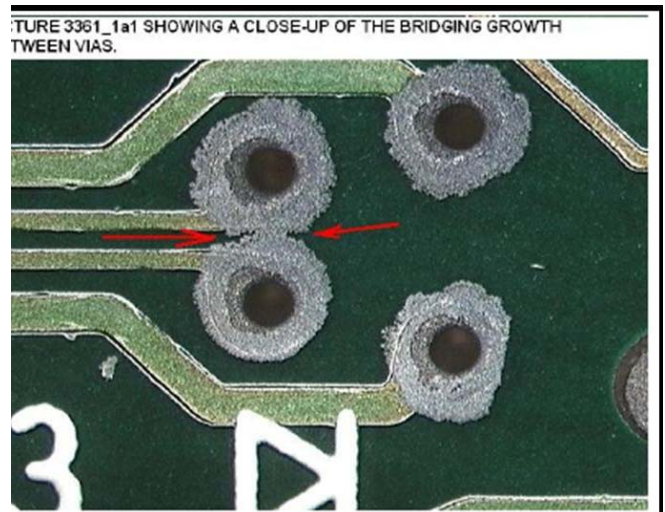
**Figure 1.** Creep corrosion field failure in high sulfur environment (bridging vias).

A typical creep corrosion failure is shown in Figure 1. Figure 2 provides an EDX spectrum of the corrosion product. It is primarily copper sulfide ( $\text{Cu}_2\text{S}$ ) with a small amount of silver sulfide ( $\text{Ag}_2\text{S}$ ). Studies have shown that high amounts of  $\text{Cu}_2\text{S}$  typically indicate the presence of active sulfur compounds such as elemental sulfur, hydrogen sulfide ( $\text{H}_2\text{S}$ ), or organic sulfur compounds [7]. Creep appears to begin by growth of dendrites, as shown on a HDD in an early stage of corrosion (Figure 3). However, this is not electro-chemical migration (voltage potential driven) dendritic growth, since creep takes place equally in

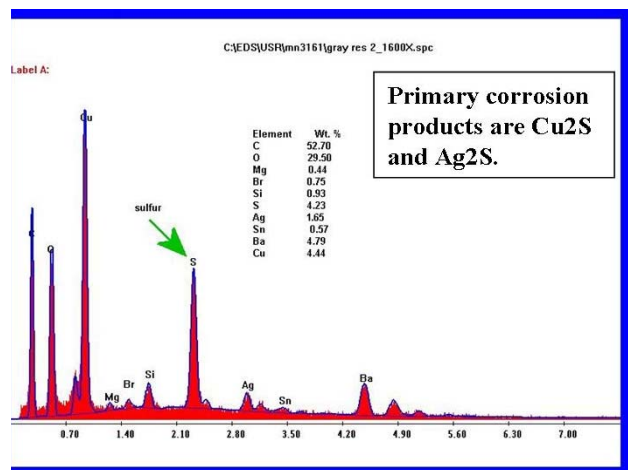
**Figure 2.** EDX of typical creep corrosion product.

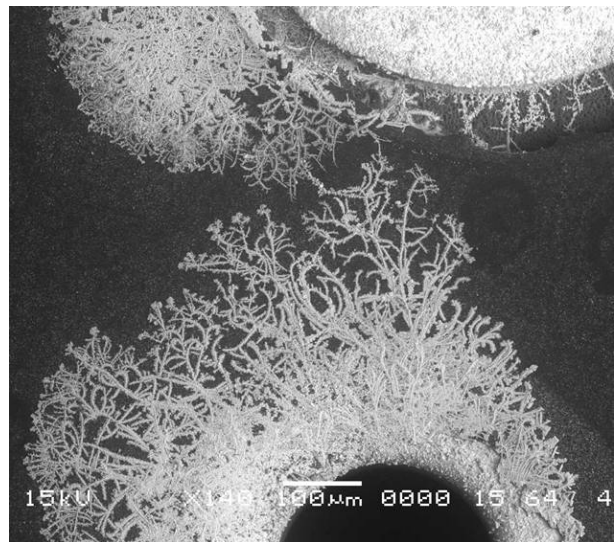
**Figure 3.** HDD with ImAg surface finish.  $\text{Cu}_2\text{S}$  precipitates out of solution in a dendritic structure.

all directions and does not require the board to be powered. Rather it appears that  $Cu_2S$  is being formed in a layer of moisture on the surface and precipitates out of solution as it forms (since  $Cu_2S$  is insoluble in water).

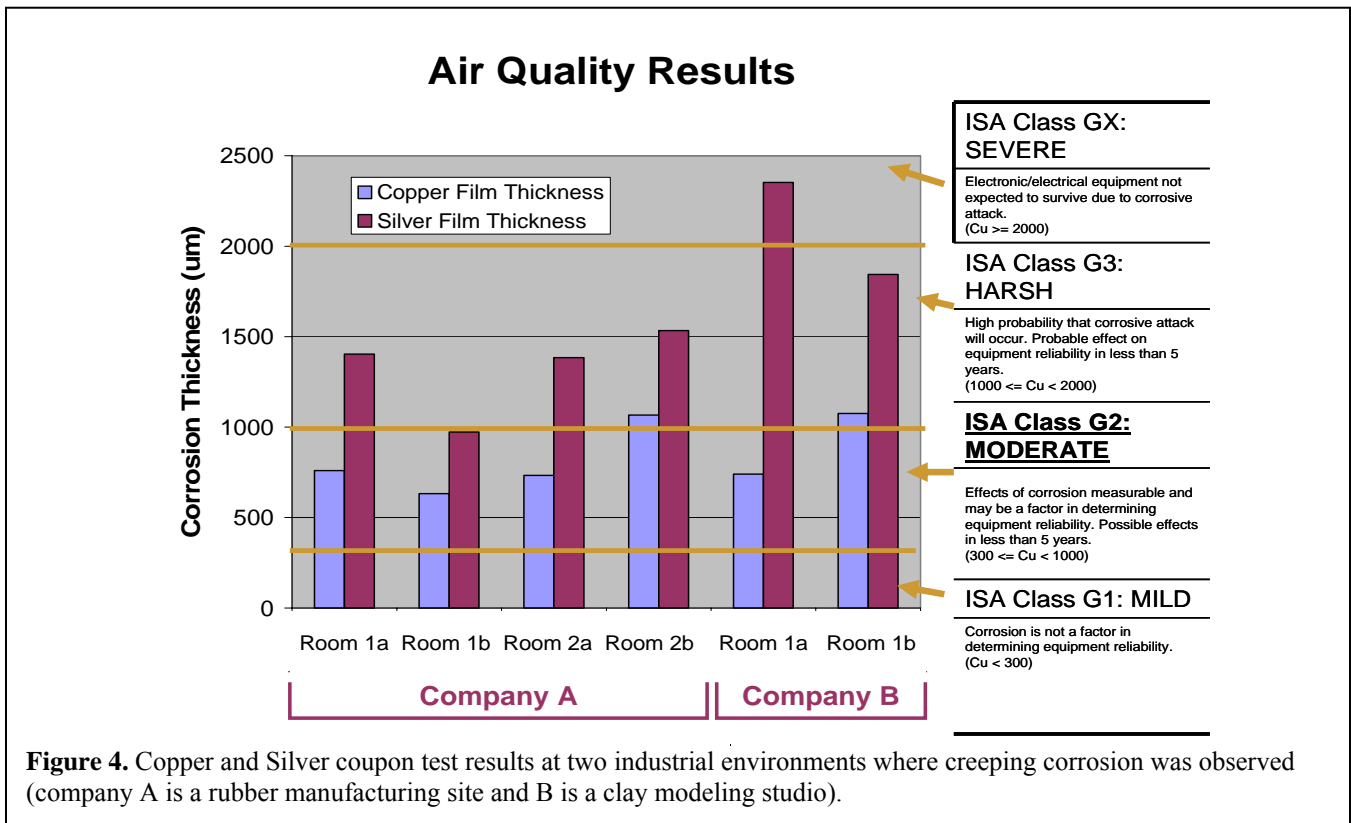
**Figure 4.** Copper and Silver coupon test results at two industrial environments where creeping corrosion was observed (company A is a rubber manufacturing site and B is a clay modeling studio).

Efforts were made to evaluate a few of the environments in which creep corrosion was taking place. Best success was found using copper and silver coupon testing as carried out by a 3<sup>rd</sup> party [7]. This test involved placing a pure copper and pure silver coupon in several locations in the facility. These were undisturbed for two weeks, at which time they were carefully packaged and shipped back to the 3<sup>rd</sup> party for measurement of the corrosion product thickness. From this information the ISA class environment was determined and the level of sulfur estimated. Figure 4 shows results of two industrial environments (rubber factory and a clay modeling studio). The advice from this 3<sup>rd</sup> party was to use the thicker of the Cu and Ag films to determine the ISA class; suggesting these environments were both class G3. The relative humidity level was charted in the rubber factory

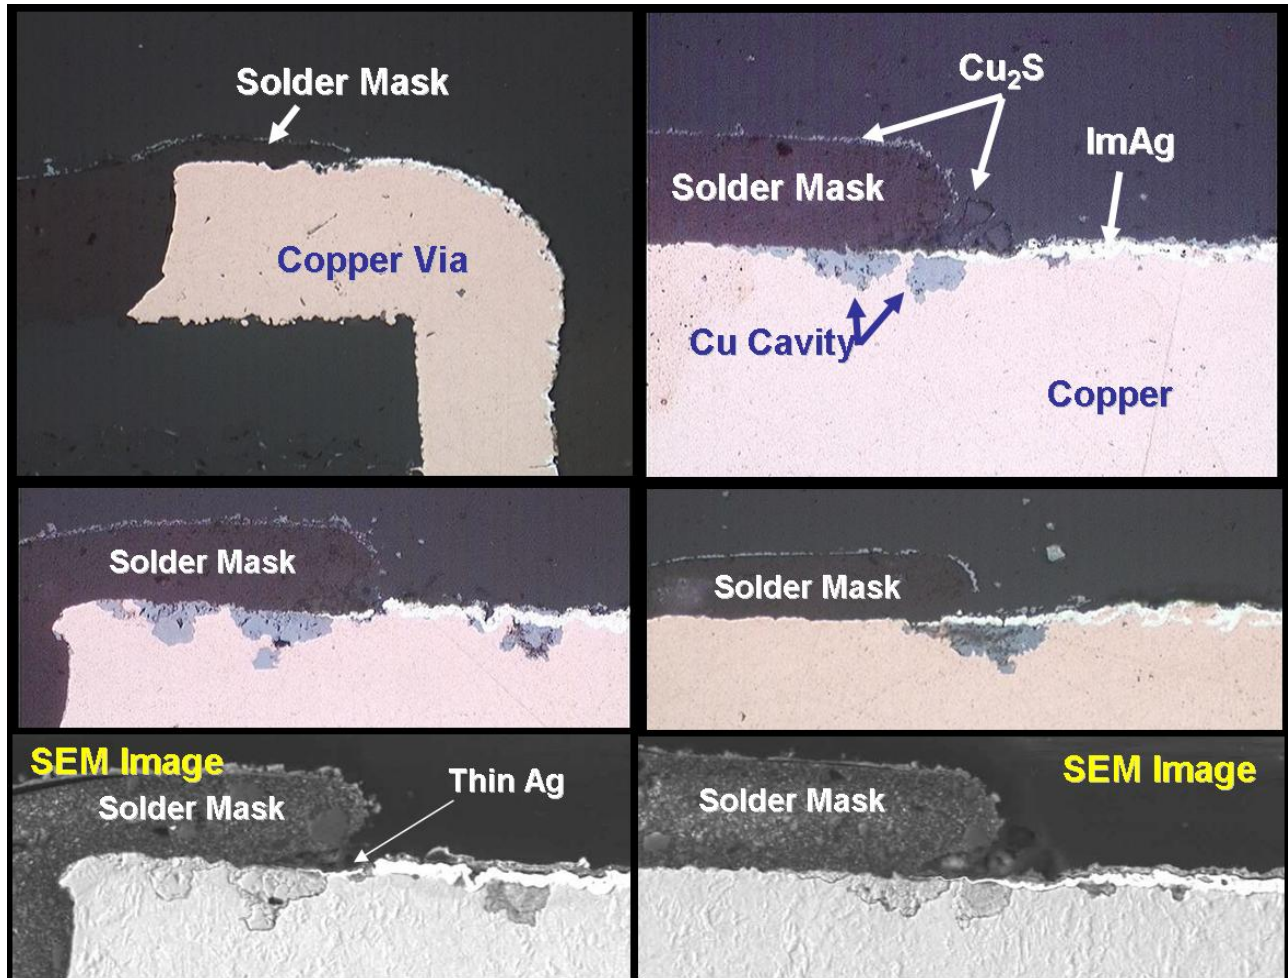
**Figure 5.** Cross section images of several soldermask encroached vias. The ImAg finish naturally thins down beneath the soldermask. Copper is exposed at the base of this crevice and electrolyte ingress initiates the galvanic corrosion that forms  $Cu_2S$  corrosion product (which is seen to creep along the soldermask surface).

Data show that this same type of behavior (exposed Cu at edge of soldermask) is the primary reason most creep corrosion seems to emanate from soldermask defined features. Cross sections of heavily creep corroded vias are shown in Figure 5. A large amount of copper is etched from beneath the soldermask and converted to  $Cu_2S$ . The full area of silver coverage (cathode) is much larger than the small exposed copper region (anode), thus helping to drive this aggressive galvanic corrosion in the presence of sulfur and moisture. Any pinholes in the ImAg film would also result in a similarly etched Cu region.

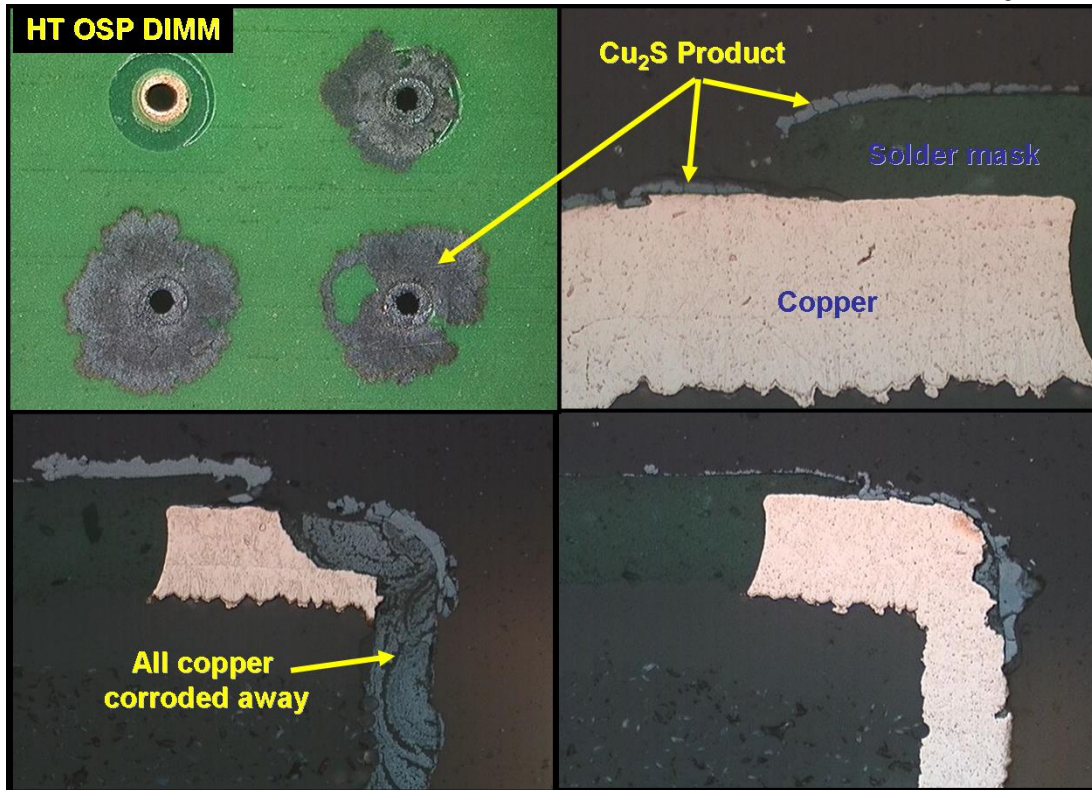
**Figure 6.** Cross-section photos of three corroded OSP vias. Copper is attacked uniformly where the OSP coating is compromised (not concentrated at the soldermask to pad interface). Note that one via is sufficiently protected.

This does not imply, however, that bare copper cannot creep corrode on its own (without an ImAg coating). PCB cards with OSP finish have been known to fail from creep corrosion when used in severe sulfur environments with high humidity (ink stripping room in a paper mill). An example is shown in Figure 5. In this case, copper was exposed through the residual OSP coating and was attacked. (some copper regions had an uncompromised OSP coating

and did not corrode). Cross sections show this attack does not occur under the solder mask edge (as with ImAg) but is more uniform. In extreme cases it consumed the full thickness of copper.

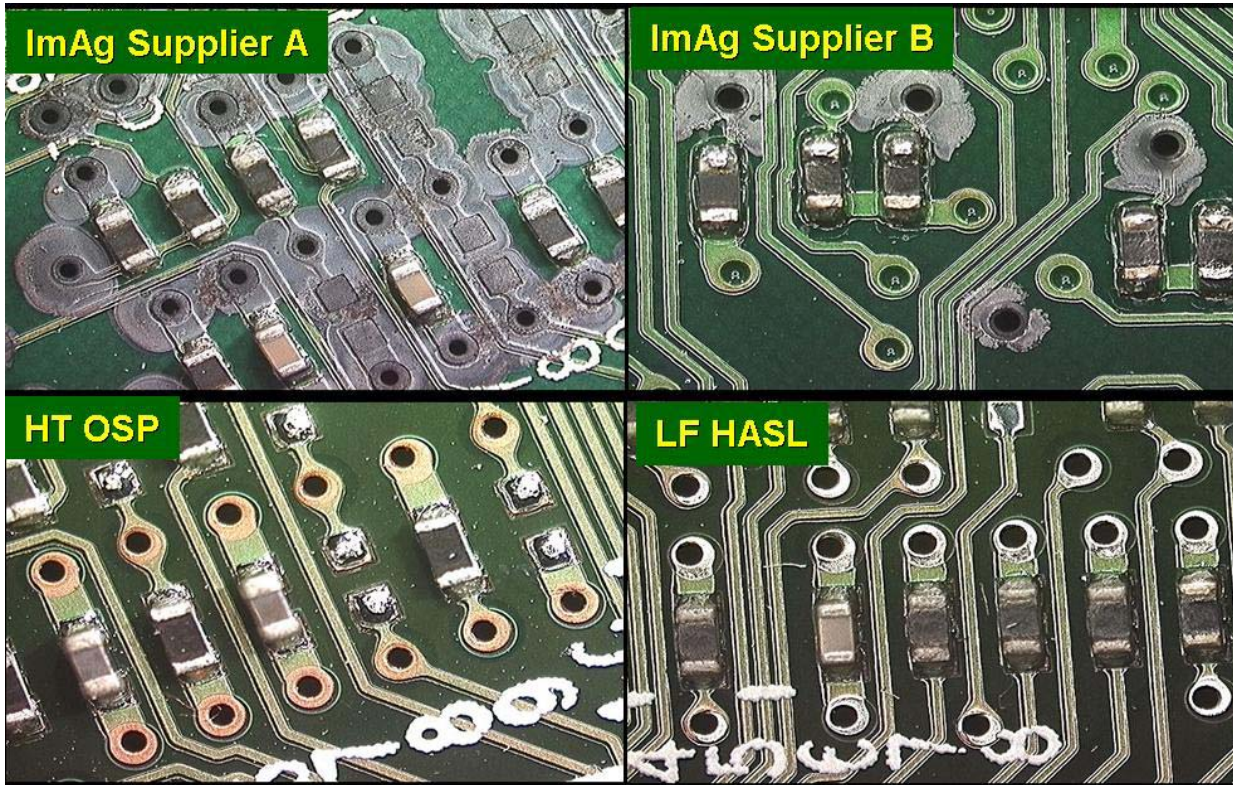
**Figure 7.** Desktop motherboard results after running continuously for 5 weeks in a clay modeling studio. Two types of silver showed creep corrosion, while HT OSP and LF HASL did not.

A second investigation was performed in a clay modeling studio. In this case two ImAg boards (different plating chemistries) an OSP board and a LF HASL board were each placed in a DT system that was configured to continuously run in idle mode. These systems were removed after 5 weeks of operation and the motherboards analyzed (none of them functionally failed). These results are documented in Figure 7. Creep corrosion was very heavy on both silver types. Note, that one PCB employed many plugged vias, which provided protection in those areas. No corrosion was detected on the OSP or the LF HASL boards, which appeared as good as when they were installed.

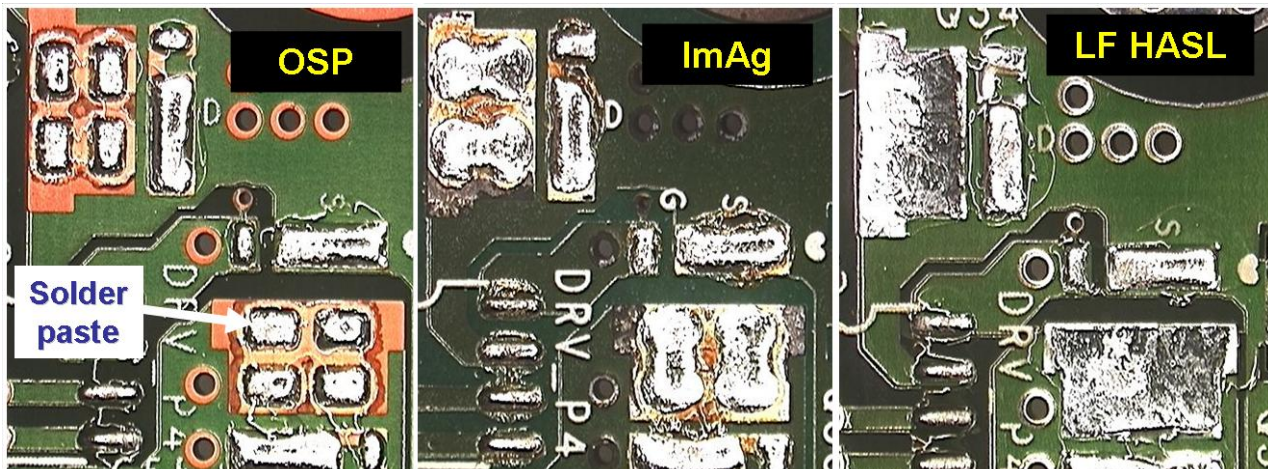
**Figure 8.** Solder paste (same in all cases) deposited and reflowed on unused FET pads with the same reflow conditions. Relative wetting characteristics can be seen. Very little flow seen with OSP finish.

solder paste printed on unused FET pads. The example in Figure 8 shows the least amount of wetting with OSP, a moderate amount with ImAg, and the most with LF HASL. These results are consistent with a more thorough investigation on this topic by Stevens et. al. [12]. A concern with poor wetting (in addition to hole fill) is a propensity for voiding in solder joints, especially under large thermal pads. LF HASL appears to be a drop-in replacement; whereas OSP may require optimization of the surface mount conditions to reduce solder joint voiding.

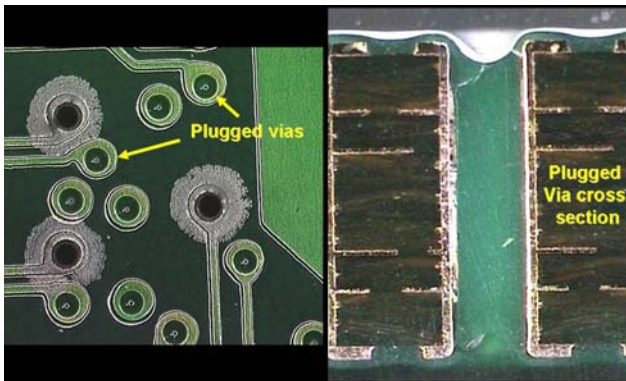
**Figure 9.** Plugged vias are shown to provide excellent protection from creep corrosion attack, thus reducing risk of failure.

If ImAg surface finish is to be used, there are several design changes that can be made to reduce the chance for corrosion failures. Solder mask defined metal features should be eliminated – at least those that will not get soldered during assembly. Non-test vias should be completely covered with solder mask (preferably fully plugged, as shown in Figure 9). Component pads should have rounded corners and the stencil designed to print paste to completely cover the pad. Figure 10 shows a TSOP package on a heavily corroded board. Note the solder paste and flux is effective at preventing corrosion at the solder mask to trace interface. The same holds true for the passive component pads. Remaining unsoldered areas on a board might include test points (pads and vias). These should be non-solder mask defined and preferably separated by more than 2.5 mm (0.10 inches) to help reduce creep corrosion bridging and shorting (recall the corrosion product was fairly resistive).

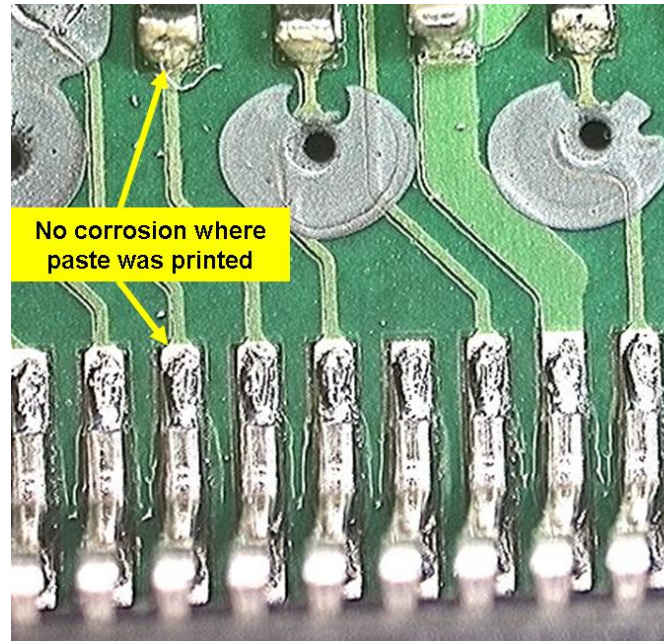
**Figure 10.** Examples of corroded PWAs. Note that solder and flux prevent creep corrosion at the soldermask to copper pad interface (both QFP fingers and resistors).

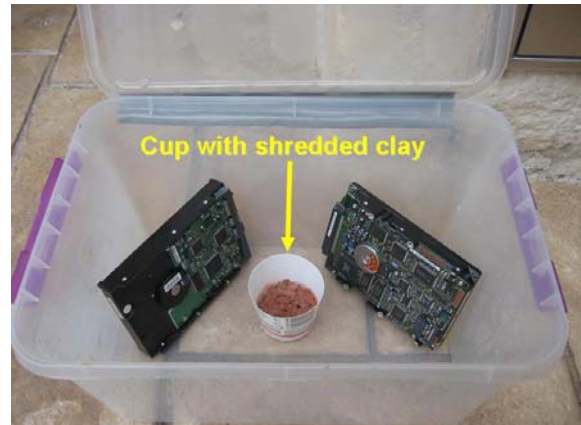
**Figure 11.** Mild clay test setup. 30g of shredded clay is placed in a cup and heated inside the enclosed container. Samples are placed in after heating.

Efforts were made to reduce the severity of this test to better represent the more typical G2 or G3 industrial environments (in which OSP finish does not creep corrode). The sulfur concentration and the degree of moisture condensation were independently explored. Sulfur concentration was reduced by using only 30 grams of clay, which was removed from a larger block with a cheese grater and placed in a plastic cup with a 1-2 ml of water (shown in Figure 11). Heating took

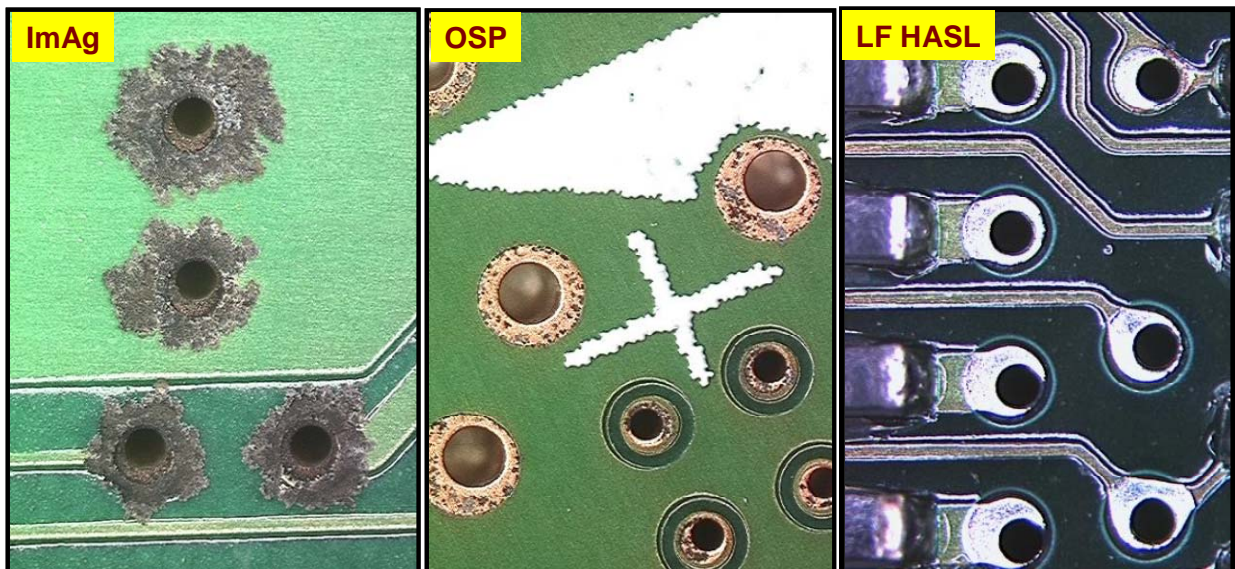
**Figure 12.** Corrosion results after 8 days of testing with 30g of heated clay (2 heat cycles per day).

per day. This test still produced creep corrosion on ImAg PWAs, but it took about twice as long to do so. Some PWAs with OSP finish still experienced slight creep corrosion in 6 days. LF HASL showed no creep corrosion (results are shown in Figure 12). Further reductions in the severity of the test can be achieved by reducing the moisture in the container and reducing the number of heat/condensation cycles.
