Review of Interconnect Stress Testing Protocols and Their Effectiveness in Screening Microvias

Edward Arthur¹, Charles Busa², Wade Goldman P.E.², Alisa Grubbs²

¹Raytheon Company, Space and Airborne Systems, El Segundo, California

²The Charles Stark Draper Laboratory, Inc., Cambridge, Massachusetts

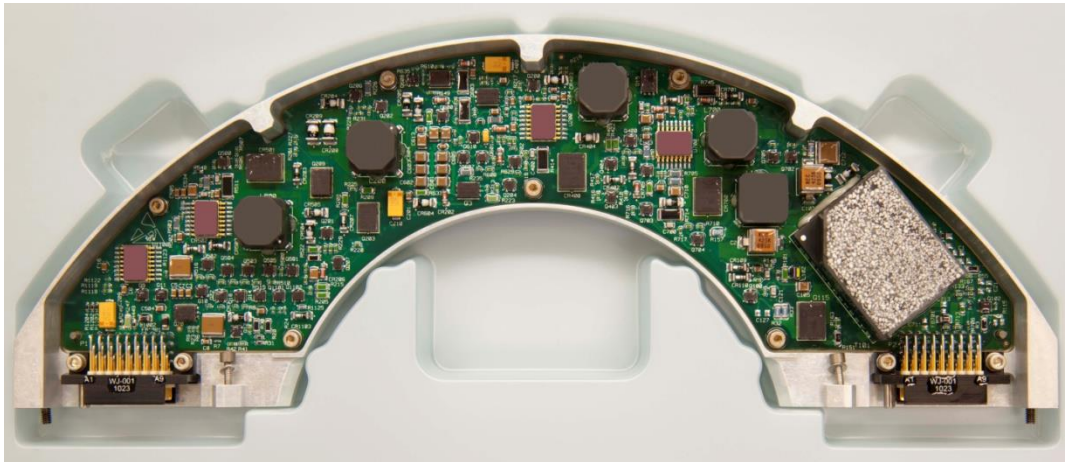
Figure 1 - PWA Top

The resistance in this circuit is only allowed to vary by 10 Ω , and an absolute resistance greater than 100 Ω would constitute a failure. An exhaustive troubleshooting procedure was undertaken to determine the root cause of the monitor circuit problem. Setup for the test isolated the trace by removing all parts, leaving only the suspect trace. The removed parts were then inspected and tested with no anomalies noted. Thermal cycling showed that the resistance of this circuit (two microvias and buried trace) spiked randomly up to, but not over, 500 Ω during the ramping of the temperature during thermal cycling. A bare board was used as a control unit during this thermal cycling. The resistance of the monitor circuit on the control unit changed in a linear and predictable manner consistent with the thermal changes. The conclusion is that there is a disturbance in the trace that could be attributed to a microvia failure and that this disturbance is isolated to one location, preventing full performance of the module. After this bench testing, a destructive physical analysis was conducted. The locations of interest can be seen in Figure 3 and Figure 4.
