Reliability Study of Low Silver Alloy Solder Pastes

Jennifer Nguyen, David Geiger and Murad Kurwa

Flextronics International

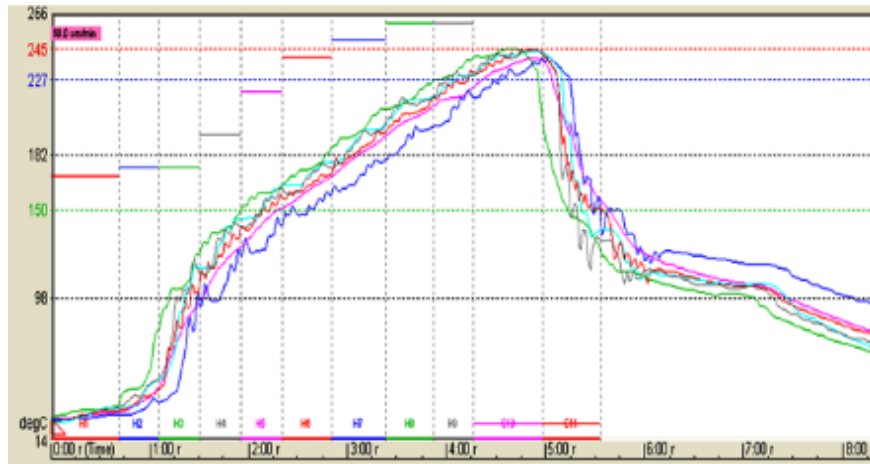
Figure 4. High-temperature Pb-free reflow profile

All the samples using solder pastes A to E were reflowed using a typical lead-free profile with a peak temperature of around 245 °C (Figure 4). SnBiAg paste (material F) was reflowed using a low-temperature reflow profile with a peak temperature of about 170 °C (Figure 5). The reflow was performed in an air atmosphere environment.

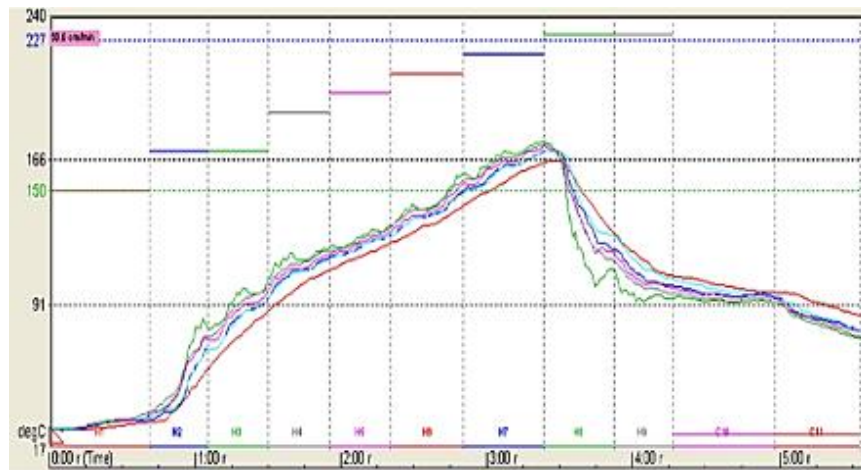
Figure 5. Low-temperature Pb-free reflow profile

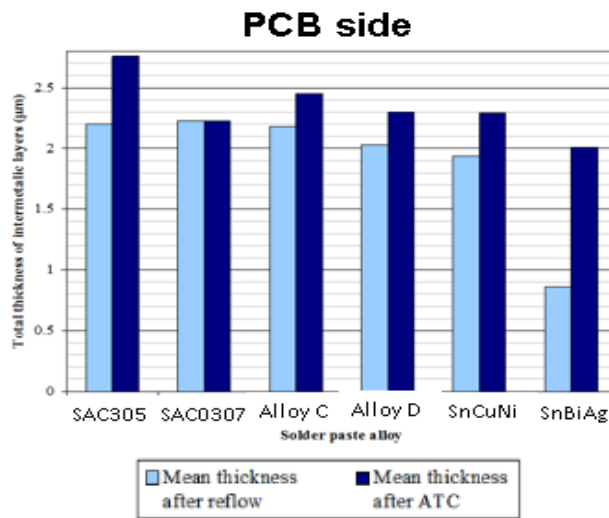
Figure 7. Intermetallic layer thickness measurements at the PCB side after reflow and after thermal cycle testing.

The intermetallic layer thickness was measured for the solder joints assembled with various lead-free alloy solder pastes. The intermetallic layer thickness at the PCB side after the reflow process was between 2 μm to 2.5 μm for SAC 305 material and alternative lead-free high melting temperature alloys. The intermetallic layer thickness at the PCB side after the reflow process for SnBiAg was less than 1 μm. The thin layer formed when using this alloy was due to the low-temperature reflow

profile used. It was noticed that during thermal cycle testing the IMC layer of SnBiAg grew significantly to around 2µm, which was similar to the intermetallic layer thickness of other tested lead-free alloys. There was no significant change in the IMC thickness for SAC 305 and alternative low/no silver high temperature alloys after thermal cycle testing. The thicknesses of the intermetallic layer at the PCB side after reflow and after the thermal cycle test were shown in Figure 7.

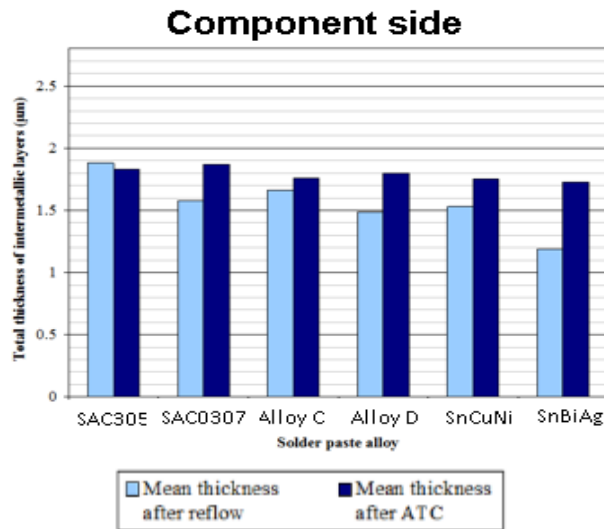
Figure 8. Intermetallic layer thickness at component interface after reflow and after thermal testing.

The intermetallic layer thickness at the component side after the reflow process was around 1.5 µm to 2 µm. It was slightly thinner than the IMC thickness at the PCB side. Similarly, the IMC thickness at the component side for alternative low silver high temperature alloys after thermal cycle testing was not changed significantly. The IMC thickness of low temperature SnBiAg was thin (~1.2 µm) after the reflow process. This thickness increased to around 1.7 µm after the thermal cycle testing. The thickness of the intermetallic layer at the component side was shown in Figure 8.

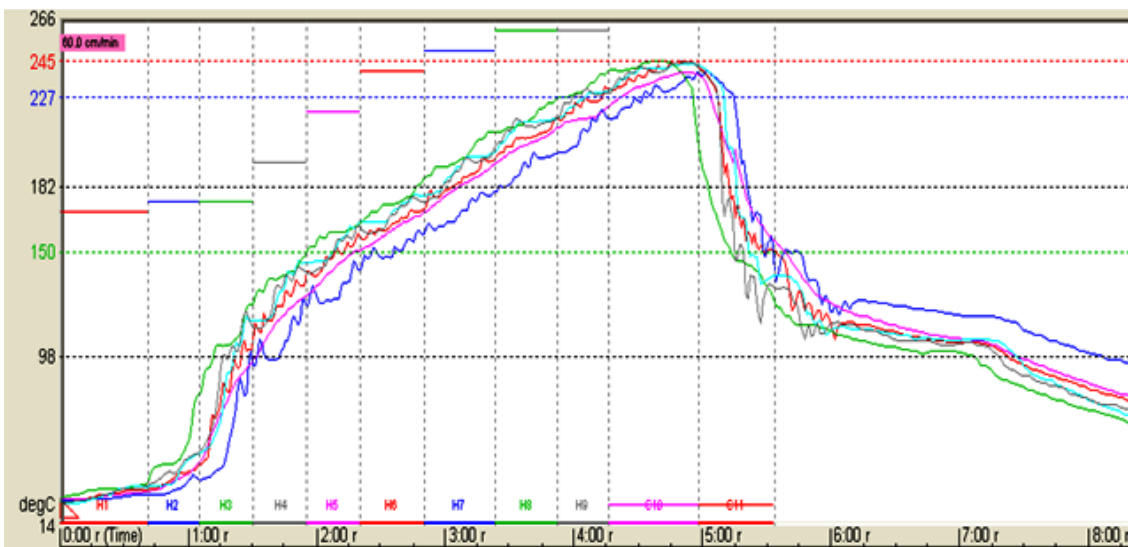
High-temperature reflow profile used for solder paste materials A-E

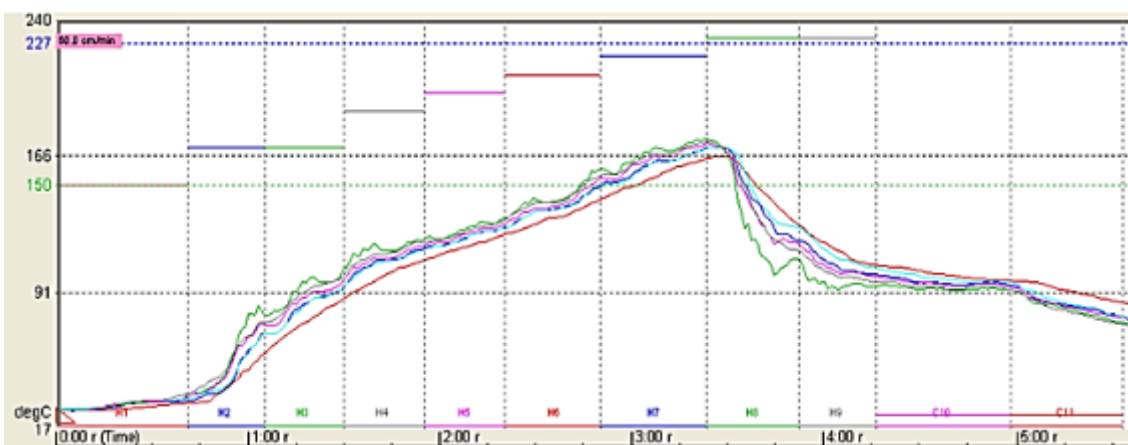
Low-temperature reflow profile used for solder paste material F

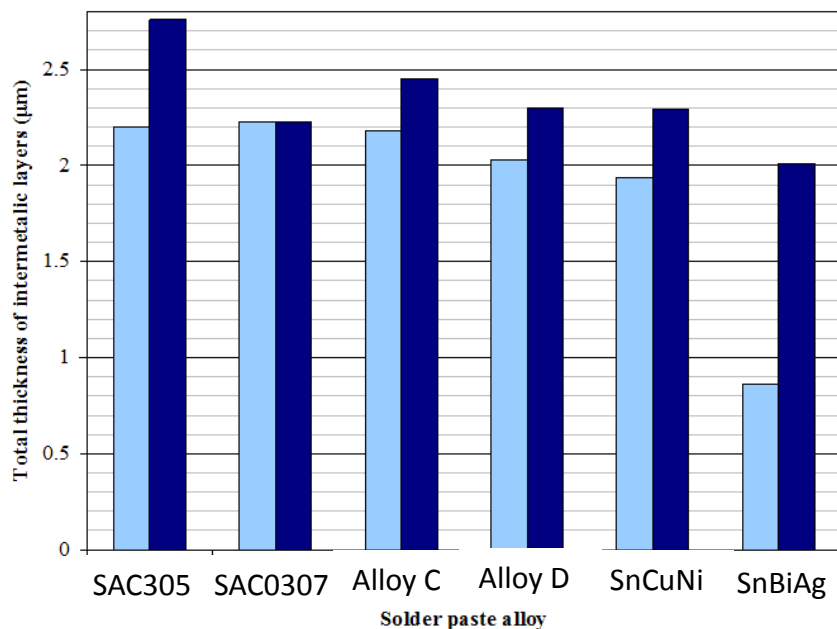
PCB side

■ Mean thickness
after reflow

■ Mean thickness
after ATC
