UNDERSTANDING CREEP CORROSION FIELD FAILS

Phil Isaacs¹, Jing Zhang² & Terry Munson³
IBM Corporation & Foresite, Inc.

Abstract

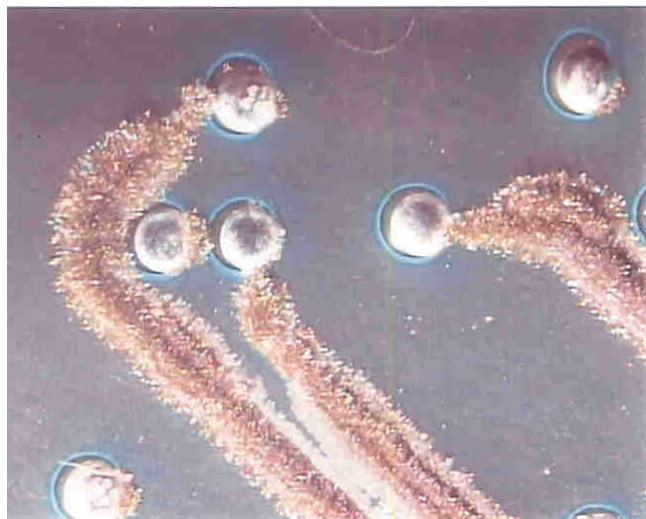
Figure 1: Creep Corrosion on Copper

Sulfur containing pollution is known to have harmful effects on the environment and to humans. Much is known about these effects. Sulfur containing pollution can also have deleterious effects on electronic components and their assemblies.⁴ Some examples can be seen in figures 1 and 2. There are different chemical compounds found in sulfur containing pollution: elemental sulfur, sulfur dioxide and hydrogen sulfide, to name a few, all of which can cause corrosion on PCBAs. The compounds have an oxidizing reaction when they come into contact with metals. In this case, the metals of interest are copper (Cu) and Silver (Ag), as provided in equations 1 – 4.

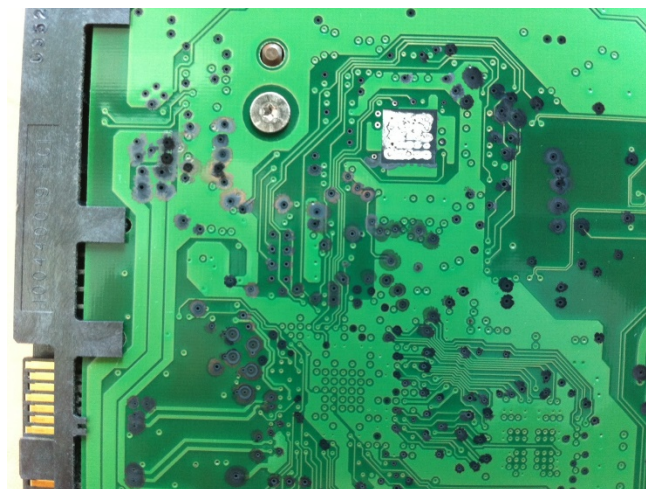
Figure 2: Creep Corrosion on Silver

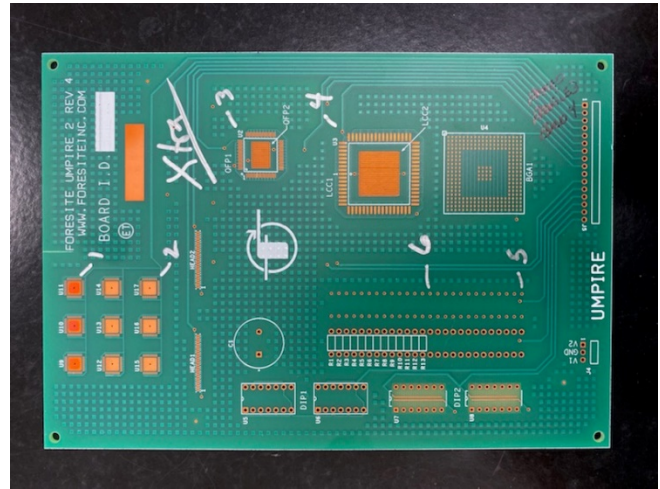
Figure 3: Umpire 2 Test Vehicle, top

A bare copper version of the Umpire 2 test vehicle was selected for this study, see figures 3 and 4. A bare copper test vehicle was selected so that the focus could be on the creep corrosion reaction itself, rather than the secondary galvanic reaction that occurs between the silver and copper.

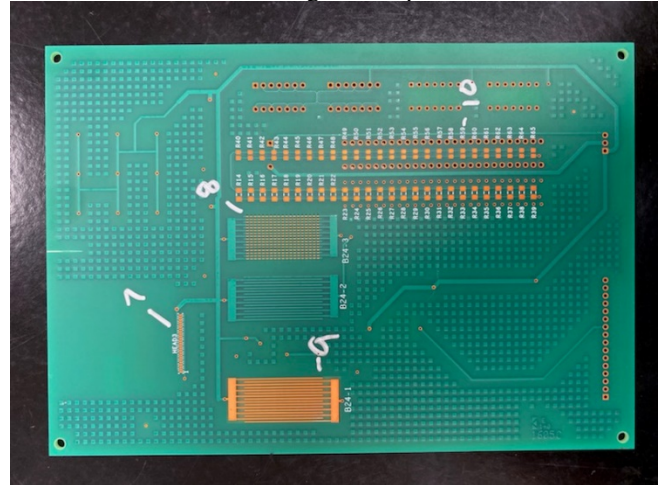
Figure 4: Umpire 2 Test Vehicle, bottom

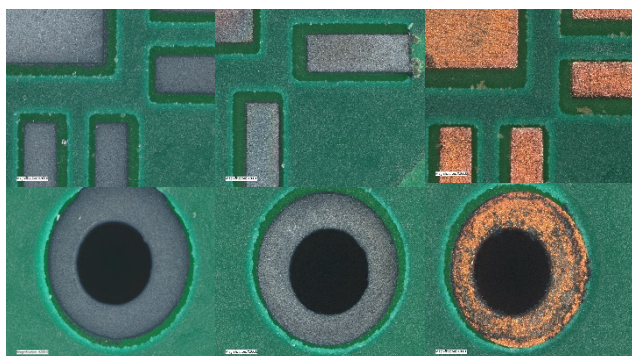
As can be seen in figure 5, the samples preconditioned with dry storage and the 65C dry bake had far more creep corrosion than the samples preconditioned with the 40C, 90% relative humidity environment.

Figure 5: Mixed Flowing Gas Visual Results; Left to Right, Dry Storage, 65C Prebake, 40C/90%RH

The samples preconditioned with 40C and 90% relative humidity have a light salting of creep corrosion, where the samples preconditioned in a dry storage environment visually have much more than a thin film of corrosion products present.

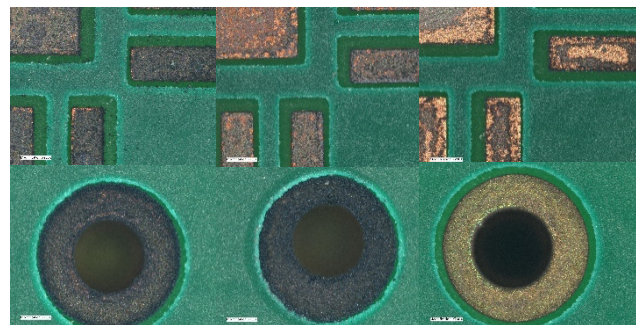
The visual results of the FoS test is very similar to the results found in the MFG test. One difference is the plated-through-holes, PTHs, have much more visual creep corrosion than the corresponding QFN mounting pads.

Figure 6: Flowers of Sulfur Visual Test Results; Left to right, Dry storage, 65C Prebake, 40C/90% RH

Another difference is the color of the creep corrosion found on PTH of the 40C and 90% relative humidity sample. It has an olive-green tint to it, indicating that the sodium hypochlorite participated in the reaction, forming cupric chloride. The results can be seen in figure 6.

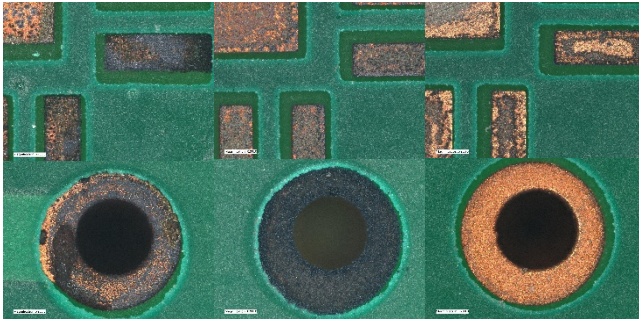
The visual test results for samples exposed to sulfur rich clay are similar to those of samples exposed to MFG and FoS tests. The cleanest samples were those preconditioned with 40C and 90% relative humidity. The results can be seen in figure 7.

Figure 7: Sulfur Rich Clay Visual test results; Left to Right, Dry storage, 65C Prebake, 40C/90% RH

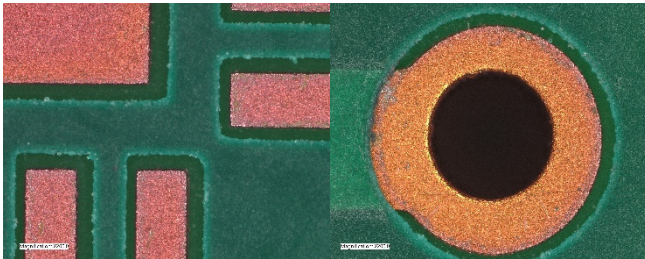
The control samples show no visual sign of general corrosion or creep corrosion, as seen in figure 8.

Figure 8: Control Samples, no preconditioning, no test exposure to sulfur

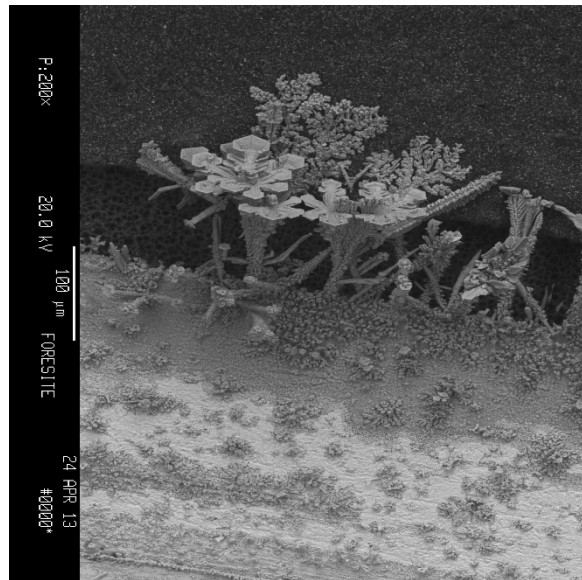
A failure caused by a rubber band left on the surface of the subassembly block holding units together during wave soldering, is presented in figure 9. The rubber band was left on the units and put into the field in a sealed enclosure operating at 60C. As illustrated in figure 9, the creep corrosion was so strong it fractured the thin soldermask and growing crystals the length of the traces bridging in multiple locations. Figure 10 shows the backside of a controller panel mounted on a wall in Canada. The panel was exposed to sulfur rich drywall. The immersion silver bare board finish to a high sulfur environment at ambient temperature and humidity conditions for four months, causing the unit to fail.

Figure 9: Immersion silver trace exposed to a rubber band at Foresite for 48 hours at 60C in sealed bag

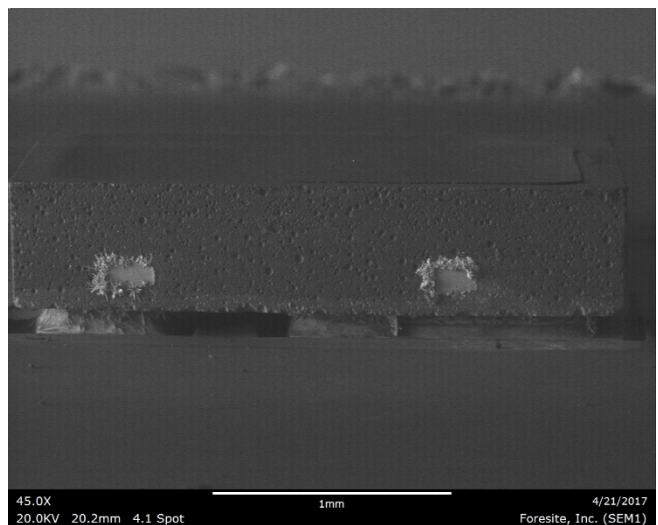
Figure 10: Plastic package with exposed copper silver plated lead frame exposed to sulfur rich air quality

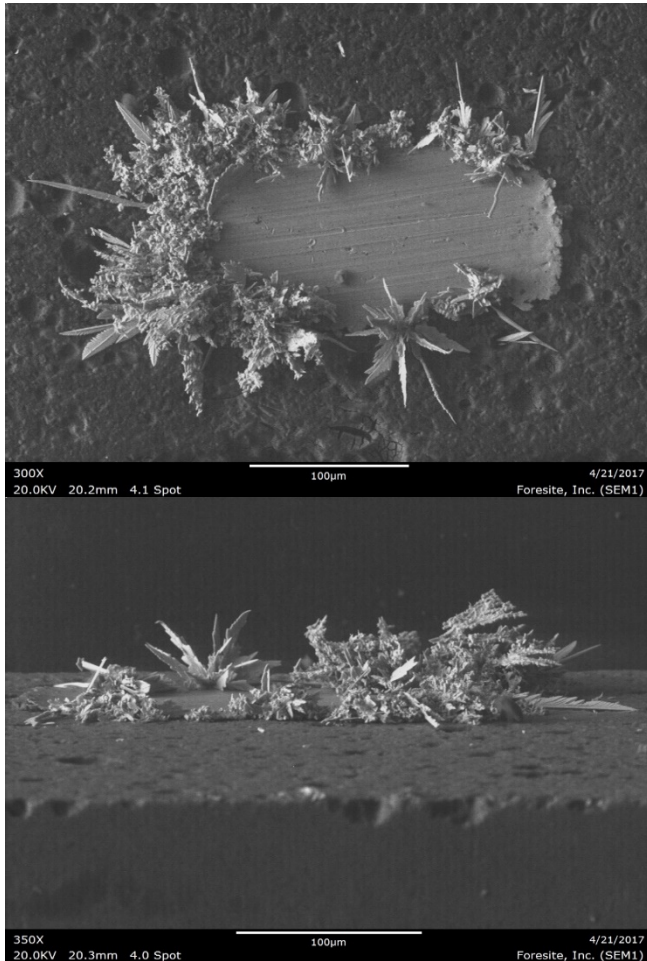
Figure 11/12: Top; plastic package with exposed copper silver plated lead frame exposed to sulfur rich air quality. Bottom; side view.

or Immersion Silver (ImAg) all can have exposed copper that can be attacked by sulfur rich sources. It is necessary to understand these sources. Examples are provided in figures 11 – 16.

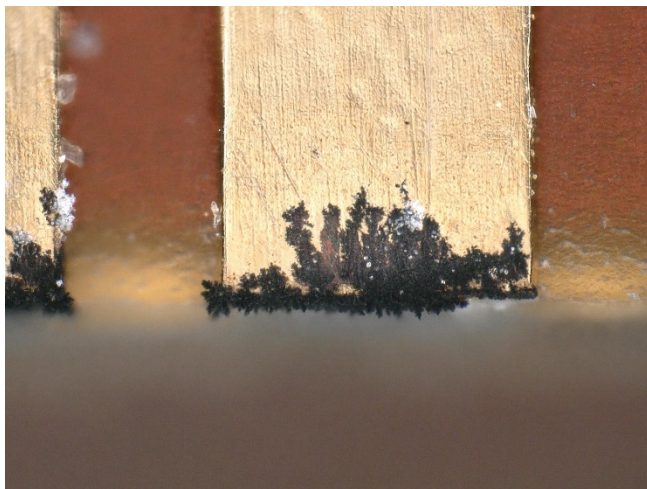
Figure 13: Flex circuit ENIG finish over copper inside ESD bag next to cardboard separators for 1 year inside box.

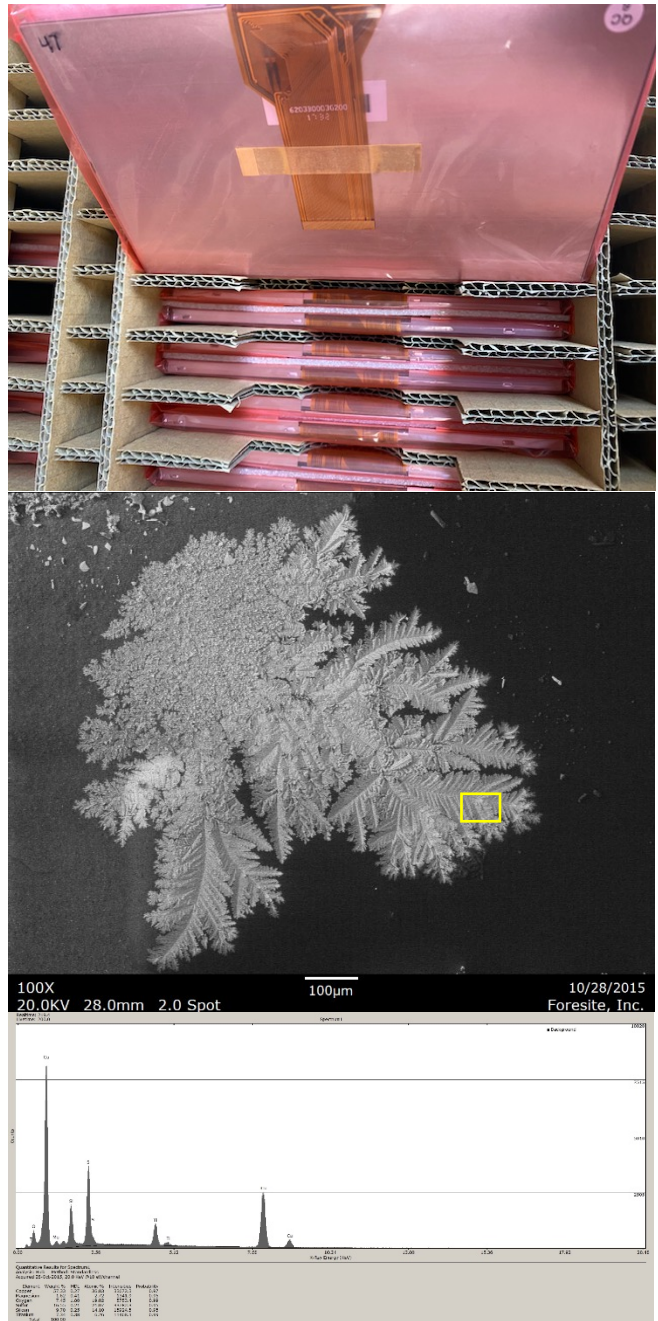
Figure 14/15/16: Display in ESD Bag, sample location for EDS elemental analysis which shows sulfur at 16.5 wt% and nothing present in the ESD Bag but at 18.9% in the cardboard separator.
