**TRACE LABORATORIES, INC**  
5 North Park Drive  
Hunt Valley, MD 21030 USA  
Telephone: 410/584-9099 / Fax: 410/584-9117  
Website: [www.tracelabs.com](http://www.tracelabs.com) / Email: [info@tracelabs.com](mailto:info@tracelabs.com)

**TEST REPORT FOR:**

SECHAN ELECTRONICS  
525 Furnace Hills Pike  
Lititz, PA 17543

One (1) partially assembled printed circuit assembly (PCA) sample, identified as "PN8423627001", was submitted for a Black Pad/Contamination Analysis.

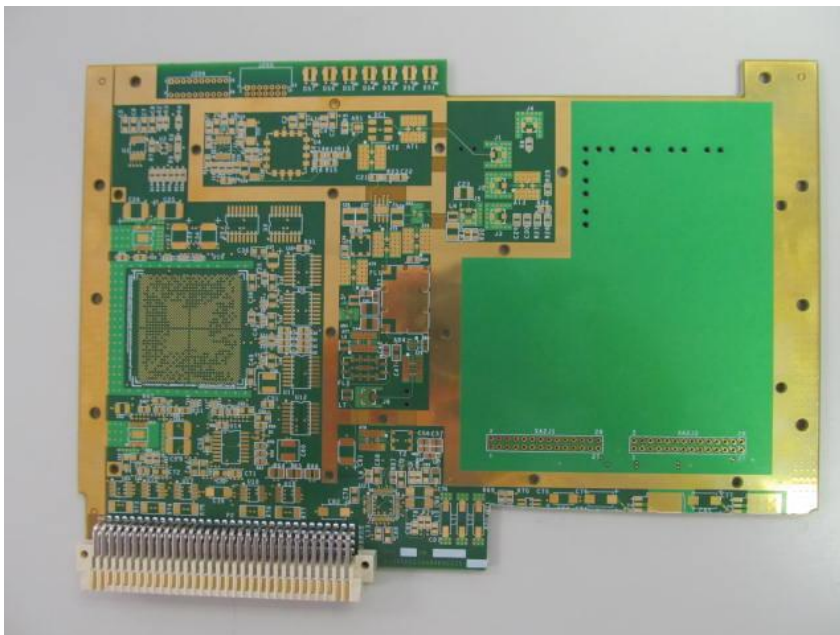
**Photograph #1:** Overview of Submitted PCA Sample

Photographs #1 through #4, below, display overviews of the submitted PCA sample, as well as close-ups of the characteristics described above. Photograph #3 also identified the PTH locations of interest as "Hole 1" and "Hole 2", as identified by Trace Laboratories.

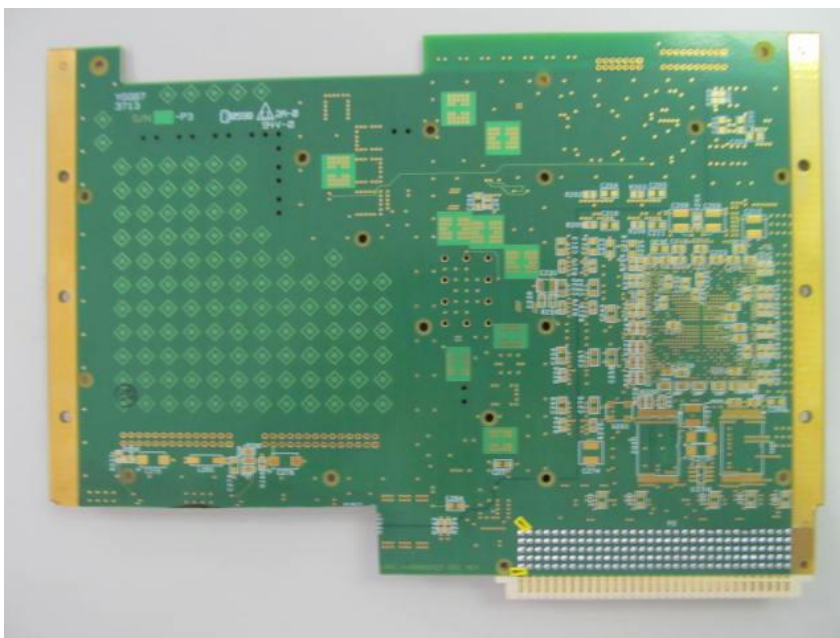
**Photograph #2:** Overview of Submitted PCA Sample

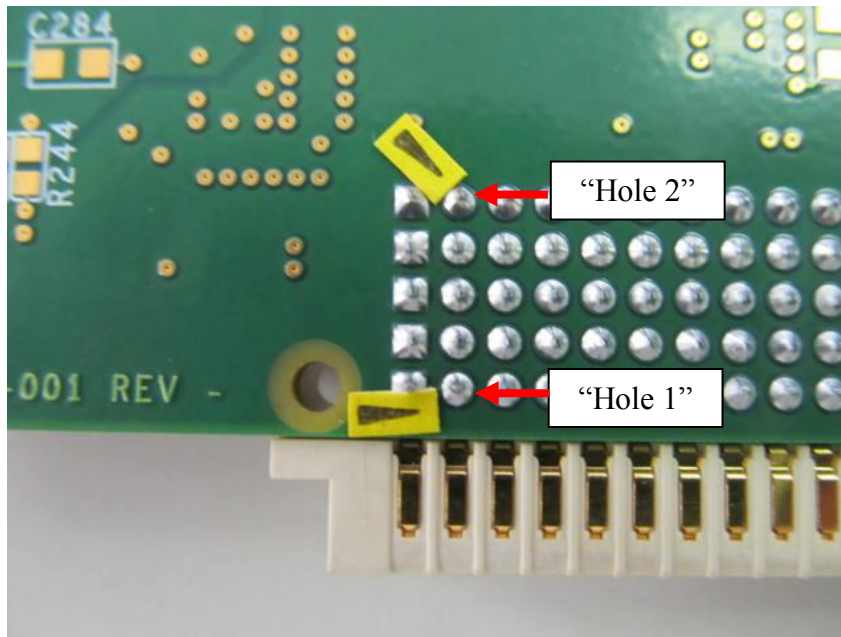
**Photograph #3:** Close-up of PTH Locations of Interest as Identified by Sechan Electronics

Additionally, two (2) plated through-hole (PTH) locations had been identified by Sechan Electronics as specific locations of interest.

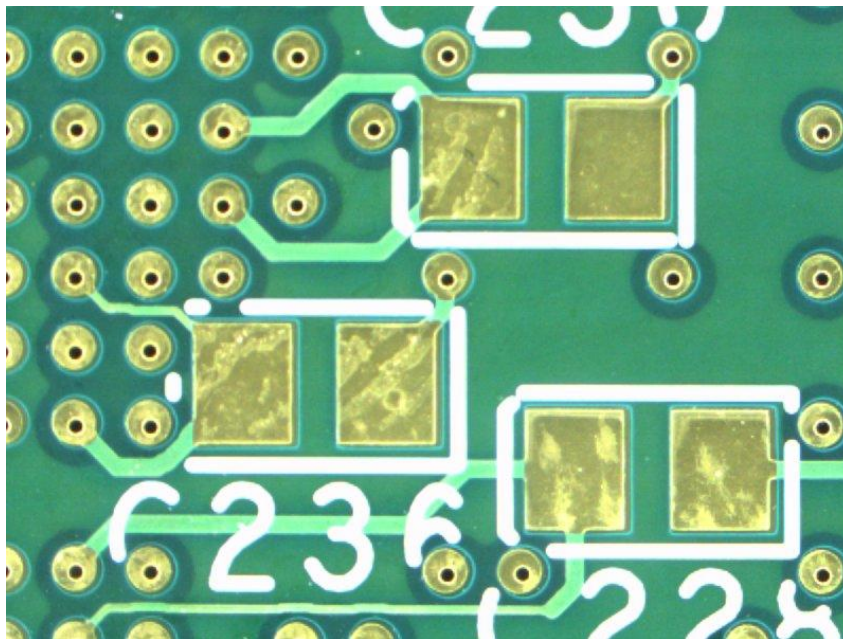
Visual Examination of the submitted sample found multiple surface mount (SMT) pad locations which appeared to contain a residue or simple discoloration. This characteristic was seen in multiple locations across the surface of the sample.

**Photograph #4:** Representative Close-up of “Residue/Discoloration” of SMT Pads

Based on the Visual Examination, it was determined that contamination analysis via FTIR and SEM/EDS would be performed on the "residue/discoloration", and that cross-sectional analysis would be performed at the locations identified by Sechan Electronics.

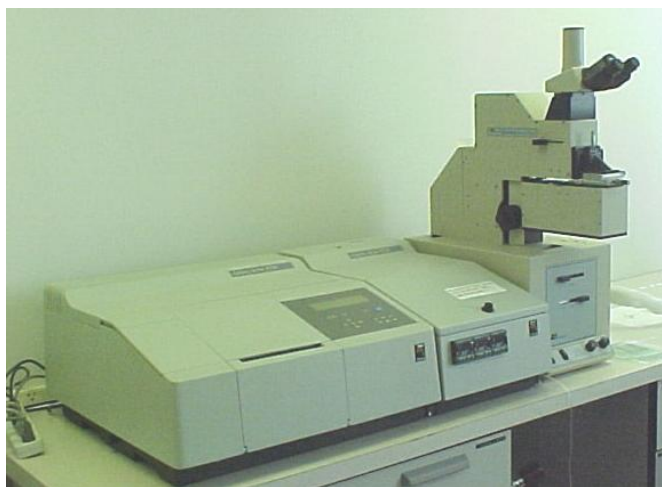
The photograph below shows the FTIR unit.

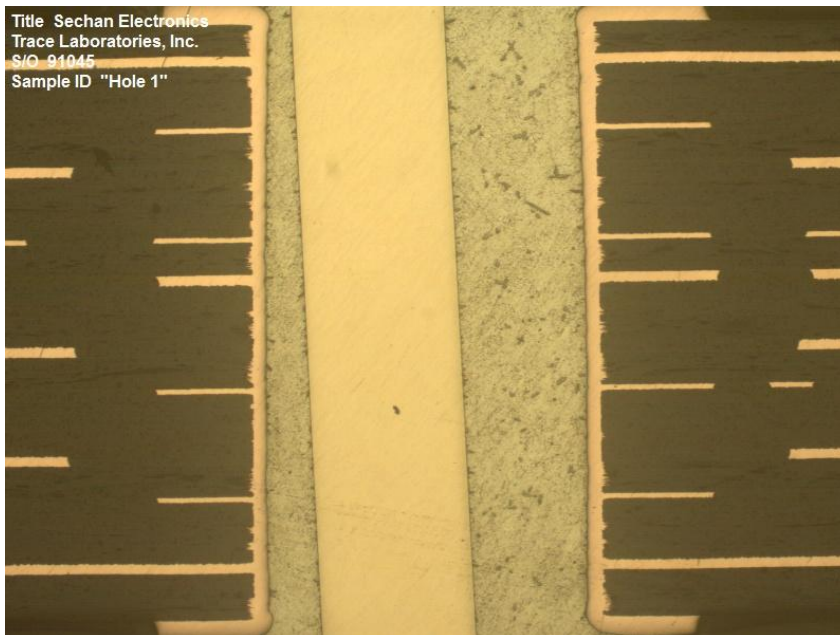
No anomalies were observed as a result of the microsection analysis. Each PTH location analyzed appeared to have fully wetted.

**Photograph #5:** Microsection Overview of PTH Location "Hole 1"

Photographs #5 through #8, below, display cross-sectional overview and close-up images of each PTH location analyzed.

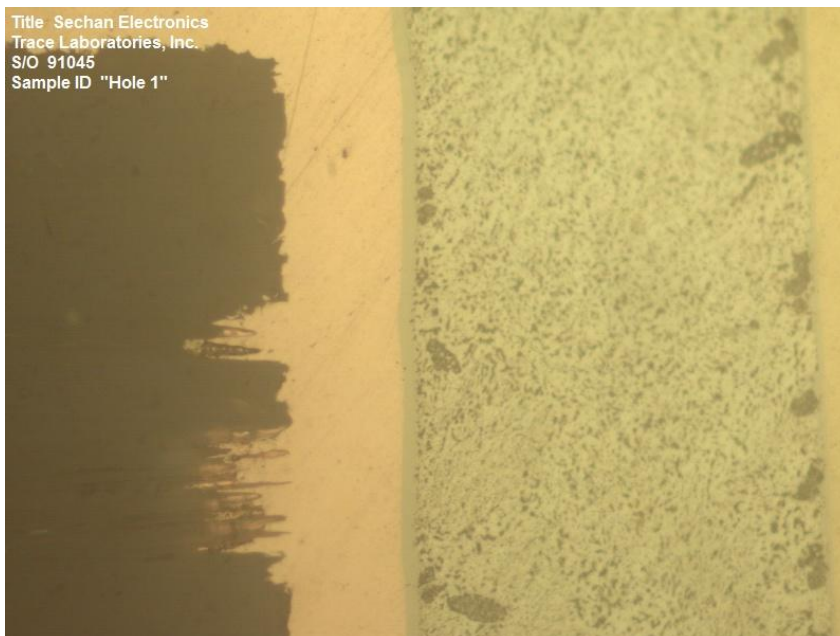
**Photograph #6:** Microsection Close-up of PTH Location "Hole 1"

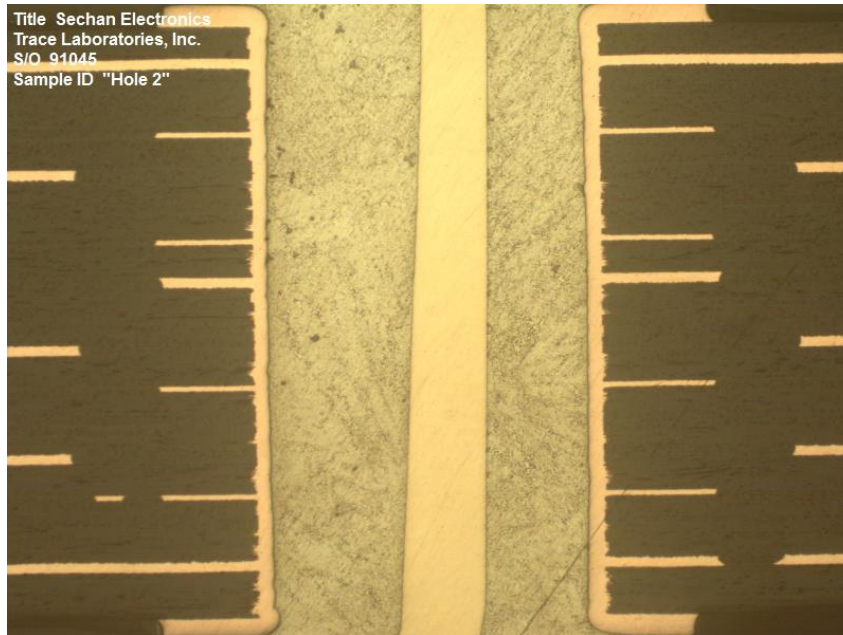
**Photograph #7:** Microsection Overview of PTH Location "Hole 2"

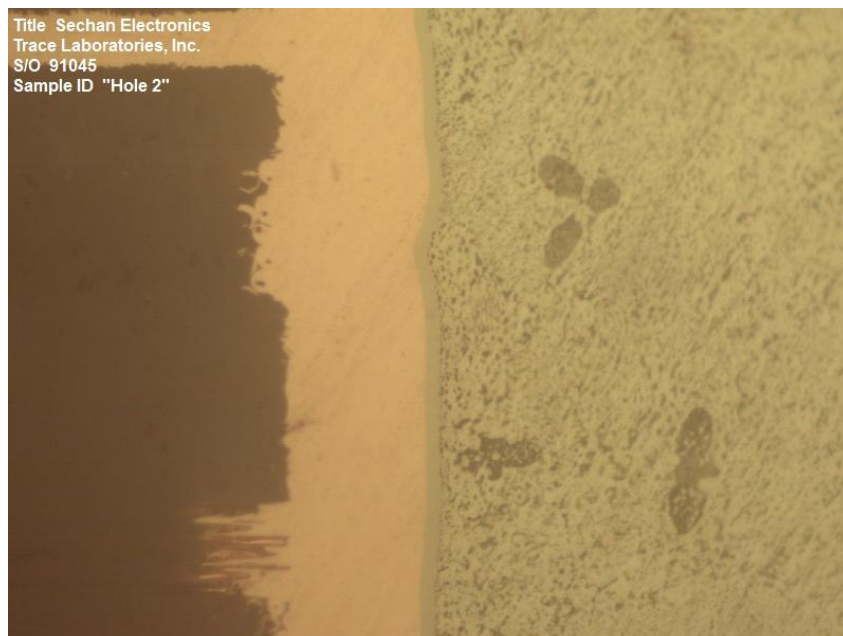
**Photograph #8:** Microsection Close-up of PTH Location "Hole 2"

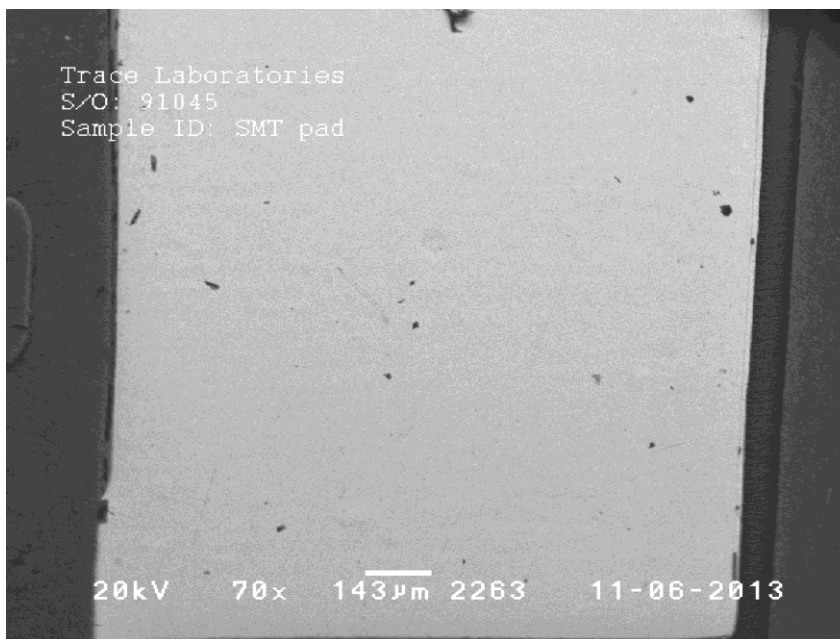
The "residue/discoloration" observed during the Visual Examination was not able to be observed visually via SEM, just as it was not able to be observed visually via FTIR. With that, the pad had a "typical" appearance of an ENIG-plated surface.

From an elemental standpoint, the sample was dominated by the presence of gold (Au) and nickel (Ni), with small amounts of phosphorus (P) and copper (Cu) also being detected. The elements detected would be those expected for an ENIG-plated board pad.

**Photograph #9:** SEM Overview Image of Representative SMT Pad

Photographs #9 and #10, below, display the SEM images obtained. The EDS can be found attached at the end of the report.

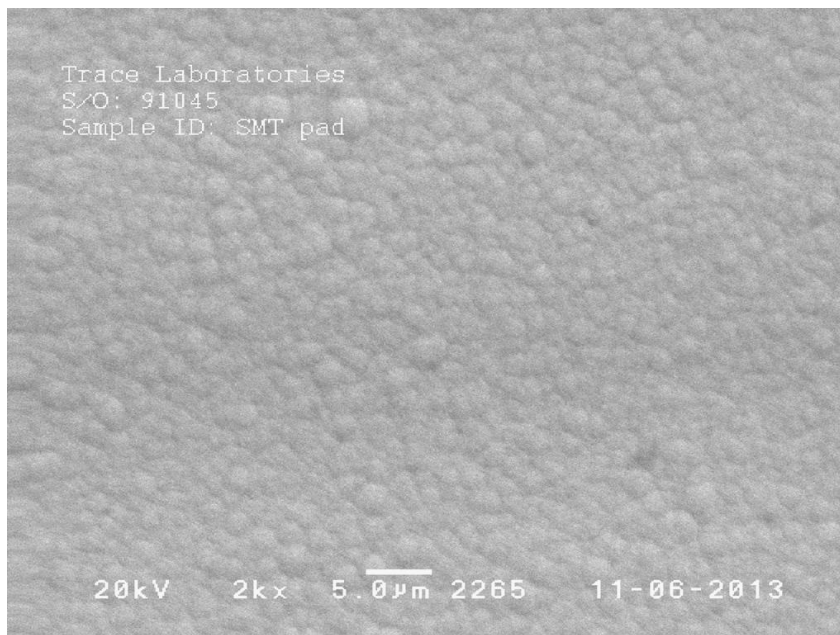
**Photograph #10:** SEM Close-up Image of Representative SMT Pad

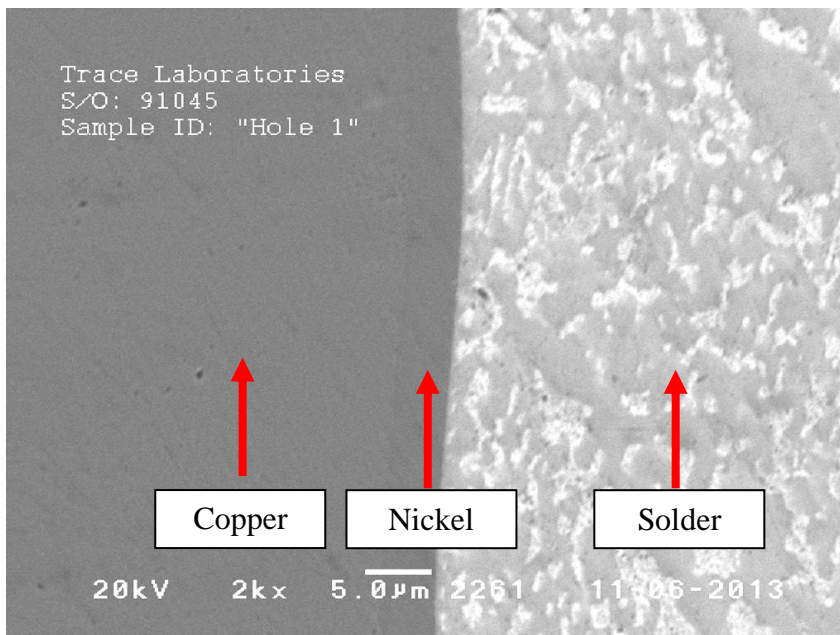
**Photograph #11:** Representative SEM Image Displaying Plating Layers of Interest

Confirmation of the presence of Black Pad Syndrome is typically characterized by evaluating the phosphorous concentrations at the “surface” layer and the “bulk” layer. In this case, Black Pad Syndrome does not appear to be present at either of the locations analyzed. Specifically, high phosphorous levels in relation to the nickel (> 11 wt%) and/or an increasing phosphorous concentration gradient are the key elemental characteristics present within a Black Pad “infected” board. Neither of these characteristics was observed for the submitted sample.

Photograph #11, below, displays a representative SEM image which identifies the plating layers of interest. All of the EDS scans obtained can be found at the end of the report.

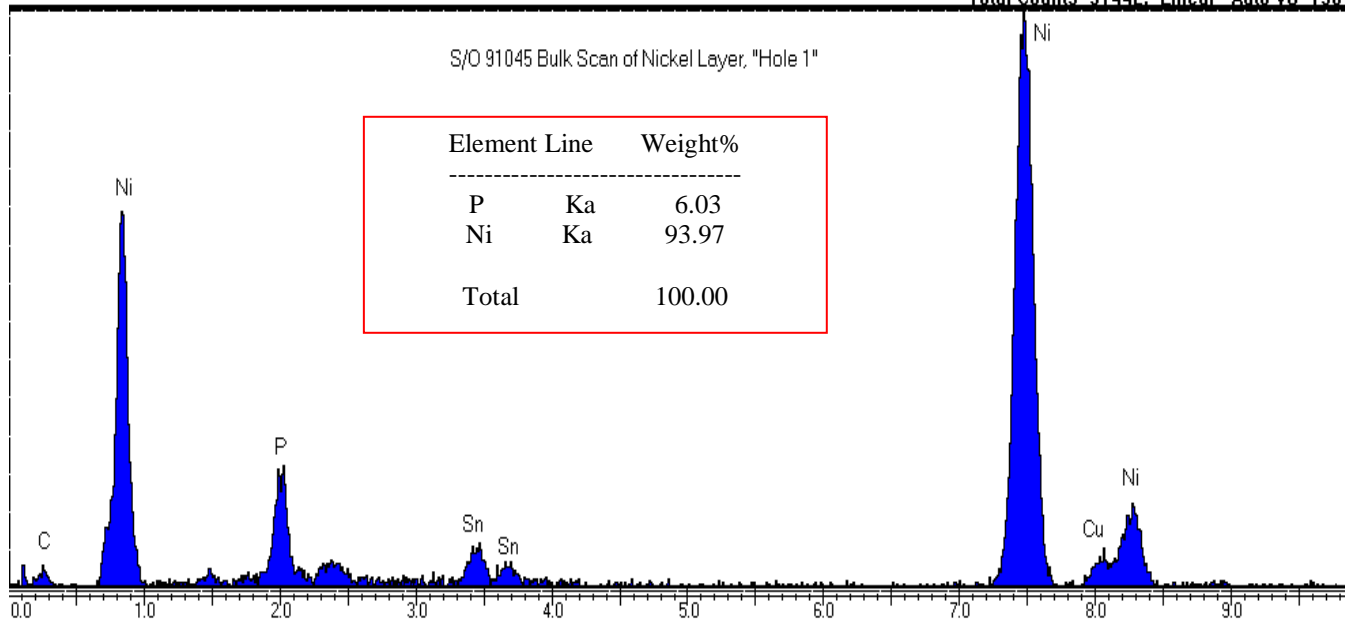
Spectrum: 91045HOLE1BULK Range:20 keV

Location ID	“Bulk” Layer		“Surface” Layer	
	P	Ni	P	Ni
“Hole 1”	6.03	93.97	6.80	93.20
“Hole 2”	6.12	93.88	6.12	93.88
