## “Reliability of Stacked Microvia”

Hardeep Heer & Ryan Wong

FTG Corp.

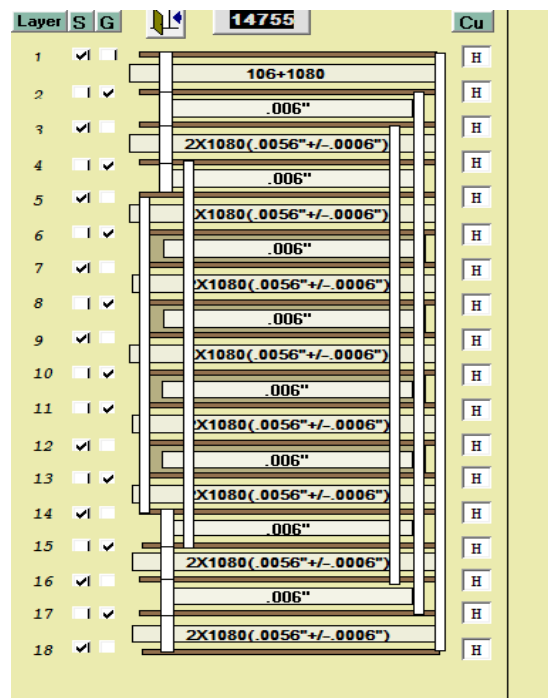
A 2.25mm (0.090”) thick eighteen layer board was designed (see Fig.1). Microvias with a diameter of 0.15mm (0.006”) were ablated from layers 1-3 and layers 18-16 for 2 stacks, layers 1-4 and layers 18-15 for 3 stacks and layers 1-5 and layers 18-14 for 4 stacks. Buried vias were between layers 3-16, 4-15 and layers 5-14, respectively. All microvias were plated shut.

Fig. 1: Design Stackup

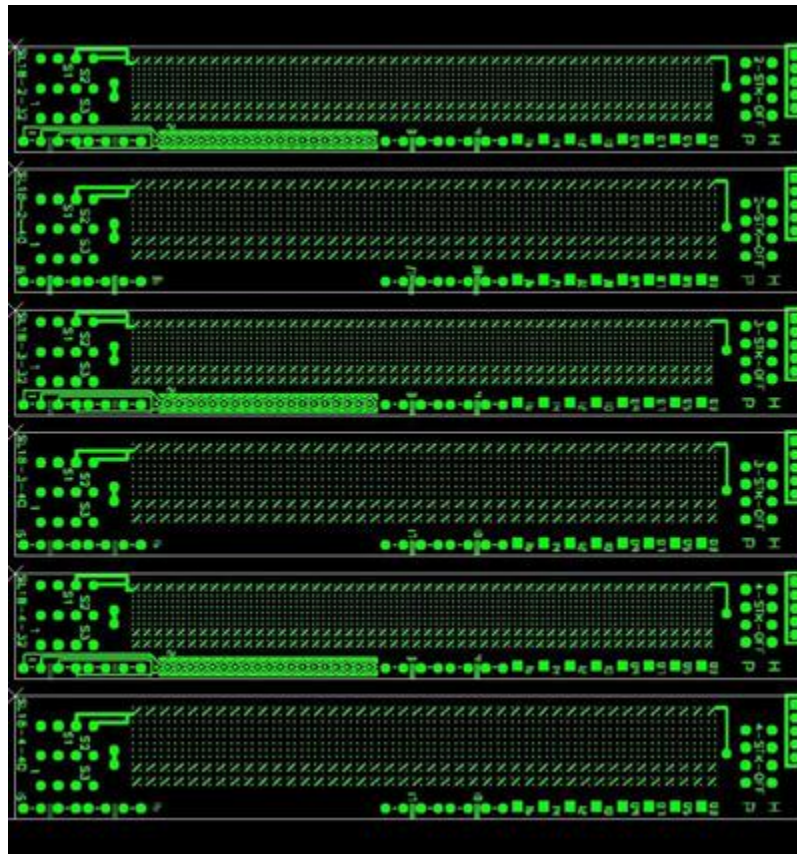
Coupons were designed for 2/3/4 stacks (See Fig.2), on and off buried vias and pitches of 0.8mm (0.032) and 1.0mm (0.40") as controlled variables. Each variation was placed in a sub-panel form (see Fig.3). Six of these subs were placed on an 18x24 panel. In all, each panel contained 6 on buried via and 6 off buried via IST coupons. There were a total of 568,512 microvias per panel and 3 of such panels were produced.

**Fig.3: Sub-Panel Coupon Layout**

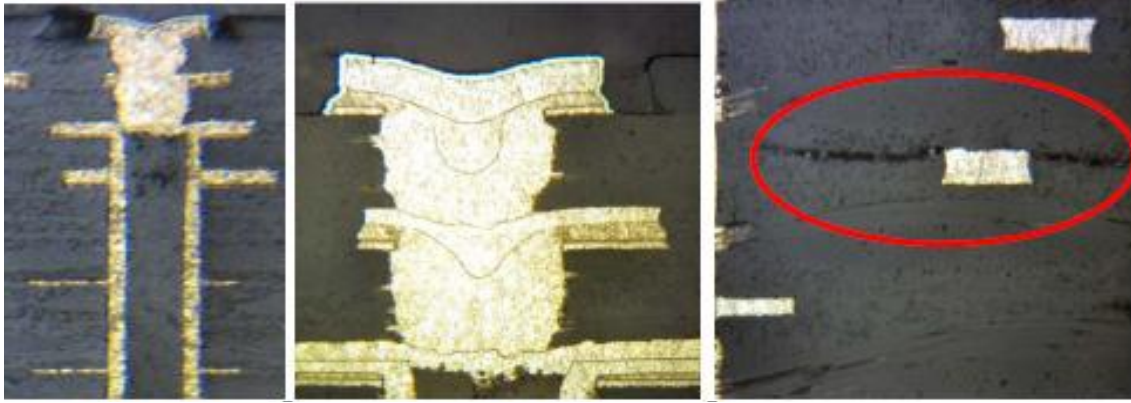
Only five 4 stack coupons failed during pre-conditioning at 6x245°C. There were no failures identified during thermal cycling at 150°C. The same test was repeated with a pre-conditioning temperature of 260°C. Out of 236 coupons tested, 24 coupons failed at Sense 3 (combination of buried and microvia) on the 4 stack via structure. The experimental objective was to evaluate microvias and this did not show any microvia failures. Cross-sectional analysis of the coupons showed no failure in via structures but material degradation was observed (see Image 3, Fig. 5 below).

**Fig. 5: Two Stack Microvias after 6x@ 260°C Pre-Conditioning and 1,000 cycles at 150°C**

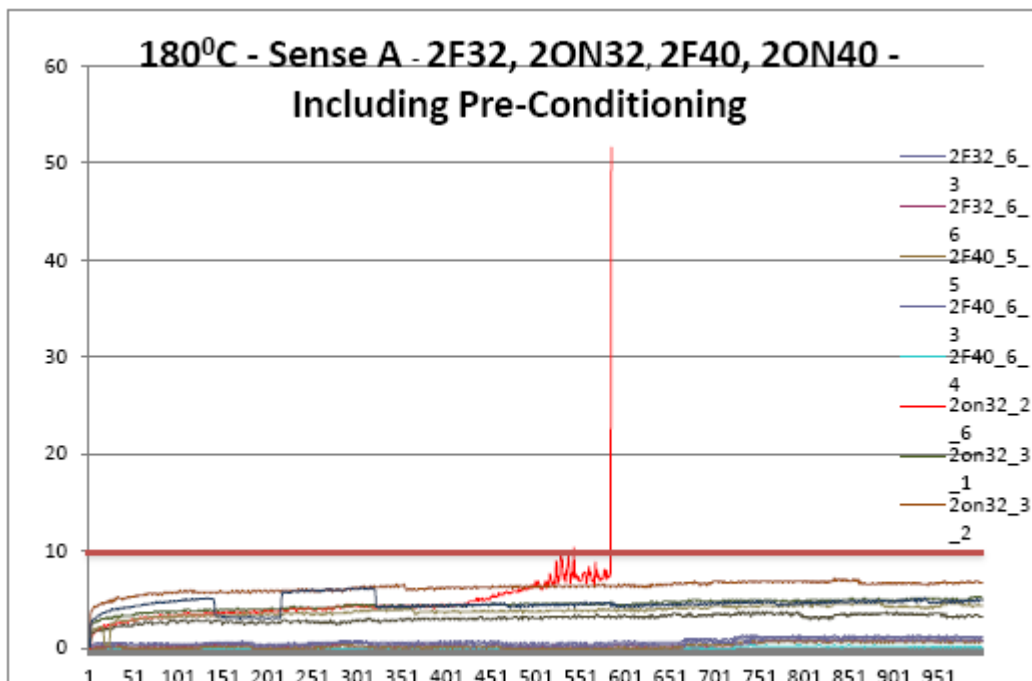
Plot 1 through Plot 4 shows data for two stack on and off buried vias. Plot 1 includes pre-conditioning change in resistance, whereas Plot 2 is showing data from after pre-conditioning to 1,000 cycles. Sense A has one microvia failure at the 585<sup>th</sup> cycle. The failure is clearly indicated by a straight vertical line. All other data points are well below 10% resistance change.

Plot 1 – 2 Stack Microvias off Buried via – Sense A

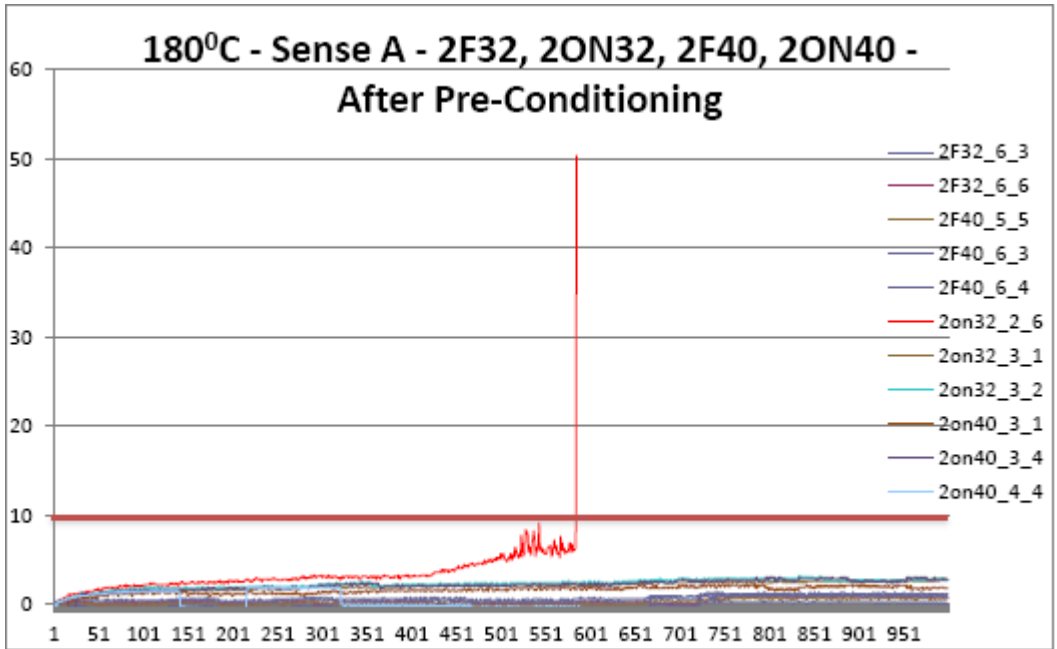
**Plot 2 - 2 Stack Microvias on Buried via - Sense A**

Plot 2 is for Sense B and shows much different results. Majority of the coupons show a steeper upward curve indicating that vias are degrading fast. This is being caused by the test temperature of 180°C. The test temperature is above the Tg of the material, resulting in almost 10 times the thermal expansion factors below Tg of the material. It must be understood that the thermal cycling temperature is above the Tg of the material and at this point, shear forces are playing a role in the barrels' failure mode. It is also believed that the length of the barrel is playing a significant role here. The barrel of the buried via below the 2-stack microvia structure is the longest of all the combinations in this design and at this temperature the thermal expansion is extremely high. Even under these severe conditions, the coupons were able to reach a mean IST cycle of 452 which is indicative of reliable copper plating structure.

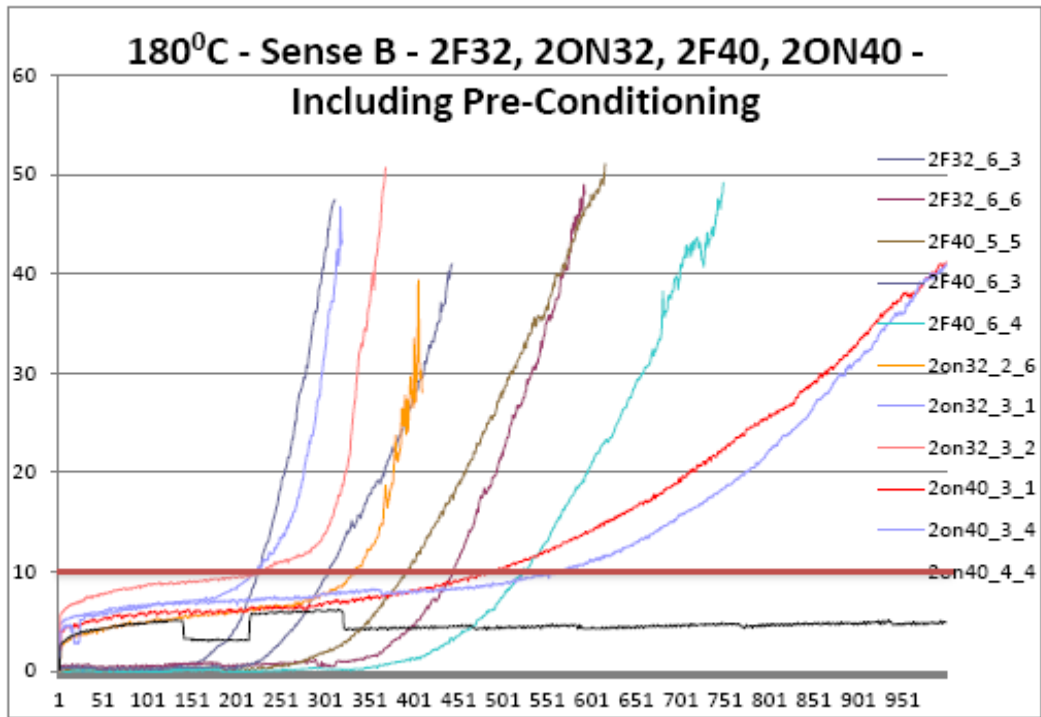
**Plot 3 - 2 Stack Microvias Off Buried via - Sense B**

It is interesting to note that Sense B showed higher degree of failure for 2 stacks than for 3 and 4 stacks. This confirms the hypothesis that the barrel length of buried vias is contributing significantly to the degree of failures. It must be kept in mind that the material used for the test is an FR4 material with a Tg of 173<sup>0</sup>C. Thermal expansion for this material in the Z-axis is 44ppm below Tg and 255ppm above Tg. A test temperature of 180<sup>0</sup>C induces a tremendous amount of stress on the material. It also worth noting that this test vehicle has gone through 4 lamination cycles and 6 pre-conditioning cycles at 260<sup>0</sup>C. All these lamination and thermal cycles have resulted in degradation of the material to an extent.

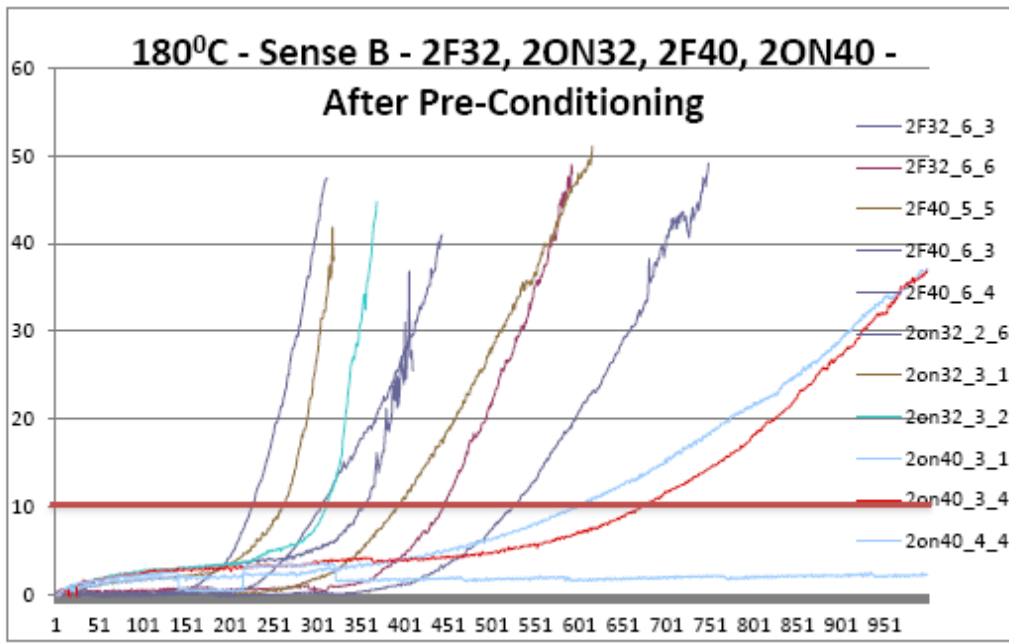
**Plot 4 – 2 Stack Microvias On Buried via – Sense B**

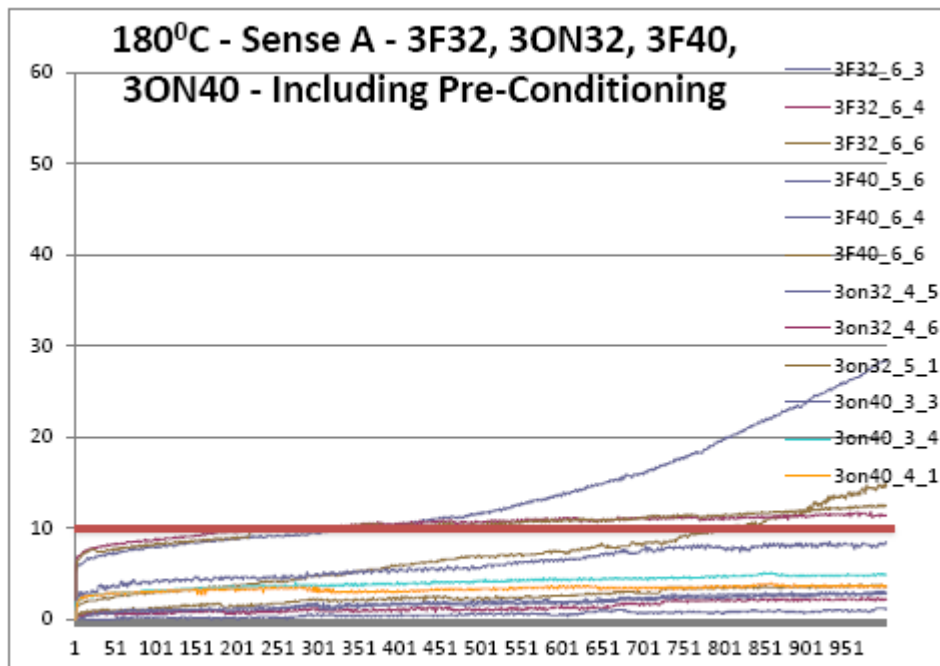
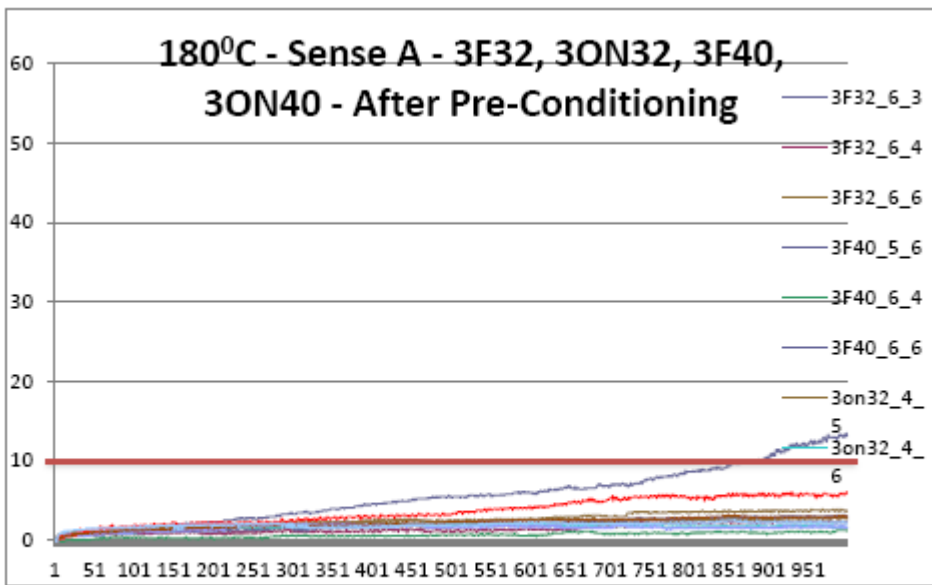
**Plot 5 – 3 Stack Microvias on Buried via – Sense A**

**Plot 6 – 3 Stack Microvias on Buried via – Sense A**

Results for 3 and 4 stacks were different than what we saw for 2 stacks. The change in resistance for one 3 stack microvia (Sense A) went over 10% at 893 cycles. The change in slope for this microvia is still gradual. All other microvias are still showing a change in resistance below 7%. Similar to 2 stack microvias, Sense B is showing different results than Sense A. Here we see one test coupon starting to degrade at 216 cycles.

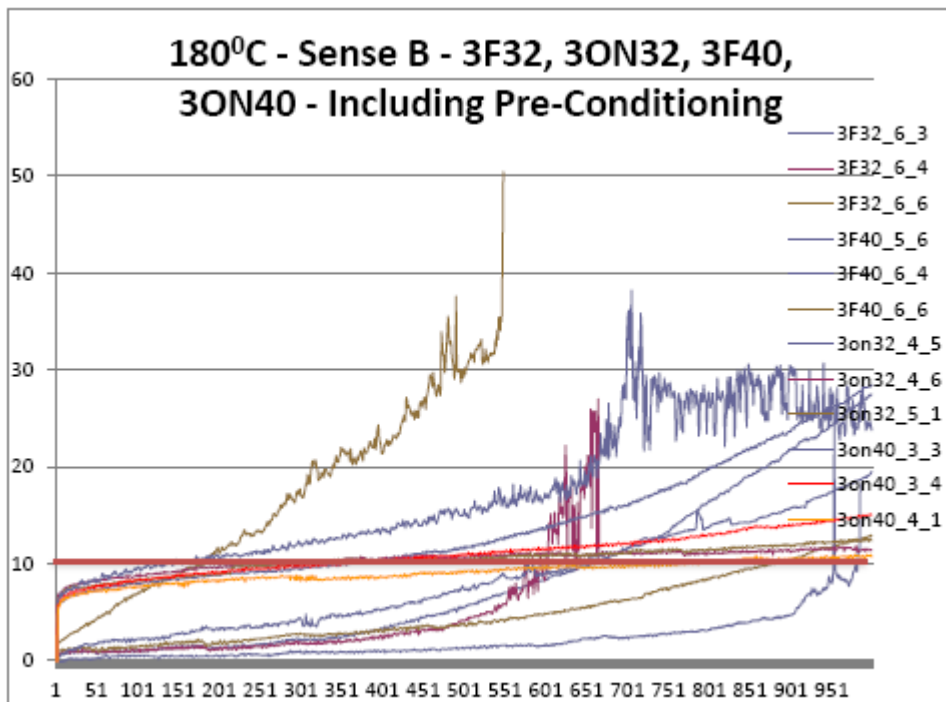
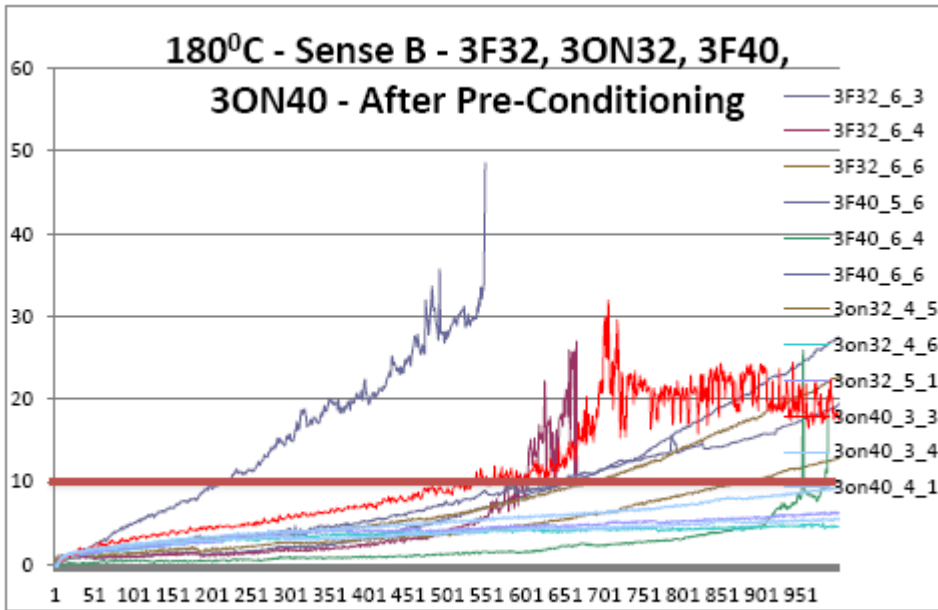
**Plot 7 – 3 Stack Microvias on Buried via – Sense B**

**Plot 8 – 3 Stack Microvias on Buried via – Sense B**

There are several other coupons starting to move above the 10% threshold resulting in one complete failure at 543 cycles. The other coupon crossed the 10% threshold at 557 cycles and continues to degrade over the remaining test period without completely failing. Only one more coupon had a complete failure at 949 cycles.

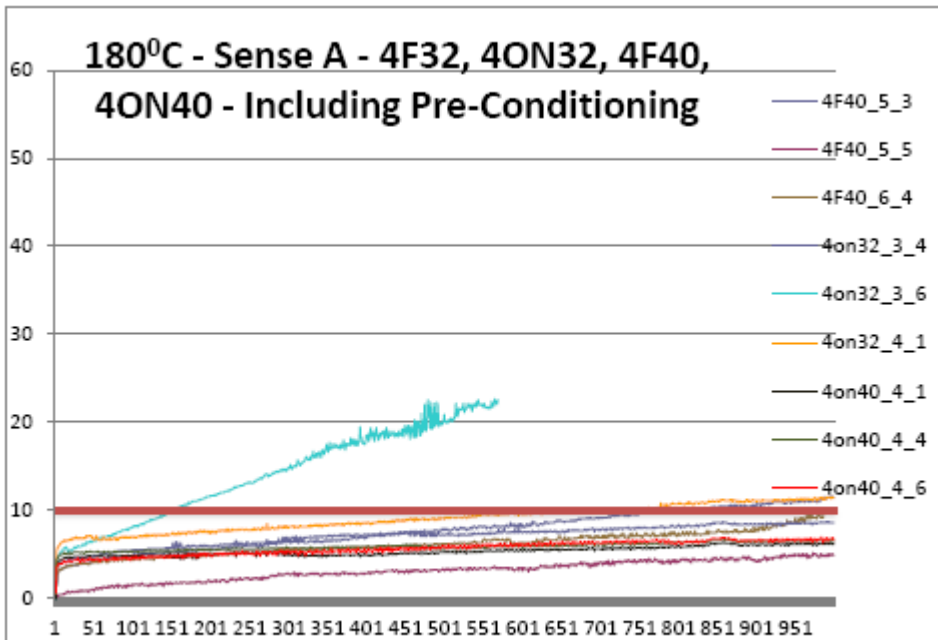
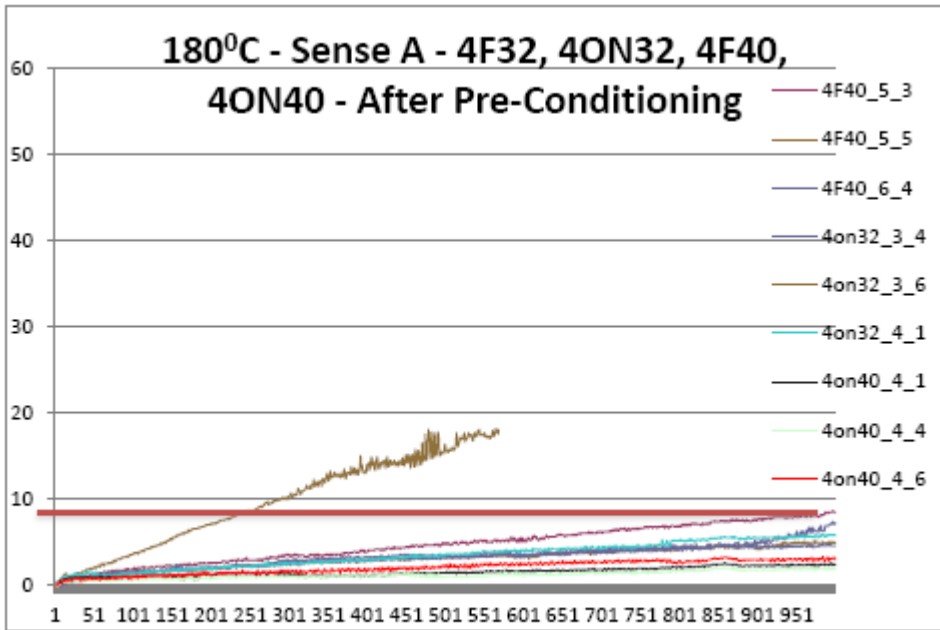
**Plot 9 – 4 Stack Microvias on Buried via – Sense A**

**Plot 10 – 4 Stack Microvias on Buried via – Sense A**

Four stack microvias show an improvement over 2 and 3 stacks. For Sense A, there is one microvia coupon that starts to show degradation at 280 cycles and has a complete failure at 561 cycles. All other coupons for Sense A stayed below a 10% change in resistance. Sense B also shows improved results over 2 and 3 stack coupons. The first coupon to cross 10% limit had completed 570 cycles but didn't show a complete failure. This coupon reached a maximum resistance change of 28% at 944 cycles. The third coupon reached 695 cycles before crossing the 10% change threshold and showed a failure at 993cycles.

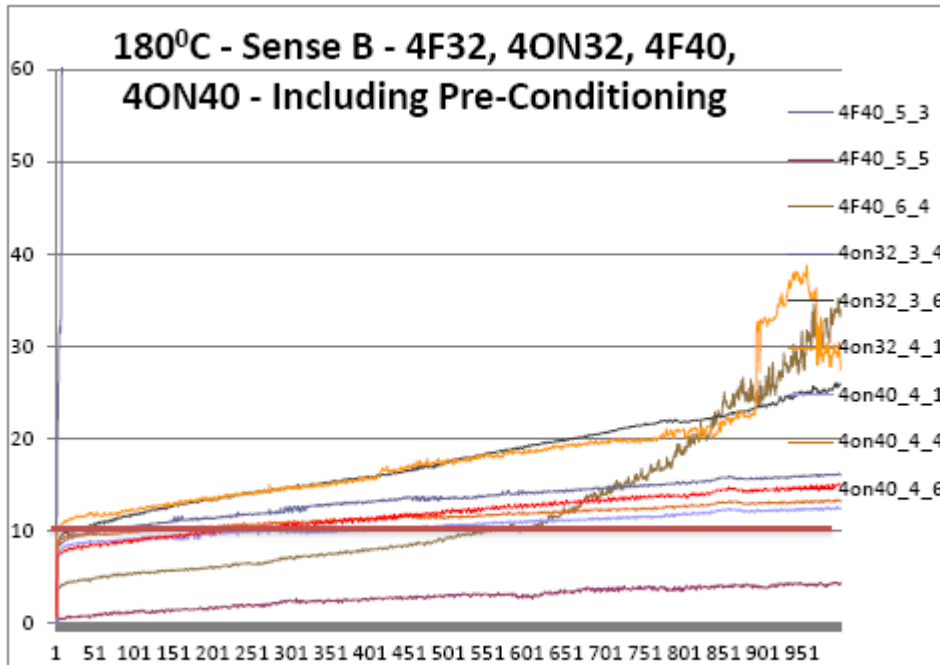
**Plot 11 – 4 Stack Microvias on Buried via – Sense B**

**Plot 12 – 4 Stack Microvias on Buried via – Sense B**
