## Mixed Metals Impact on Reliability

**Rick Gunn**

### Abstract

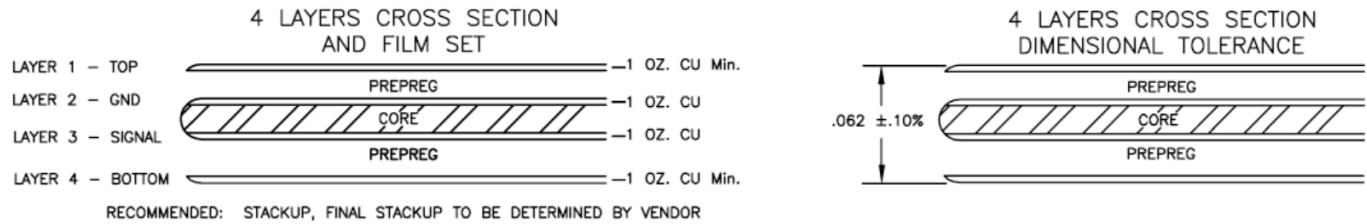
**Figure 1 – PCB Stackup**

PCB was designed in-house in order to accommodate all of the test requirements. The design was built with lead free compatible laminate meeting the IPC- 4101/26 requirements. The PCB was 4.0 x 3.0 x 0.062 thick and 4 layers with immersion silver finish. Figure 1 and Figure 2.

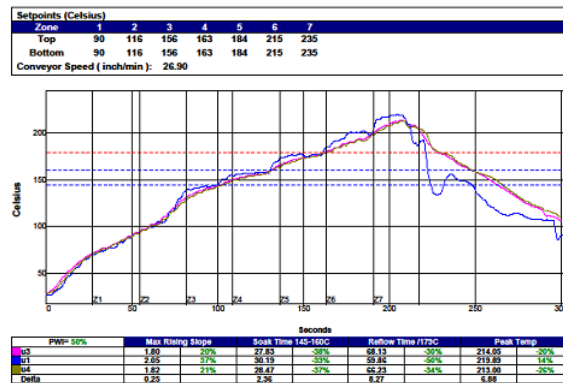
Figure 3 – Profile 1

The PCA's were reflowed in a 7-Zone, forced convection, nitrogen purged reflow oven. Three reflow profiles were used in the experiment. Profile 1 was a linear ramp reflow profile for leaded solder, peak ~ 220C, time above liquidus ~ 60 sec. Profile 2 was a modified version of profile 1, peak ~ 235C, time above liquidus ~ 110 sec. Profile 3 was a linear ramp profile, peak ~ 245C, time above liquidus ~ 60 sec.

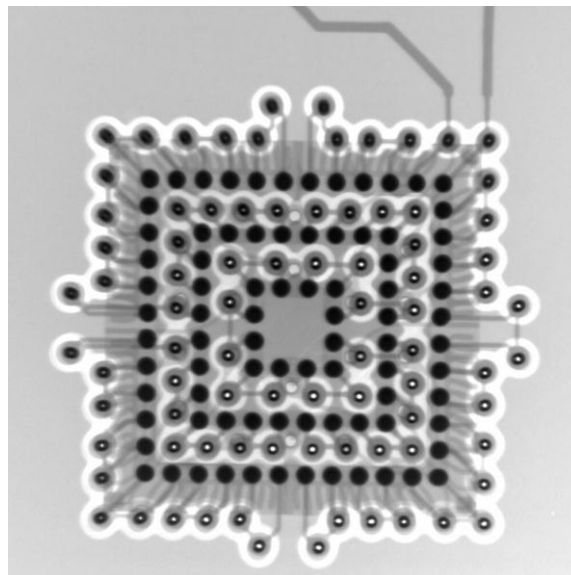
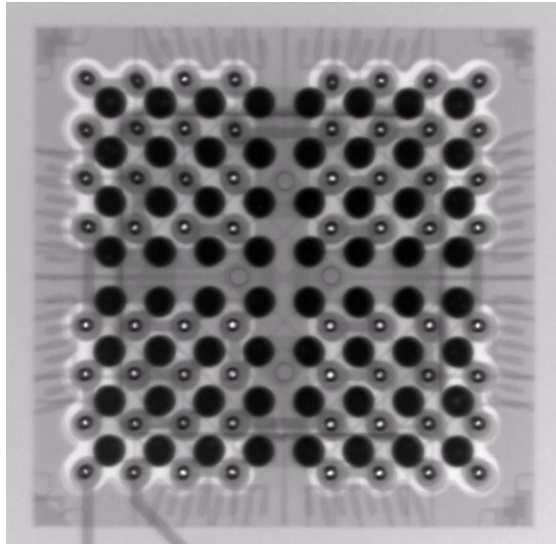
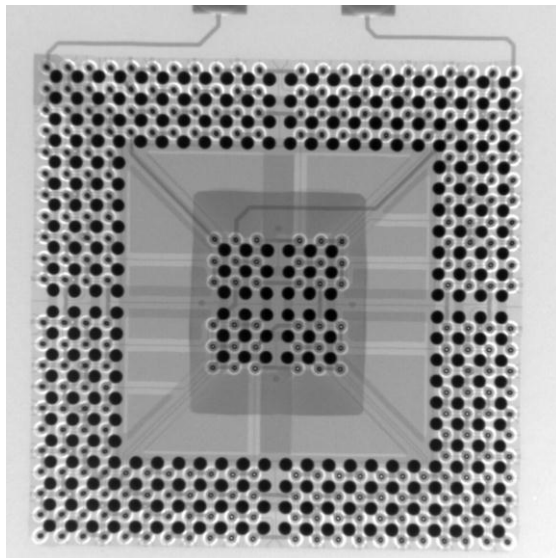
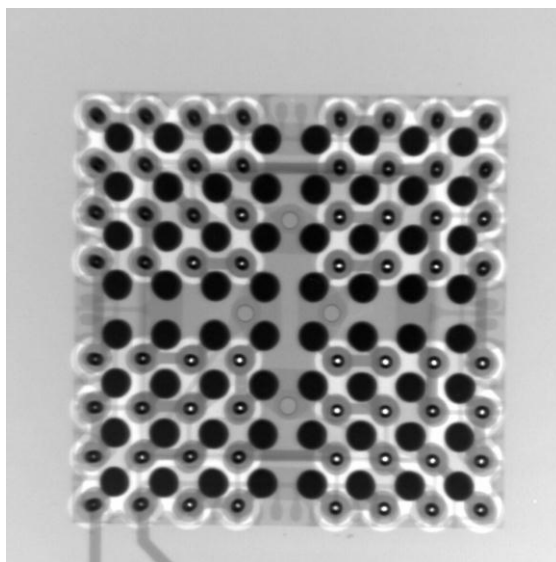
All of the test assemblies were built in one consecutive run. Printing and solder paste inspection were performed on the production line and placement was performed on high speed modular placement platforms with +/- 30 micron accuracy. After reflow the parts were inspected 100% with X-Ray to verify no shorts or excessive voiding was present. Figure 6-9 are representative samples of the devices after reflow.

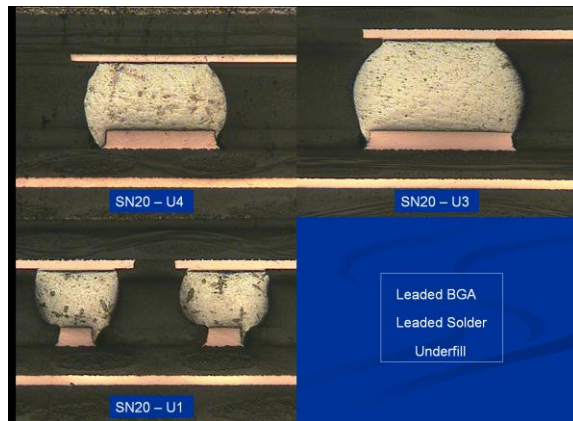
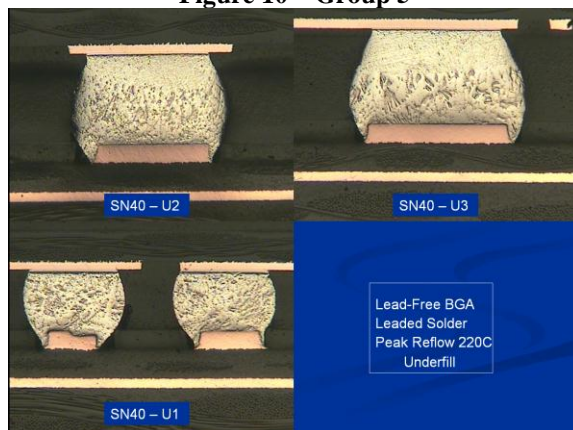
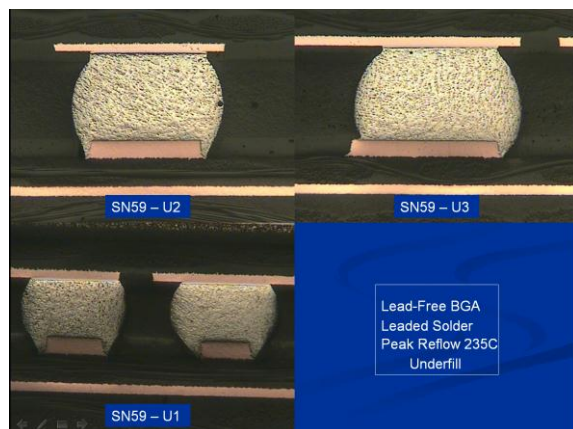
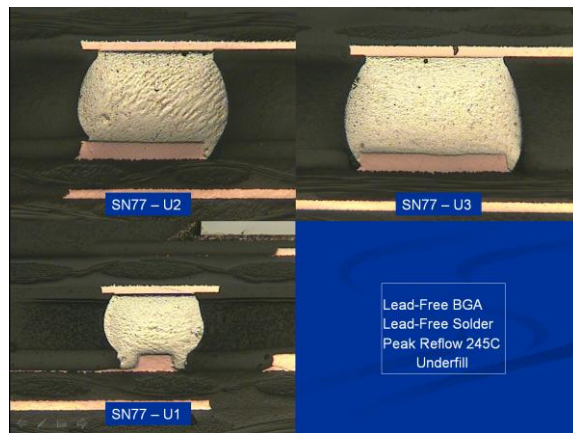
After x-ray the assemblies were electrically tested on a custom test fixture that we designed and built for this experiment. The tester measures continuity of every device on each card independently and is the same tester used during the balance of the test to capture failures during temperature cycling. Assemblies in group 5 through 8 were underfilled after x-ray inspection in the class 10,000 clean room and cured in a convection oven. Cross-sections were performed on one sample assembly from group's 5-8 see figures 10-13. These groups were evaluated before thermal cycling to assess any differences in grain structure and to validate the underfill.

All of the samples showed good wetting to the PCB and complete reflow of the solder joint. Underfill in each of the samples showed complete fill and minimal voiding. The most interesting solder formations were in group 6 which exhibited a distinct demarcation line between the leaded solder from the solder paste and the lead free solder from the solder ball.

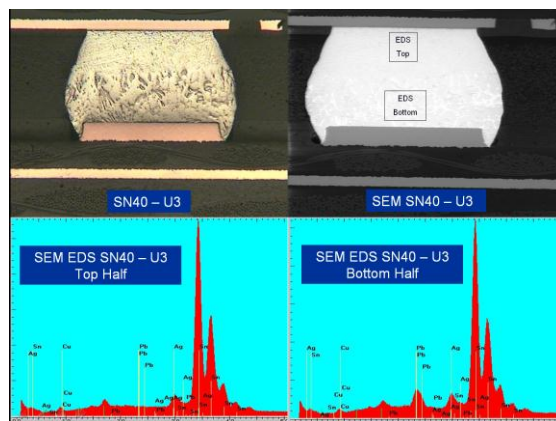
**Figure 14 – Group 6**

Scanning Electron Microscope (SEM) was used with Energy Dispersive Spectrometer (EDS) to determine the elemental makeup of the solder at two separate locations in each sample. Samples from groups 5 and 8 had only one alloy type involved in the solder matrix and were used as control groups. The EDS spectrum pulled for group 6 showed that the leaded solder at the circuit card did not alloy uniformly with the lead free solder ball when reflowed at 220C, see figure 14.

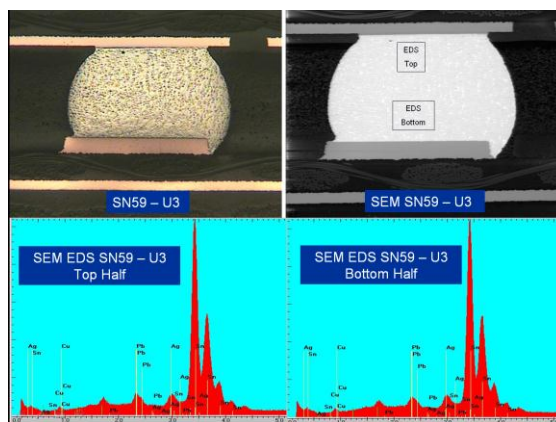
**Figure 15 – Group 7**

Group 7 which was the same as group 6, leaded solder with lead free solder balls but reflowed at 235C, showed uniform grain structure and alloying of the two solders, see figure 15.

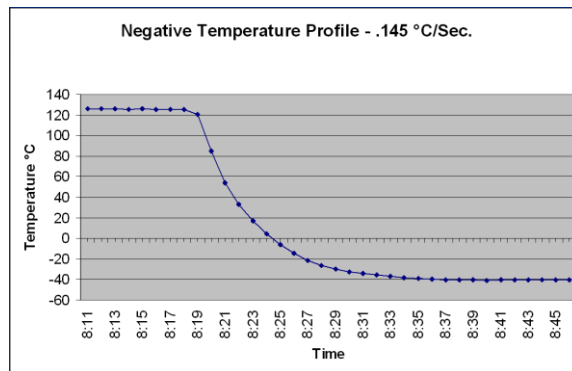
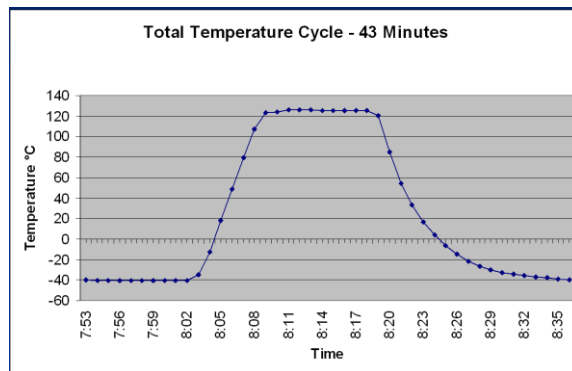
Temperature cycling of all groups was performed over a one year period with testing of each coupon being performed at 100 cycle intervals. Test parameters were -40C to +125C with 10 minute dwell at each extreme. Ramp rates positive and negative were not specified but were as fast as the equipment could make the transitions which turned out to be .393C/sec on the positive slope and .145C/sec on the negative slope, see figure 12, 13. The total cycle time for each cycle was about 43 minutes, see figure 18.

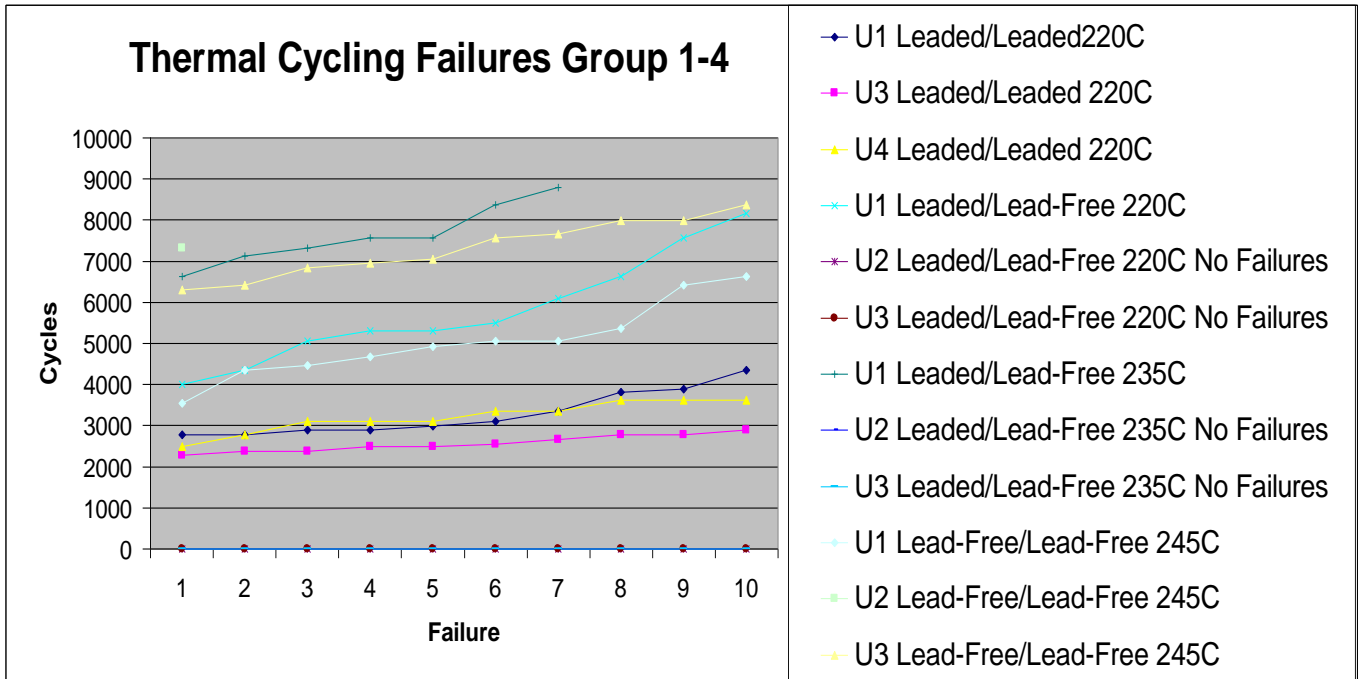
**Figure 19 –Temperature Cycle Failure Data**

Failures were cataloged as they occurred and the failed component was pulled from the test coupon for cross section analysis and validation. Non-underfilled devices were evaluated first by component type/pitch; figure 19 details all of the failures.

As you can see from this data there were many of the devices that did not fail or had only one failure. In Group 1, Leaded/Leaded at 220C, there were 100% failures starting at 2285 cycles and ending by 4345 cycles. In Group 2, Leaded/Lead-Free at 220C, the U1 device had 100% failures starting at 4013 cycles and finishing at 8164 cycles. There were no failures in group 2 for U2 or U3. Group 3, Leaded/Lead-Free at 235C, had 7 failures at U1 from 6631 cycles to the 7<sup>th</sup> failure at 8786 cycles. Three of the U1 devices in group 3 did not fail by the end of the testing and no failures occurred at U2 or U3. Group 4 Lead-Free/Lead-Free at 245C, had 100% failures at U1 3552 to 6631 cycles and at U3 6312 to 8378 cycles but only had one failure at U2 which occurred at 7323 cycles. Breaking out the failures by device gives us a better view of how the different groups performed by pitch of the device. Figure 16 shows U1 failure data across groups 1 to 4. Figure 20 and 21 shows failure data for the U2/4 device and the U3 device respectively.

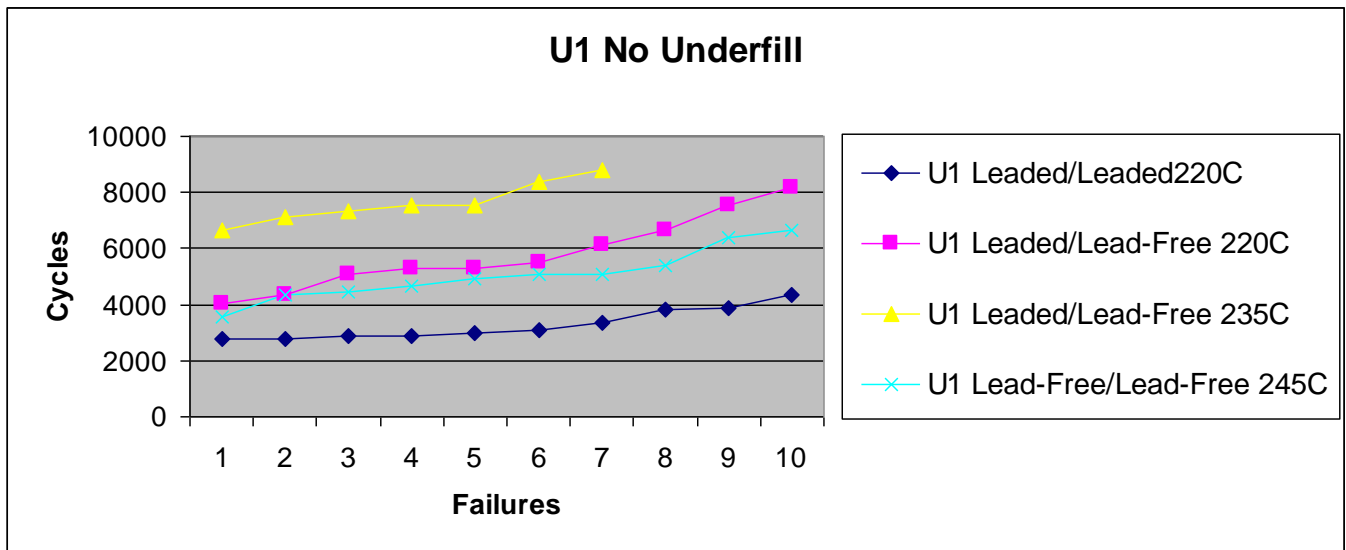
**Figure 20 – U1 Failure Data**

In the case of U1 it is clear that when mixing leaded and lead-free the best performance was achieved by reflowing at the 235C temperature. It is also interesting that the mixed metals soldered at 220C out performed the two control group samples.

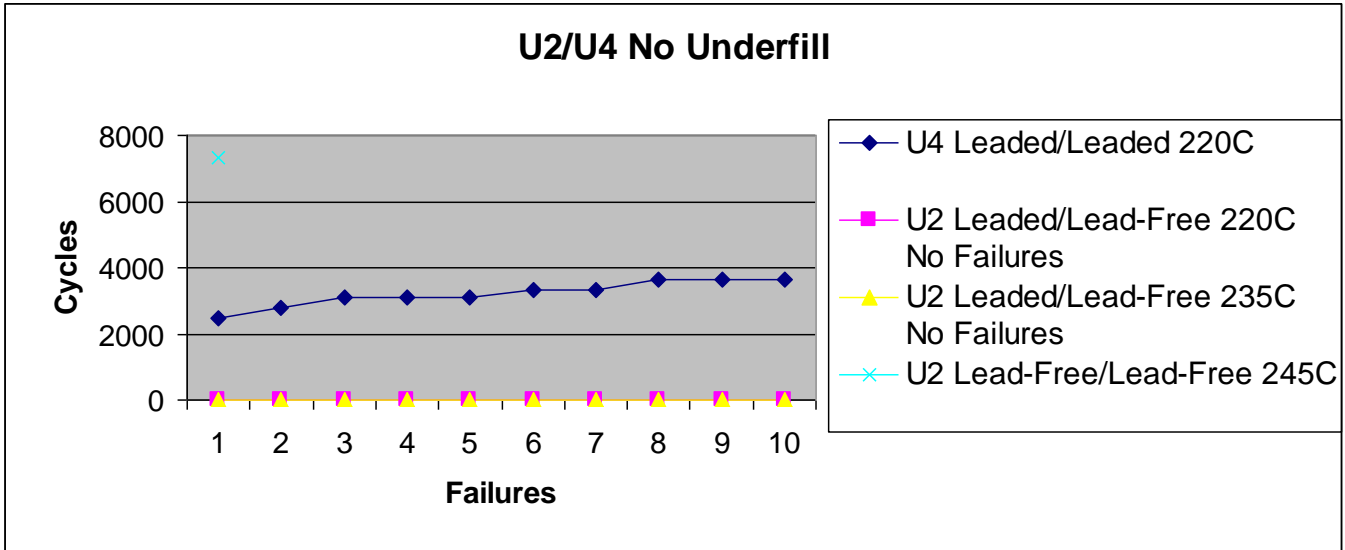
Figure 21 – U2/4 Failure Data

The U2/4 component failed in the leaded group 100% and only had one failure in the lead-free 245C group. The mixed metals groups have no failures.

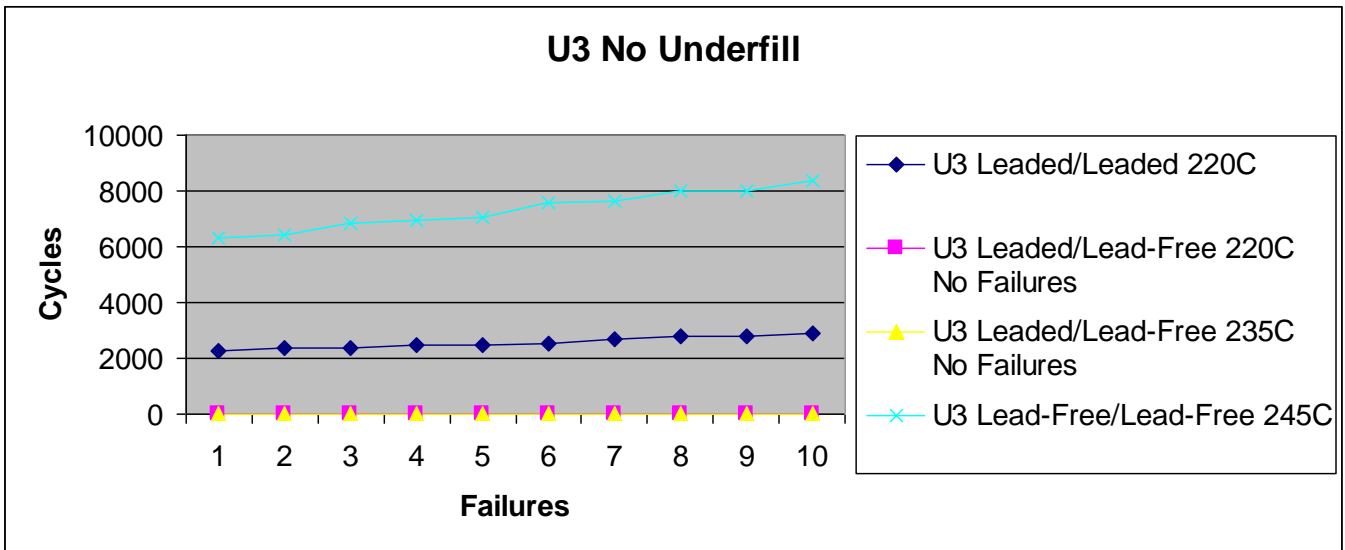
Figure 22 – U3 Failure Data

Failures in the U3 devices occurred only in the two control groups with no failures occurring in the mixed metals groups. This is an important trend that follows from package to package. The trend shows that mixed metals assemblies are outperforming the two control groups in every case.

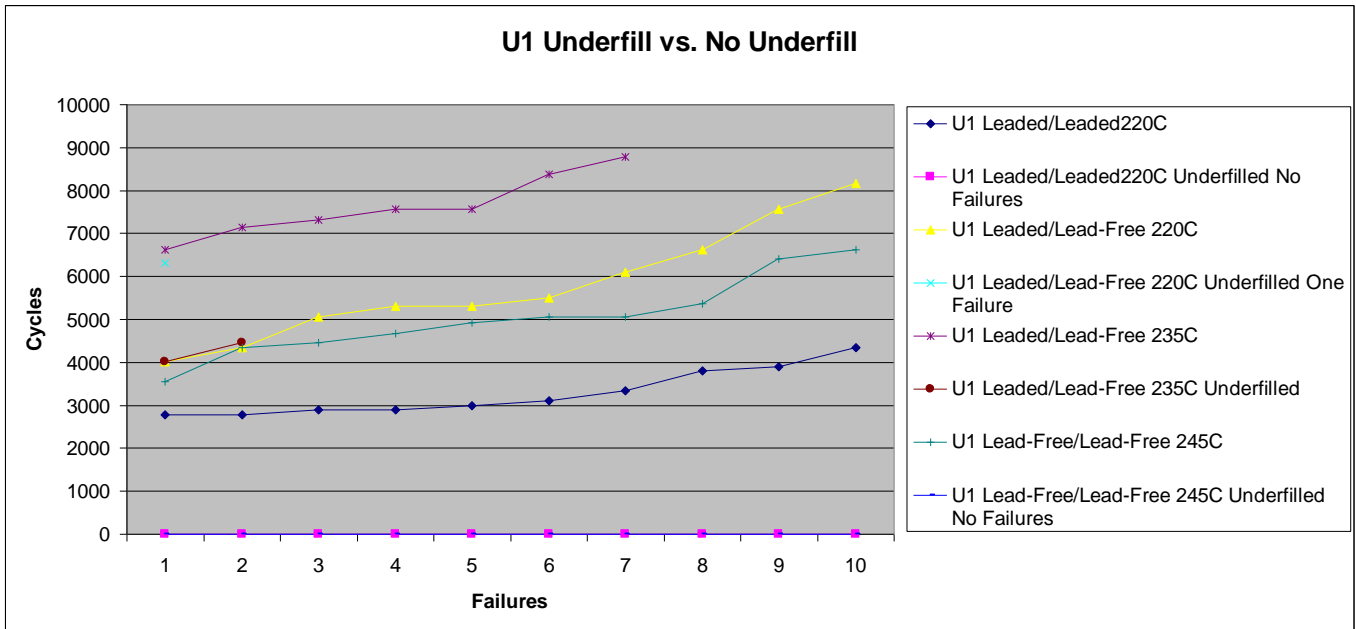
Figure 23 – U1 Underfill vs. No Underfill

The U1 package/location has three underfilled devices that experienced a failure compared to 100% of the non-underfilled U1

As a part of the study underfill was evaluated as an additional strategy to improve overall reliability. The figures below detail the failure data by package/device location, figure 23-25.

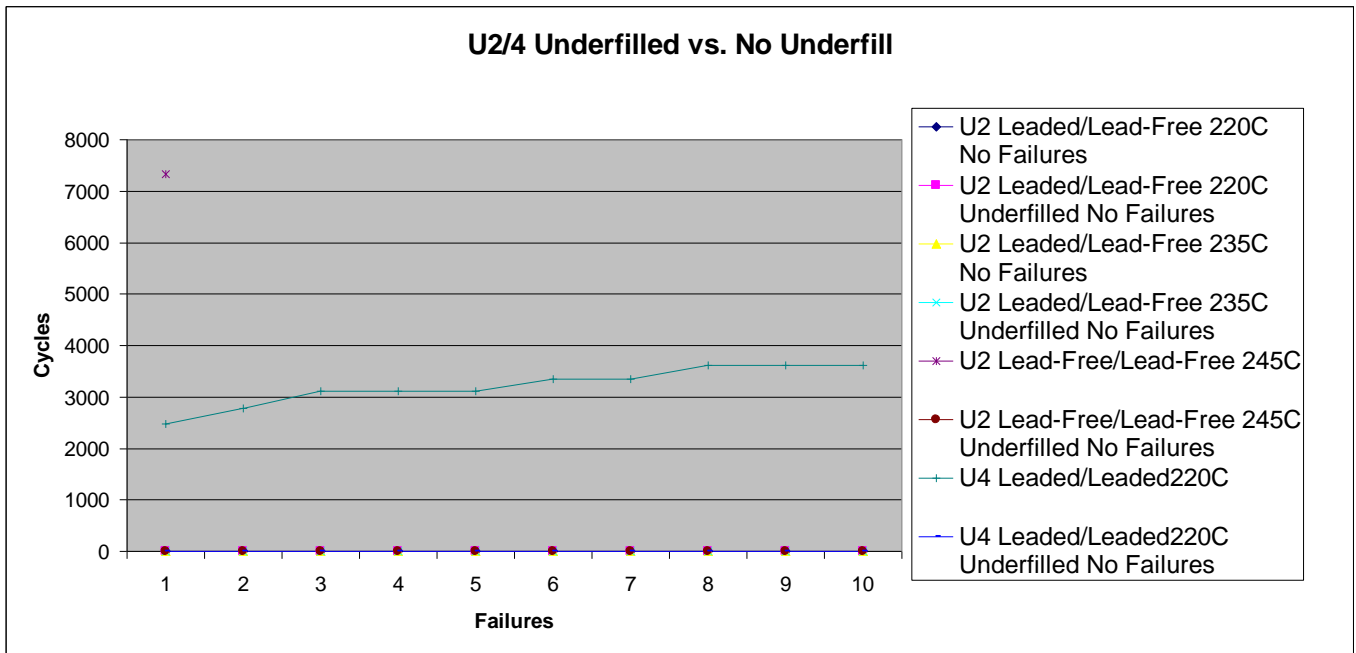
Figure 24 – U2/4 Underfill vs. No Underfill

The U2/4 package/location had no failures in the underfilled assemblies.

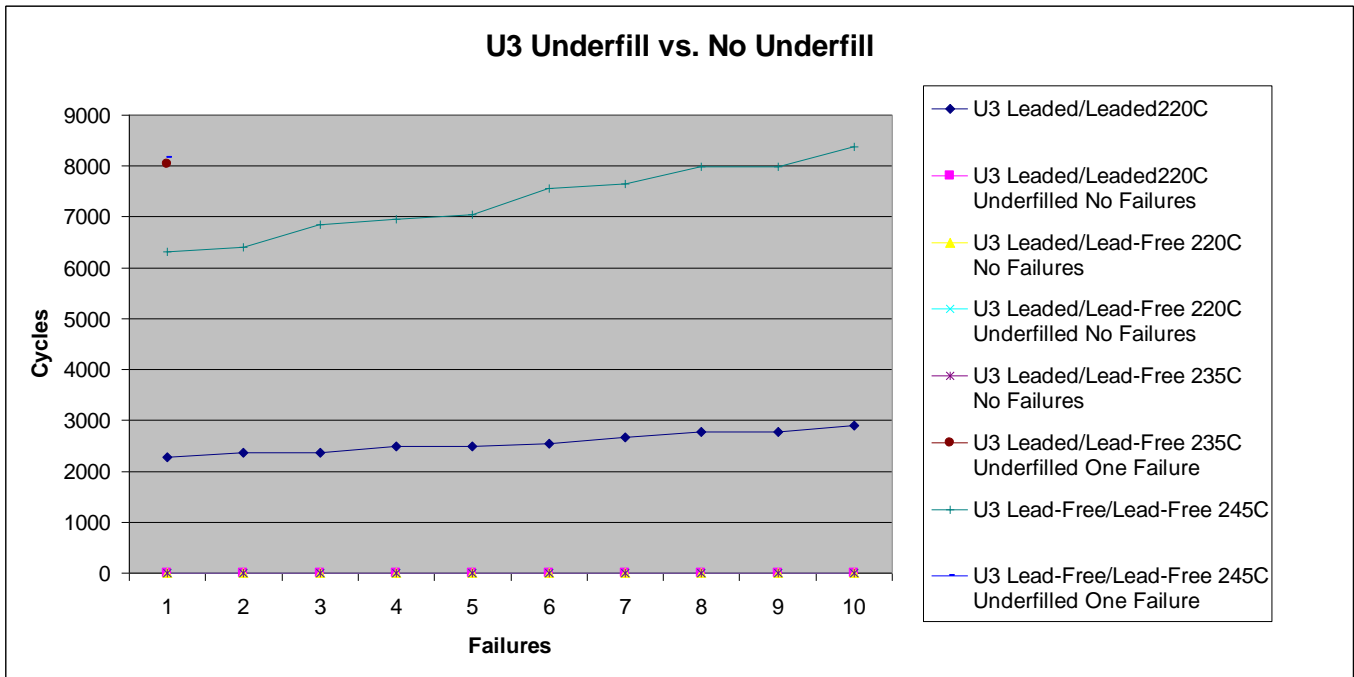
**Figure 25 – U3 Underfill vs. No Underfill**

The U3 package/location there were two failures in the underfilled groups and both were out beyond 8000 cycles. Across all groups underfill improves the reliability of these devices by 50% on average compared to not underfilling.

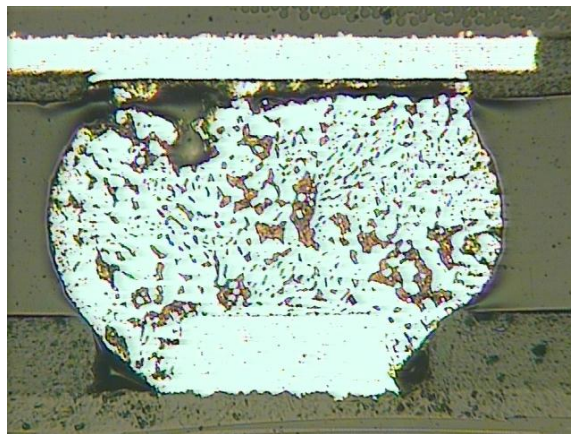
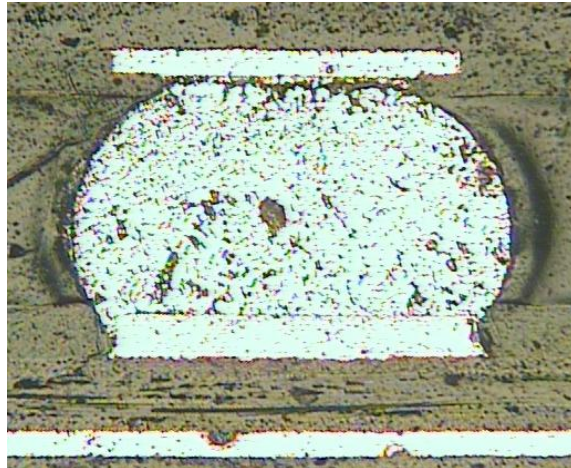
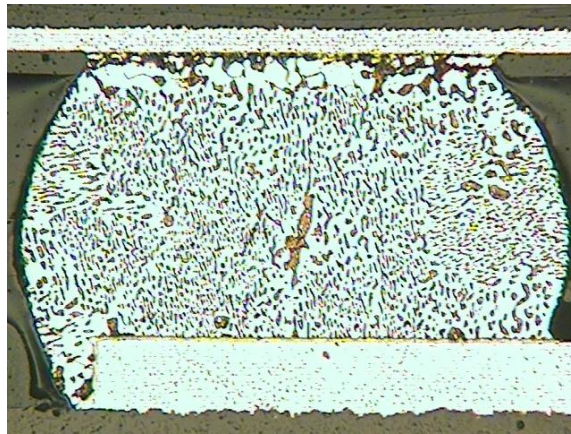
**Sample of Cross Sections**

Cross sections of the failed packages were performed to evaluate where the failure occurred. On U1 device/locations across all groups the failures occurred 86% of the time at the package interface. 7% of the failures at U1 were at the PCB interface and 7% of the failures had fractures at both package and PCB interface. Failures on the other devices followed with similar results. The only group that had a full set of failures and was group 1, leaded/leaded at 220C, and they all failed at the PCB interface.
