“Why Signal Always Be Loss in a High Speed High Frequency Transmission Line”

Albert Chen
Elite Material Co., Ltd.
Taiwan, ROC

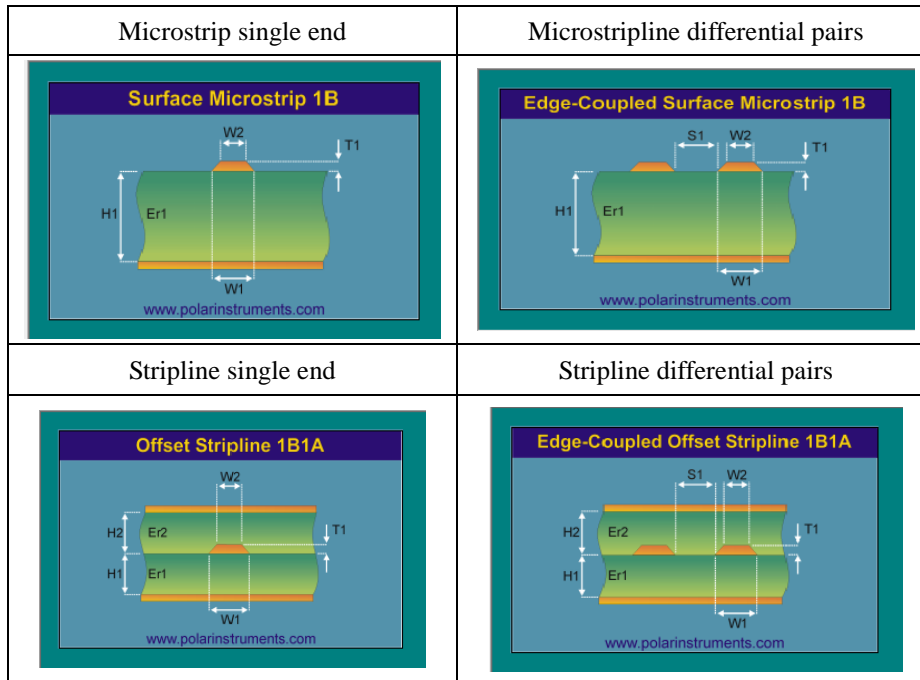
Figure 3 Typical Microstrip and Stripline structure for PCB (source: Polar Instruments Ltd)

The transmission line in a PCB stack up could be represented by following models; every model has specific formula for the

impedance calculation in a transmission line.

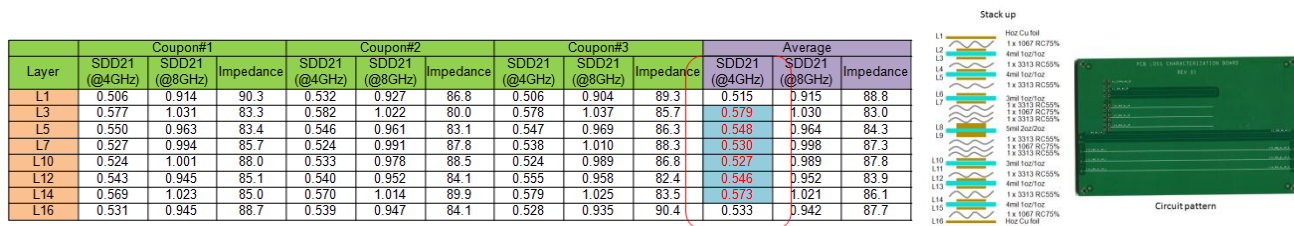
Here is an example of 16L SI measurement, a PCB shop did a good controlled impedance board that the characteristic impedance of all the traces meets a target spec value of 85 Ohms. However the insertion loss value of every layer is exceeded -0.48db/in at 4GHz what they expect.

Figure 4 – 16L stackup, circuit pattern and measuring data

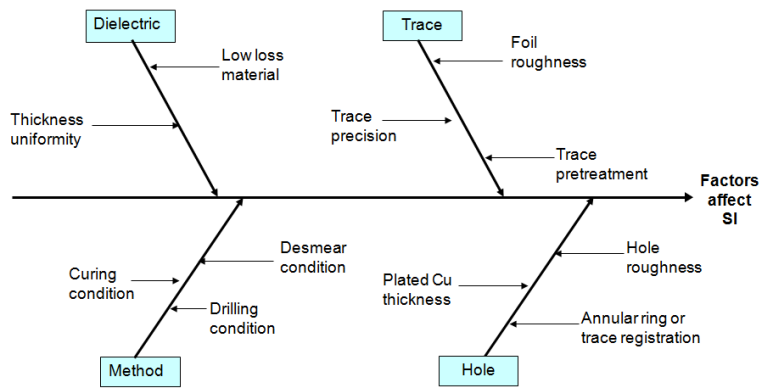
Figure 5 - Fishbone analysis of signal integrity

Elite Material Co., Ltd did following failure analysis in order to find out what's wrong in the measurement.

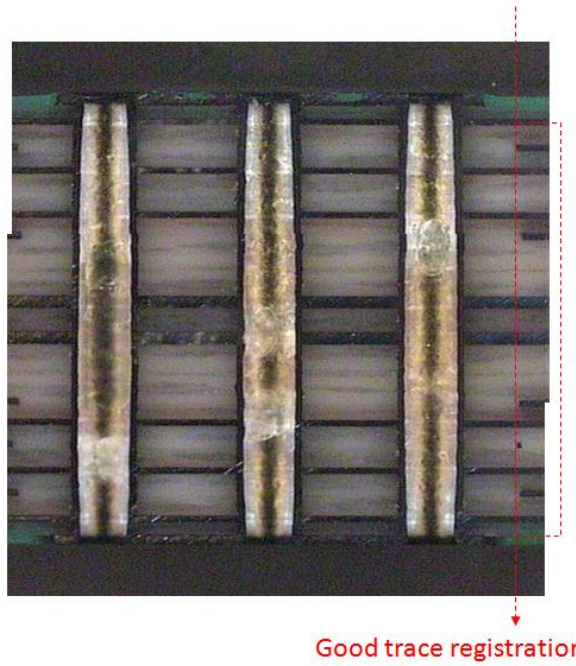
Figure 6 – Layer registration

Then we did cross-sectioning to check the registration, plated copper thickness and resin integrity of the coupons. However we don't see any obvious variation when referring to figure 6 & 7.

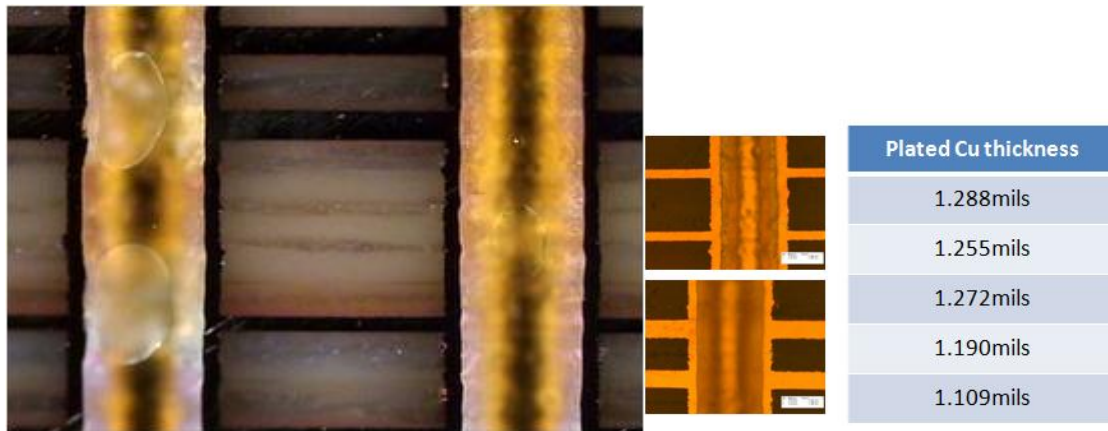
Figure 7 – (left) No resin starvation defect found, (right) plated Cu thickness >0.8mil

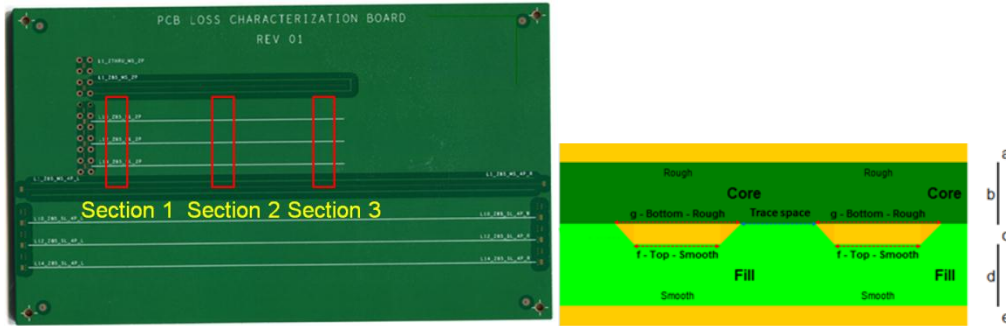
Figure 8 – Cross-sectioning location

We decided to do more cross-sectioning of trace according to below locations;

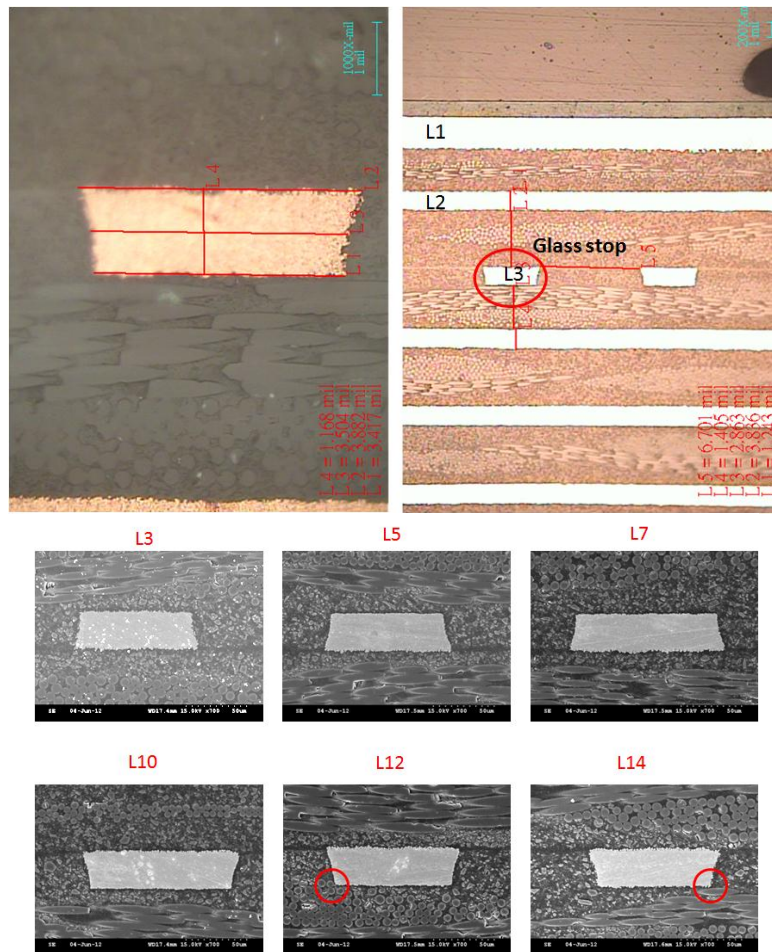
We also observe glass fiber touch onto the copper trace without sufficient resin coating at those thinner dielectric layers. As a result, the bulk resistivity of the dielectric would be dropped inevitably to cause signal loss increase.

Figure 10 – Glass fiber touch copper trace

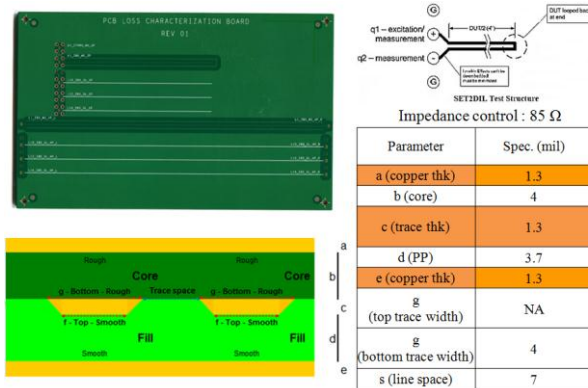
Figure 11 – Circuit pattern design

Here is another example of 16L SI measurement from three different PCB shops. They used the same circuit pattern design and same low loss FR4 material to build the same 16 layers SI test vehicles. We measured them under the same environment condition. Unfortunately we don't see the best result at B shop even she get the best impedance controlled value of 85 Ohms.

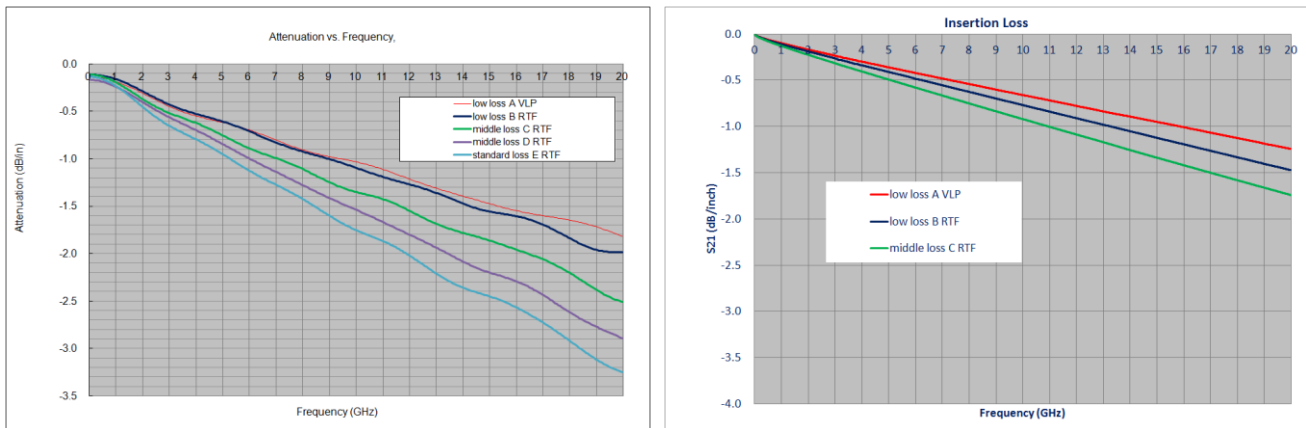
No matters of SPP or S3 results, PWB base materials always are played a major role for insertion loss performance. The low dissipation factor of material the less loss we can observe in figure 13.

Figure 13 – (left) attenuation result convert by GammaZ from SPP measurement & (right) S21 result measures by VNA from S3 measurement

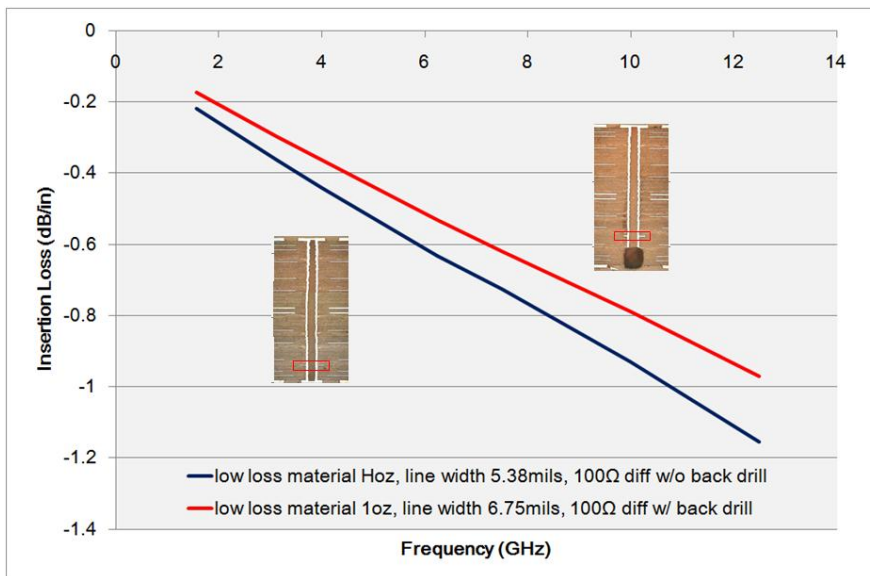
Figure 14 – Insertion loss of a 24 layer SI board

In order to reduce the return path in a transmission line, some PCB manufacturers develop back drill technique to reduce via stub effect. The via stub effect occurred at AC current the signal will travel longer return path than it should go. Back drill could eliminate the inductance on the extra path and should have better loss performance.

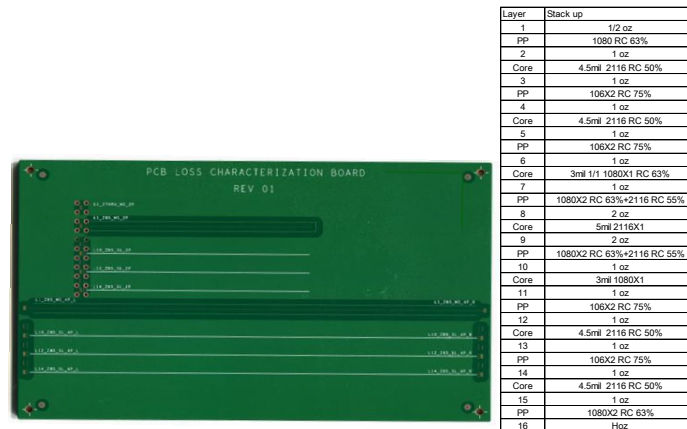
Figure 15 – Test pattern and stackup design of low loss material A

In this experiment we want to find out which factors dominant to signal loss performance by doing SET2DIL measurement. We prepare a 16L SET2DIL stackup each for different set of factors and use low loss A material for the test vehicle.

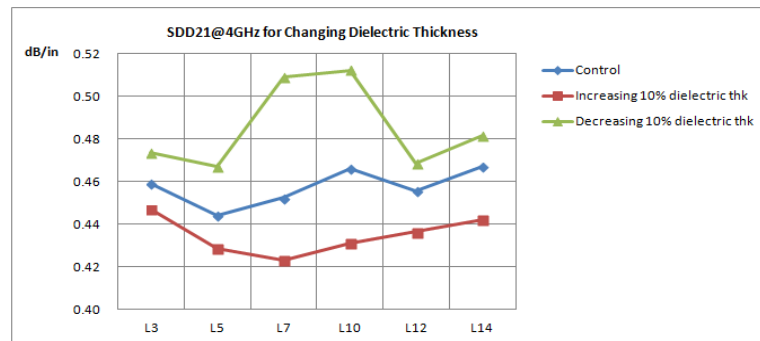
The dielectric thickness is an apparent influence factor for SDD21 result. When it is increasing about 10%, it could reduce SDD21@4GHZ about 5%.

Figure 16 - The relationship between SDD21 and dielectric thickness

5. Regarding with experiment result of SET2DIL measurement,
 - i. The dielectric thickness increase about 10% could reduce SDD21@4GHZ about 5%. This can explain why the multilayer board the insertion loss sometimes is increased even under same stackup and PCB manufacturing if there is insufficient dielectric.

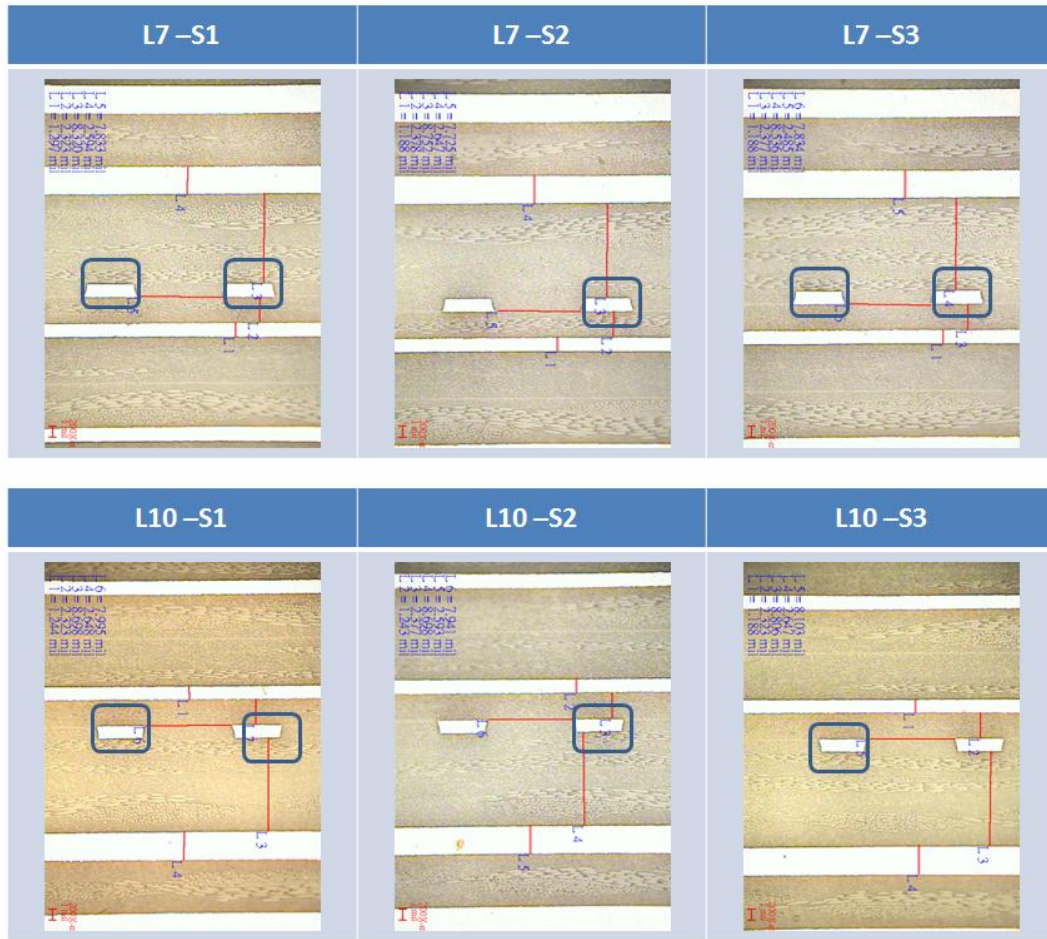
The insertion loss suddenly arise at layer 7 & 10 of the coupon with decreasing 10% dielectric thickness which is caused by resin starvation between glass fiber and copper trace shown as figure 17.

Figure 17 – Resin starvation found between glass fiber and copper trace of the “-10%” specimen

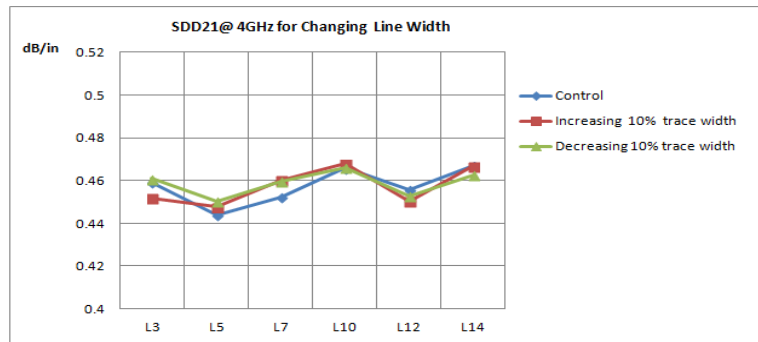
The trace width varies within +/-10% doesn't affect the SDD21 performance.

Figure 18 - The relationship between SDD21 and trace width

- ii. The trace width and space within +/-10% doesn't affect the SDD21 performance.
 - iii. The lower copper roughness is beneficial for SDD21 performance. The HVLP copper foil (1oz / Rz 1.7um) could improve about 5.8% SDD21 compare to the one using VLP copper foil (1oz/ Rz 2.5um)

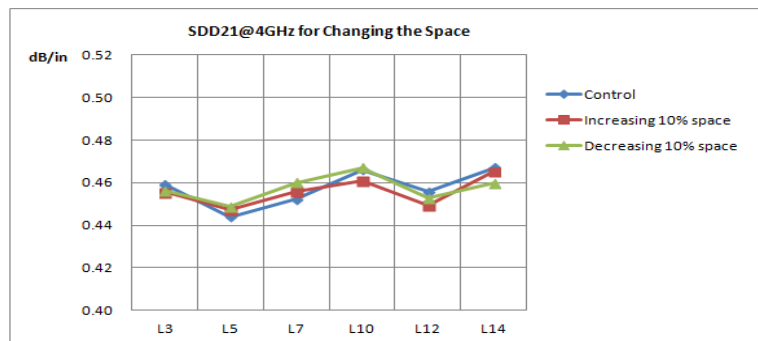
The trace space within +/-10% doesn't affect the SDD21 performance.

Figure 19 - The relationship between SDD21 and trace space

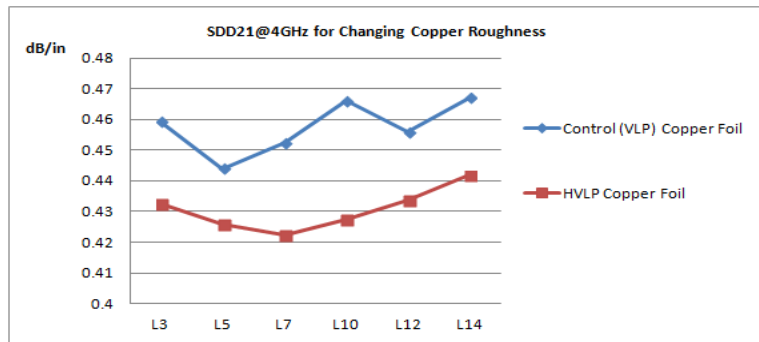
The copper foil roughness is an apparent influence factor for SDD21 result. The lower copper roughness is beneficial for insertion loss. The HVLP copper foil could improve about 5.8% SDD21 compare with VLP copper foil.

Figure 20 - The relationship between SDD21 and copper foil/roughness

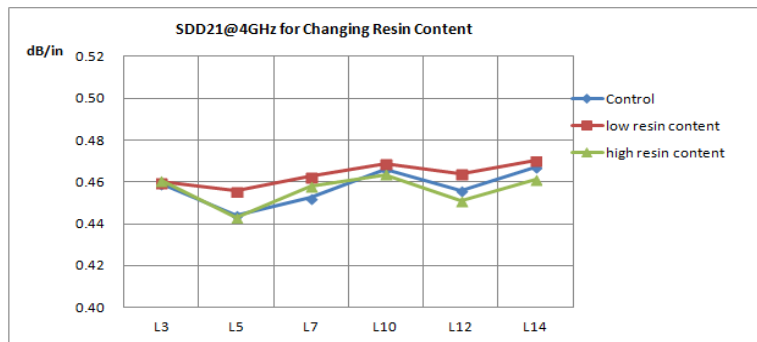
Changing stack up resin content seems not improve the SDD21 result obviously.

Figure 21 - The relationship between SDD21 and resin content

- iv. Changing resin content of stack up with keeping the same thickness (e.g. 2 ply of 106 instead 1 ply of 2116) doesn't affect SDD21 performance obviously.

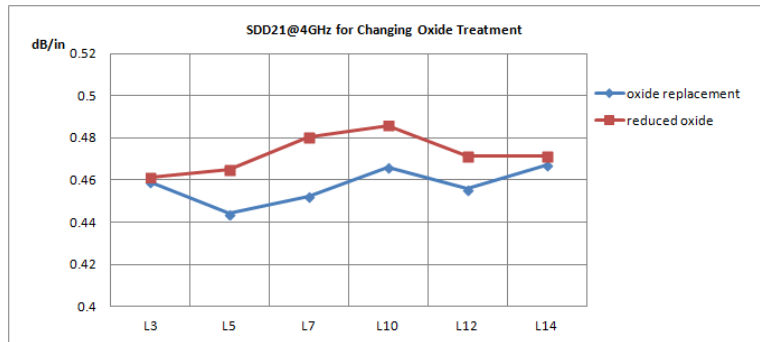
From the below figure, we could see that black oxide replacement could improve SDD21 slightly compare to oxide alternative treatment about 3%.

Figure 22 - The relationship between SDD21 and oxide treatment

- v. From the result it looks oxide replacement could improve SDD21 slightly compare to reduced oxide treatment about 3%. However we need to do further study for confirmation.

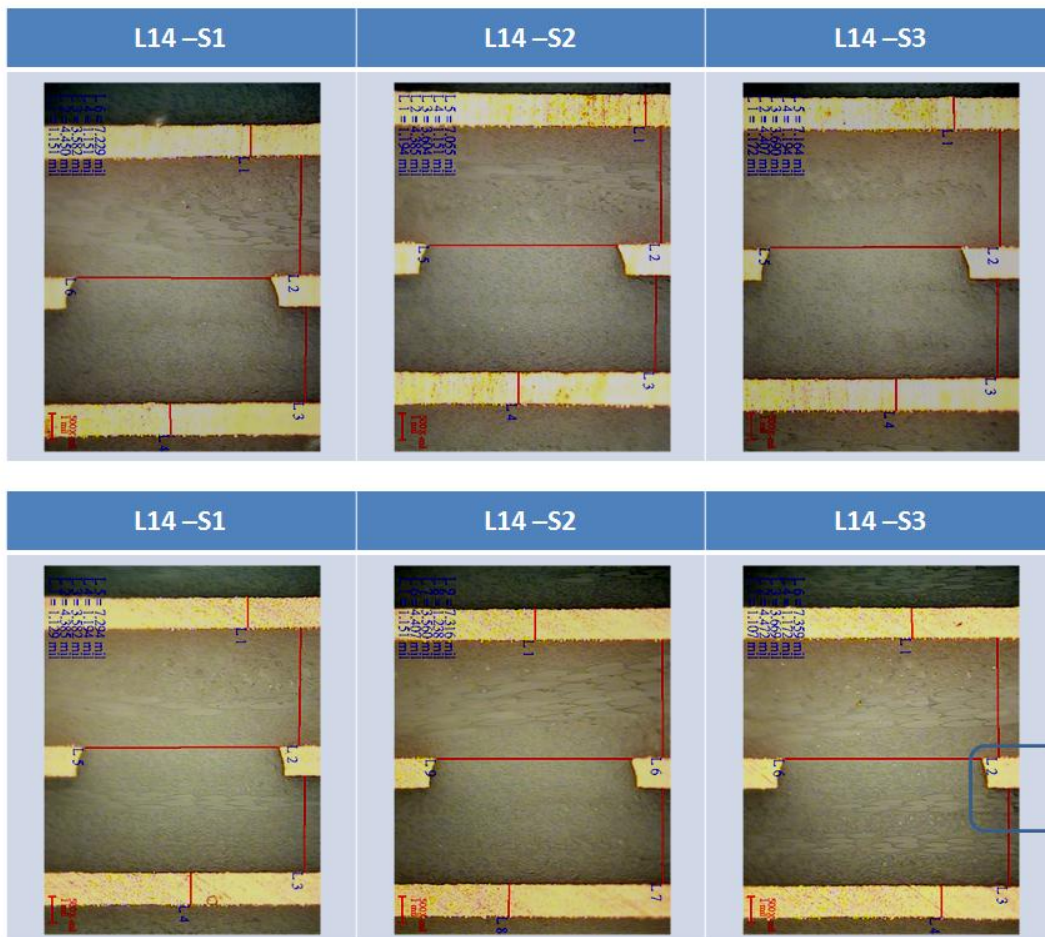
The trace at layer 14 of the oxide replacement specimen looks high and close to the one of reduced oxide maybe cause by a glass fiber touch to the copper trace in figure 22. It should take more cross-sectioning for confirmation.

Figure 23 - The cross-section of layer 14 (upper) for reduced oxide specimen and (lower) for oxide replacement specimen which show a glass fiber touch the copper trace
