## Investigation of Factors That Influence Creep Corrosion

*Speaker: Cherie Chen, IST  
IMPACT, Taipei  
October 21, 2011*

Thrust Area: Miniaturization	<b>Creep Corrosion Project</b>	Nov-11
TIG: Board Assembly	<b>Current in Phase 3: Investigation of Factors That Influence Creep Corrosion</b>

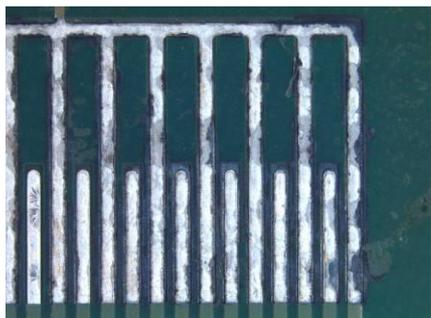
# Pb-free HASL, Organic Flux, After 20 Days MFG Testing

Creep corrosion and edge corrosion  
due to poor HASL coverage

Corrosion	Edge corrosion	Creep corrosion	Creep corrosion severity
ImAg + organic acid flux	Yes	No	Yes	High
ImAg + rosin flux	Yes	No	No	---
OSP + organic acid flux	Yes	No	Yes	Low
OSP + rosin flux	Yes	No	Yes	Low
Pb-free HASL + organic acid flux	No	Yes	Yes	High (in isolated areas)
Pb-free HASL + rosin flux	No	Yes	No	---
