# Equipment Impacts of Lead Free Wave Soldering

*\* This paper was presented at APEX 2003 and received the Best U.S. Paper Award from IPC*

The popular tin (Sn) rich lead free solders are causing severe corrosion to many of the materials used in today's Wave Solder systems. Users are experiencing higher maintenance frequency and reduced life of wave solder machine components. This paper describes the effects of Sn rich solders in contact with various materials and discusses alternate methods to alleviate this problem.

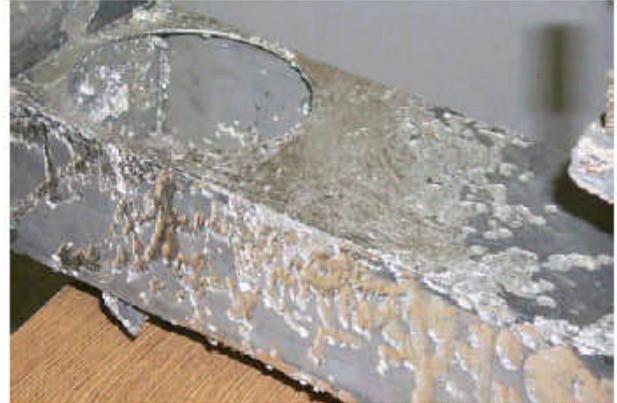
Figure 1 – Failed Stainless Steel Solder Flow Duct

Figure 1 shows a typical failure of an unprotected stainless steel solder flowduct used in a lead free application. Severe erosion and pitting of the metal has occurred and some areas have lost all structural integrity. The most vulnerable stainless steel components are those in contact with flowing solder (i.e. pump impeller, ducts, and nozzles).

Older equipment that has been drained and filled with lead free solder has brought to light the severe corrosion that occurs to the internal stainless steel components. Experience has shown that corrosion occurs after as little as six months of operation in high uptime environments.

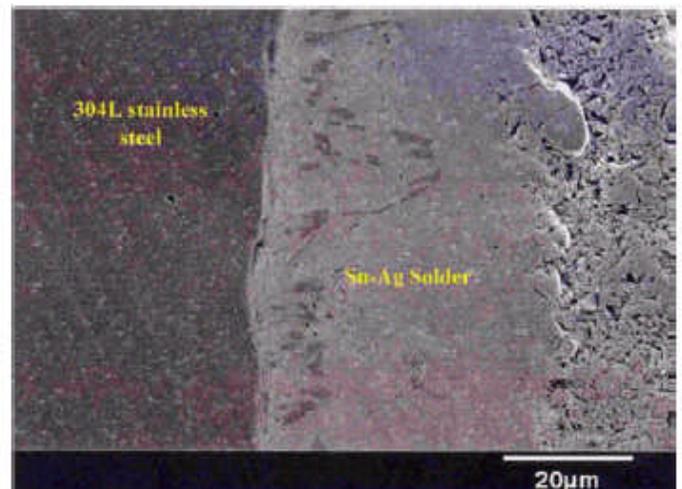
Figure 2 – SEM Image of Corrosion Pit

Figure 2 shows a scanning electron microscope (SEM) image of a sectioned sample of a corrosion crater from a stainless steel component operated with 97% Sn solder for approximately 1 year. Energy dispersive spectroscopy (EDS) compositional analysis was then performed in the SEM on the crater in 20µm increments, as shown in Table 1. Both indicate that a gradient of elements exist between the underlying stainless steel substrate and the external bulk Sn-Ag solder. This confirms that wetting to the stainless steel has occurred and that the underlying material is dissolving into the molten Sn bath of solder.[1]

Table 1 – EDS Analysis of Corrosion Pit

Element	Bulk 304L SS	20µm	40µm	60µm	Bulk Sn-Ag Solder
Nickel	8.76	0.00	0.00	0.25	0.00
Iron	71.25	18.19	16.97	0.59	0.00
Manganese	1.69	0.09	0.02	0.00	0.00
Chromium	17.31	2.36	0.80	0.05	0.00
Silicon	1.00	0.71	0.67	0.21	0.00
Tin	0.00	75.71	78.71	95.61	93.87
Silver	0.00	2.95	2.82	3.29	6.13

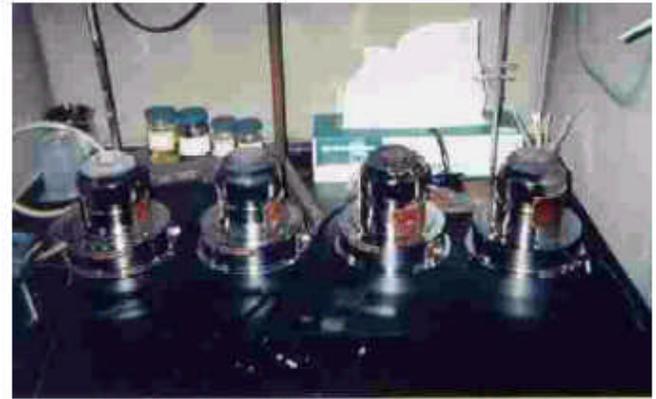
Figure 3 – Solder Exposure Baths

Laboratory testing was conducted on representative samples exposed to 97%Sn solder at different temperatures and various exposure times. Material samples were fabricated into strips approximately 1 in. wide by 3 in. long. These strips were then immersed into a static bath of 97%Sn solder and examined at 2-week, 4-week, and 8-week intervals for signs of wetting (Figure 3). Baseline pictures were taken prior to running tests.[2]

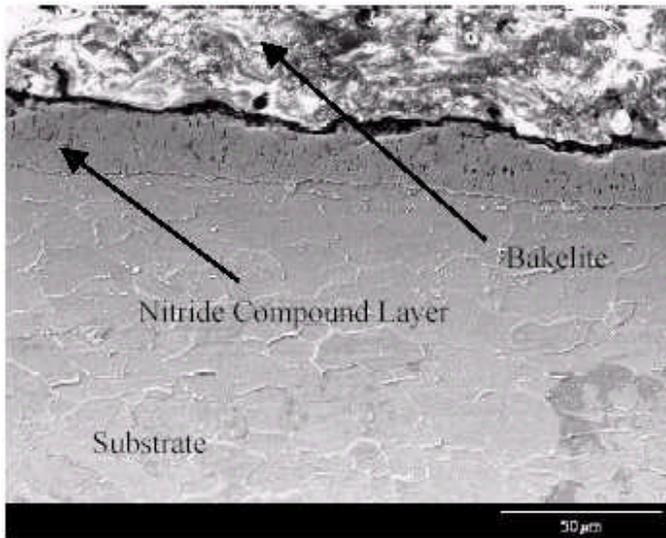
**Figure 5 – SEM Image of Melonite® Coated Substrate**

Melonite.[3] coating is one form of treatment that is used on stainless steel and other materials to improve properties. It is a salt bath nitriding process used to improve the surface properties of ferrous metal parts. The specific process used is designated as Melonite QPQ. The QPQ designation indicates that the part goes through a quenching process followed by a polishing operation and finally quenched again. This last quenching operation enhances the corrosion protection properties and sets this method apart from other common nitriding processes.[4] The Melonite coating consists of two layers, a compound layer and a diffusion layer. The compound layer consists of  $\epsilon$ -iron nitride ( $\text{Fe}_3\text{N}$ ) that is a hard, chemically stable material and is primarily responsible for the improved corrosion resistance. The diffusion layer is  $\alpha$ -iron nitride ( $\text{Fe}_4\text{N}$ ) and is responsible for improved material fatigue strength.[5]

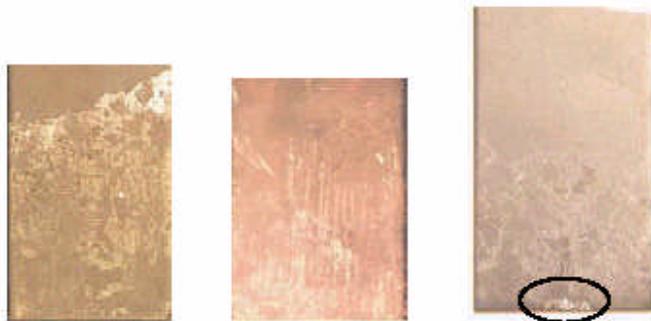
**Figure 6  
Melonite Coated Plain Carbon Steel  
Wetting only on 8-week sample at scribe mark.**

Macroscopic Images are given below for samples exposed to the Sn-Ag solder for the 2, 4, and 8-week exposure period at 250°C. Note: All photos are sequenced left to right according to exposure time with the 8-week sample shown on the right.

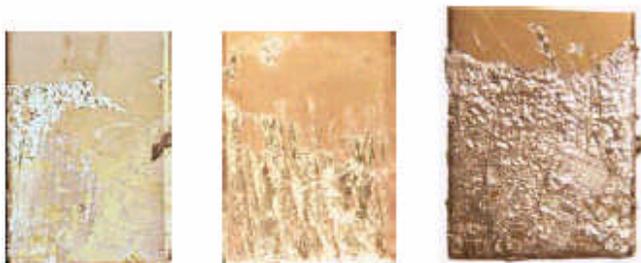
**Figure 7  
Uncoated 304 Stainless Steel Samples  
Wetting Present on all samples.**

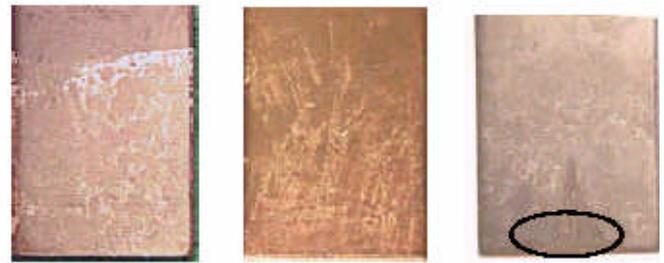
**Figure 8  
Melonite Coated 304 SST Samples  
Wetting only on 8-week sample at scribe mark.**

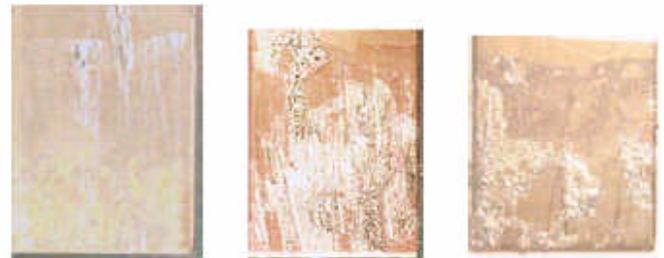
**Figure 9  
Uncoated 316 SST Samples  
Wetting present on all samples.**

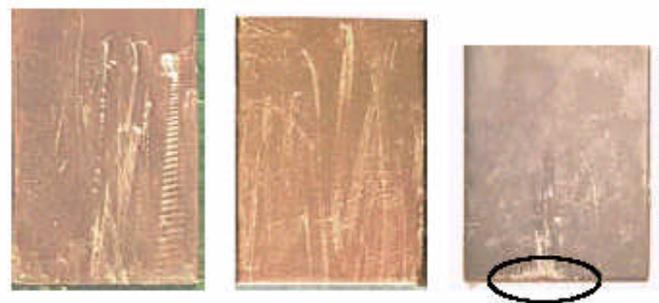
**Figure 10  
Melonite Coated 316 SST Samples  
Wetting only on 8-week sample at scribe mark.**

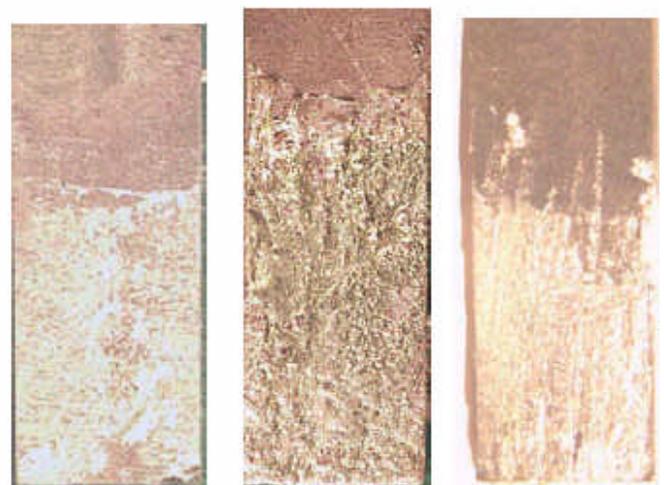
**Figure 11  
Grey Cast Iron Samples  
Wetting on all samples.**

Cast Iron Effects: Solder pots made of cast iron that are currently being utilized in lead free applications show what appears to be a slight wetting. Severe pitting and corrosion has not been observed in field use as it is seen on the components made from stainless steel.
