TECHNICAL INFORMATION

CRACKS: THE HIDDEN DEFECT

by John Maxwell
AVX Corporation

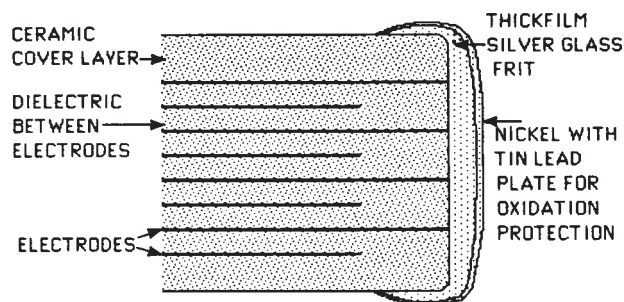
Figure 1. MLC Structure

Multilayer ceramic capacitors are sensitive to thermal shock due to device construction consisting of interleaved layers of ceramic dielectric and metal electrodes with metal terminations for electrical contact. This structure has been described earlier.[3] (See Figures 1 and 2)

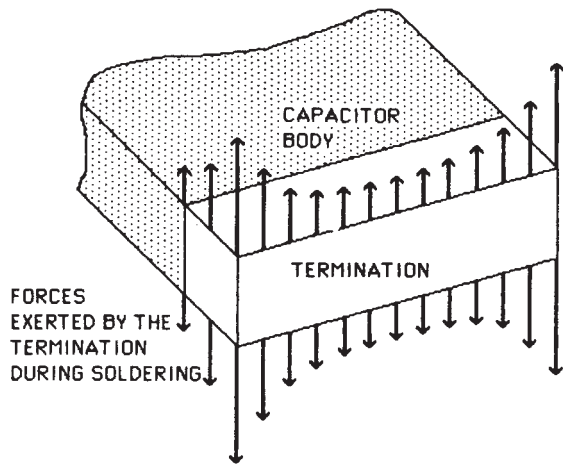
Figure 3. Stress Risers Caused by the Termination on the MLC Body

Compatible materials used in MLC manufacture have differences in CTE and δT that cause internal stress. When the temperature rate of change is too great, thermal shock cracks occur. These cracks are initiated where the structure is weakest and mechanical stress is concentrated. This is at or near the ceramic/termination interface in the middle of the exposed termination. Mechanical stress is greatest at the corners where the chip is strongest but cracks tend to start where the structure is weakest. When temperature rates of change are excessive, as in uncontrolled wave soldering, large visible U-shaped or thumbnail surface cracks are formed.

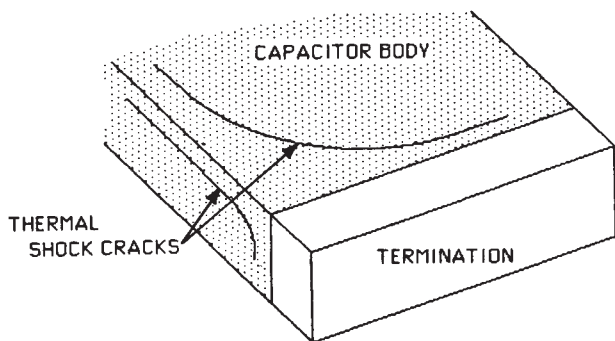
Figure 4. Extreme Thermal Shock Cracks in MLCs

Thermal shock has two manifestations, obvious visible cracks (Figure 4) and the more insidious, invisible micro crack (Figure 5). The same forces are involved but on a smaller magnitude so smaller cracks are formed. Again it starts in the middle of the exposed surface at or just under the ceramic/termination interface and propagates slowly with temperature changes or assembly flexure during handling. In a matter of weeks a micro crack can propagate through the ceramic causing opens, intermittents or excessive leakage currents, a time bomb due to processing (Figure 6).

Thermal shock cracks are always caused by improper solder processing or cleaning. Wave soldering is the biggest culprit because it has the highest heat transfer rate (using liquid metal) and the largest temperature changes which cause both visible and micro cracks. Vapor phase soldering has the second highest heat transfer rate and temperature changes which can induce micro cracks when inadequate preheat is used. Infrared (IR) reflow soldering has the lowest heat transfer rates and thermal shock is unheard of for this soldering technique. Assembly cleaning cannot be ignored because thermal shock can occur during heating or cooling. An assembly should be allowed to cool to less than $60°C$ before it is subjected to the cleaning process.

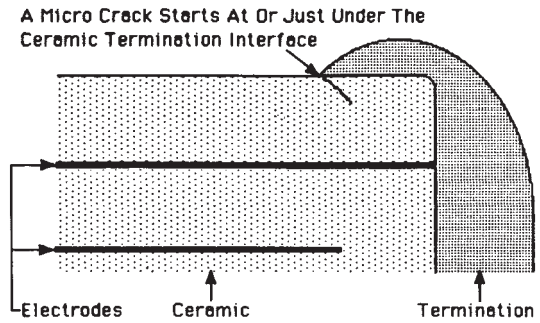
Figure 5. The Micro Crack Location

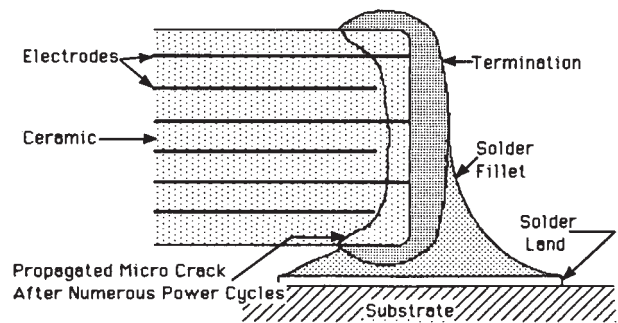
Figure 6. A Propagated Micro Crack After Power Cycling

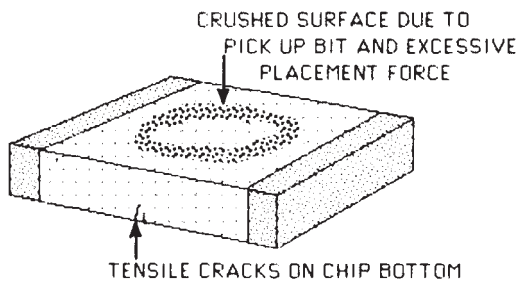
Damage or cracks caused by vacuum pick-up bits is straightforward and obvious (Figure 7). It usually consists of a crushed circular- or halfmoon-shaped area on the exposed surface of the chip and is usually quite rough with ragged edges or can be a visible impression of the placement bit. Additionally the halfmoon or circular areas will match the bit diameter. Another manifestation of bit damage occurs where solder paste is used on reflow soldered boards. Tensile cracks may be found originating on the board side of the component going from side to side in the middle of the part. These cracks may propagate to the top surface and will be rough or ragged with possible pieces of the capacitor burst from its bottom surface and trapped between the capacitor and board. This is a case where the solder paste has supported the capacitor ends but not the middle, allowing the unsupported component body to crack.

Figure 7. Placement Bit Damage With Tensile Cracks

This type of damage is caused by excessive Z-axis placement force of the bit that exceeds the rupture strength of the ceramic. Many pick and place machines use small bits (increased pounds/sq. inch) which compounds the problem by reducing the process window to avoid damage. There are two basic methods used for placement force: programmed Z-axis displacement, and pneumatic actuators. When Z-axis displacement is used for parts placement, component thickness variations, board (substrate) warpage, component land plating and solder paste thickness variations are the usual culprits. Pneumatic actuators have a separate set of problems that also include component thickness variations and warped boards. Air pressure variations within the plant can be a major cause of excessive placement pressure cracks. Also as the air cylinders age, they get sticky or suffer pressure loss, both of which are compensated for with increased air pressure and excessive force placement defects. Z-axis placement force is a process parameter that requires mandatory monitoring and control.

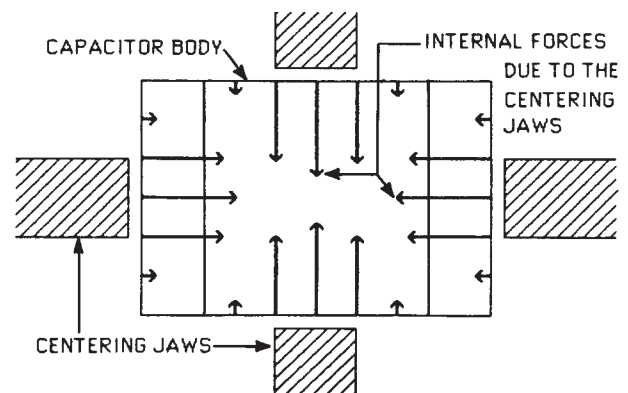
Figure 8. Top View of Capacitor Body, Centering Jaws and Force Concentration

Top centering jaw machines have the alignment jaws or tweezers as part of the pick up mechanism (Figure 8) such that the part is centered (aligned) when plucked from the component carrier (embossed tape, etc.) or during the travel time between pick up and placement. Capacitors, resistors, transistors and integrated circuits (IC) require different sizes of centering jaws which slow production rates with jaw changes. It is common practice to adjust a single jaw set to accommodate the full range of components which results in higher forces on smaller parts when the jaws are adjusted to center large ICs. Not only are higher forces used but the jaw contact areas are reduced so centering is done only on the IC body and not the leads. Now only a small portion of a capacitor's side and end surface area is used for centering which gives rise to pressures that exceed the rupture or tensile strength of the ceramic causing internal defects and visible cracks (Figure 9).

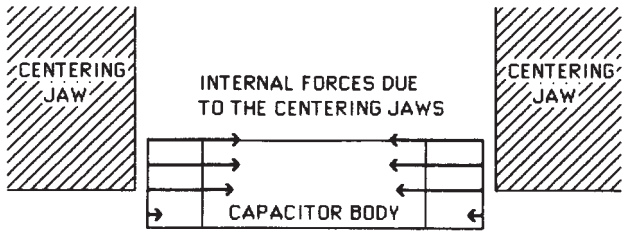
Figure 9. Side View of Capacitor Body, Centering Jaws and Force Concentration

These force concentrations from narrow centering jaws create large force or shear gradients where cracks develop. These cracks manifest themselves as visible surface cracks or internal cracks between two or three electrodes. Surface cracks originate along lines of maximum compression and ceramic displacement (Figure 10).

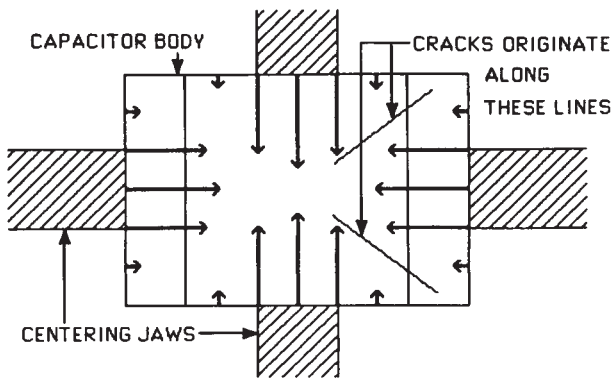
Figure 10. Surface Crack Origins

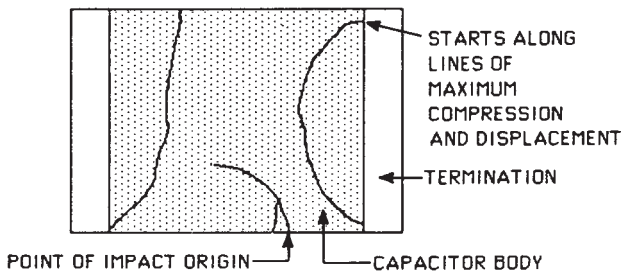
Top centering jaw machines generate surface cracks that typically originate or end under the termination while thermal shock cracks radiate away from the termination with a thumbnail- or U-shape. Centering jaw cracks will typically not extend beyond 1/3 to 1/2 of the chip length. These are quick clues to determine the source of cracks. Figure 11 illustrates typical top centering jaw damage after soldering.

Figure 11. Typical Surface Cracks from Top Centering Jaws

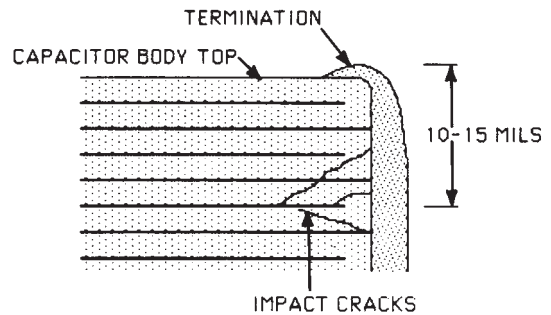
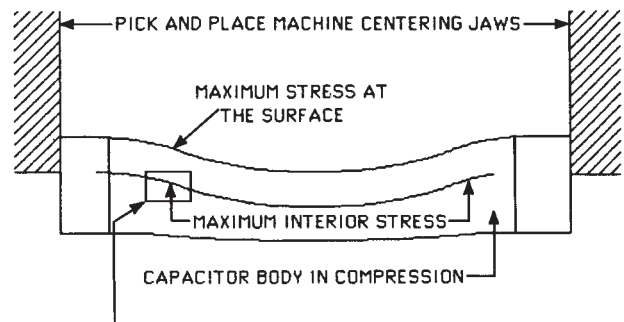
Some impact site cracks are easy to find with DPA when the centering jaw forces are low enough to just cause invisible damage. Typically these cracks have obvious origins 10-15 mils below the top surface which will be the bottom of the centering jaws, again the region of maximum stress gradients. These cracks may be deeper than 10-15 mils depending on the centering jaw depth but they will have their origins at the bottom of the jaw.

Figure 12. Typical Internal Centering Jaw Damage

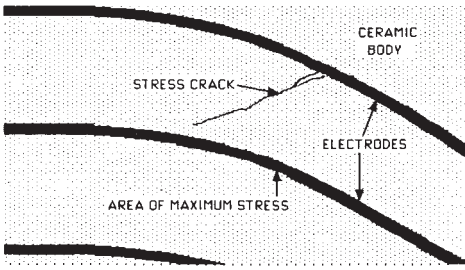
Figure 13. Capacitor Under Compression from Centering Jaws

Inter-electrode defects are the most difficult to find with DPA but they too occur at the same depth as the more obvious cracks, at the bottom depth of the centering jaws. These small cracks are again 10-15 mils below the surface (or jaw depth), near the maximum stress gradients exerted by the centering jaw. The capacitor body is slightly deformed by the compressive forces of the centering jaws. This deformation is similar to pressing on the ends of a deck of cards, and has three inflection points for this type of compression. A small crack will form between two or possibly three electrodes when the ceramic layer ruptures, relieving the stress. A small internal defect that is very difficult to find but can still kill reliability (Figures 13 and 14).

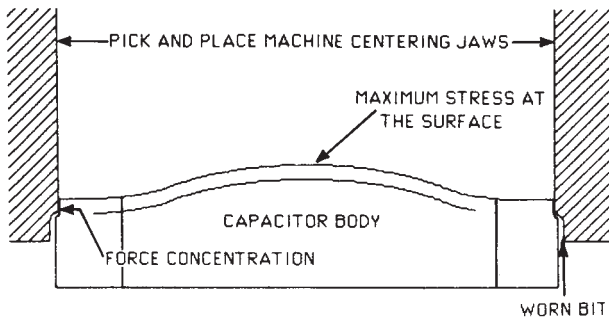
Ceramics used to make MLC capacitors have excellent abrasion characteristics which cause centering jaw wear (Figure 15). Once this wear becomes pronounced (a tenth of a mil or so), a new type of crack can appear even though the equipment has not generated defects in the past. This problem shows up when capacitor lots or vendors are changed and the parts are now slightly thicker. Now all of the force is concentrated in the top few mils, the rupture strength is exceeded and the part cracks. Worn centering jaw induced cracks are typically in the middle of the part extending from side to side on the top surface (Figure 16).

Figure 15. Worn Centering Jaws and Capacitor Distortion

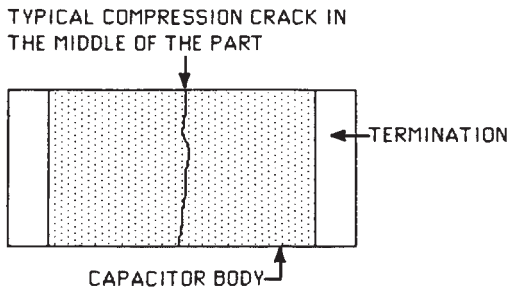
Figure 16. Typical Worn Centering Jaw Crack

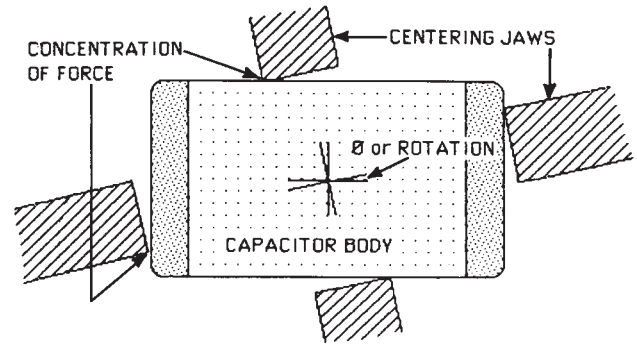
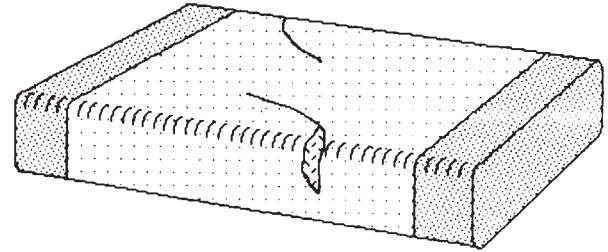
Another type of damage caused by narrow top centering jaws comes about when the part is slightly rotated in its embossed tape pocket. Now all centering or alignment forces are concentrated at the sharp corners of the jaws causing chip-outs at the impact sites. There may be cracks radiating away from the impact sites on the top surface that show up after exposure to soldering temperatures (Figures 17 and 18).

Figure 17. Misalignment of Component

Figure 18. Resulting Damage

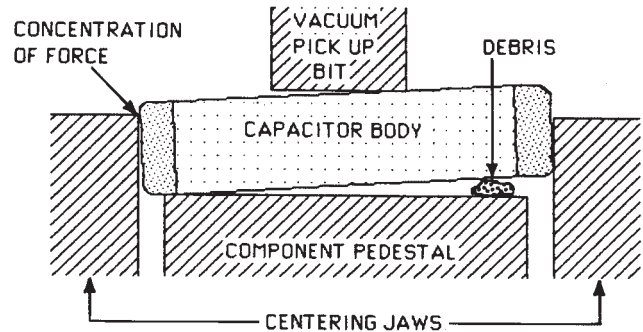
We're not out of the woods yet with pick and place machine damage. Bottom centering jaws found on some high volume chip shooting machines also have a unique centering stress crack. These cracks appear and disappear at random intervals and have been tracked to debris buildup on the component pedestal (Figure 19). When debris is present, the component will not be flat or square to the centering jaws, concentrating the alignment forces on a corner causing a displacement crack.

Figure 19. Bottom Centering Jaws With Debris

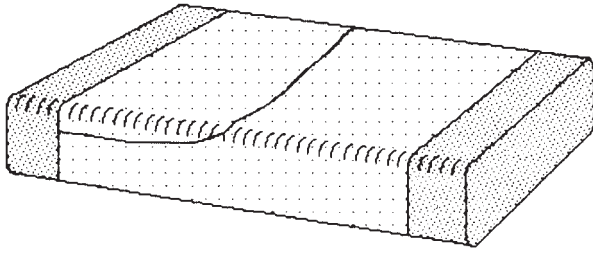
This crack propagates from side to side on the top surface (Figure 20) and is similar to surface rupture cracks caused by worn top centering jaw machines. Bottom centering cracks also extend along one or both sides of the part near the surface into the termination. These cracks are eliminated with a rigid cleaning and maintenance regime.

Figure 20. Typical Bottom Centering Crack

Complete process control is mandatory in the placement process to eliminate damage. This includes proper periodic maintenance and monitoring of all process variables. Using mechanisms the largest possible pick up bit, lowest possible placement force and centering jaws that spread alignment forces over the entire side surfaces of the component are changes that may slow the placement process but it is preferred to high speed assembly of damaged components.

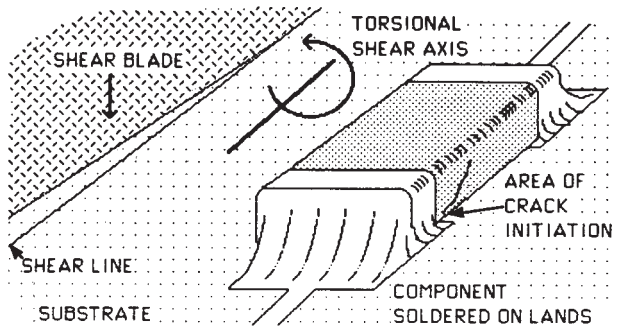
assembly techniques and is actually an extension from a sheet metal shop. There is a great deal of board bending and tearing near shear blades that can crack components and solder joints. This shearing technique can be used with care but at the loss of board real estate by placing components away from flexing edge and corners. Components located near assembly corners will receive the greatest stress because the corners are the least supported portion of the board and each corner is cut twice, once in the X direction and once in Y. Cracks generated during board shearing typically run diagonally across the top surface from corner to corner.

Figure 21. Typical Board Shearing Crack

Isolating components from board corners and away from edges is the best way to minimize shear damage and leave room for fixturing to reduce movement during the shearing process. Prerouting corners will further reduce stress and flexure in the critical corner areas. Leaving a 200-mil margin has been used successfully to eliminate damage while a 20-mil margin has always failed (Figure 22).

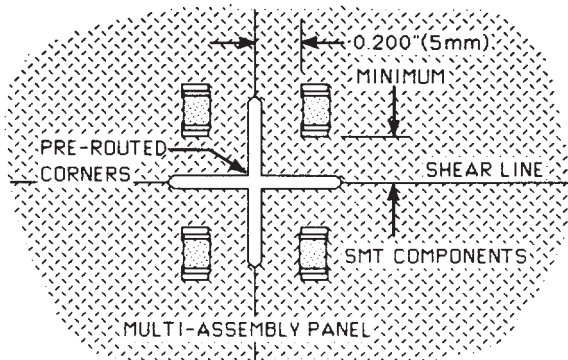
Figure 22. Prerouted Corners to Relieve Stress

Shears should be avoided if at all possible to depanelize SMT assemblies but if they must be used, isolate components from edges and corners and prerout corner areas to minimize damage. Saws or water jet cutting do not induce damage and they are preferred methods for depanelization.

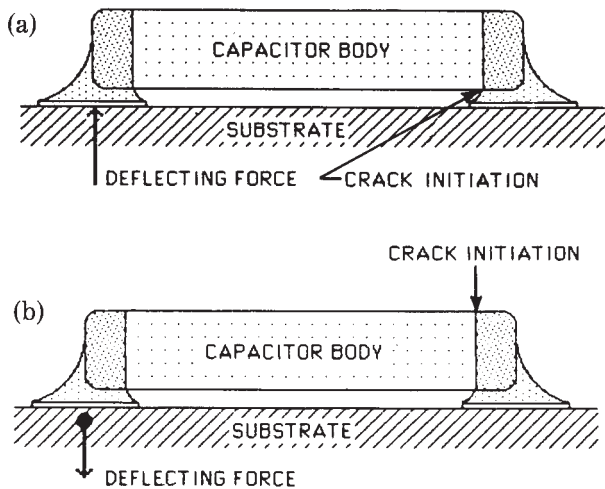
The resulting cracks occur very quickly with an audible snap. Depending on board warp, direction and component orientation, these defects propagate to relieve stress. Cracks initiate at the ceramic termination interface where ceramic movement is restricted by the termination and solder fillet. Because ceramic fails in the tensile mode at lower forces (10kpsi tensile vs 15kpsi compression), crack initiation will typically be at maximum tensile force sites as shown in Figure 23.

Figure 23. Crack Initiation Sites

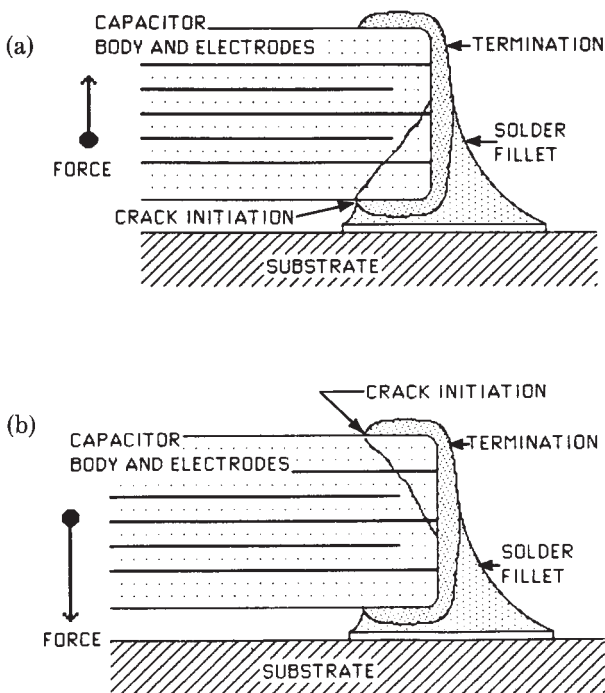
The resulting crack propagates from the initiation site to the termination at about a 45° angle. When DPA is done on this type it is confused with thermal shock or possible pick and place damage. Thermal shock cracks typically propagate from termination to termination and pick and place cracks under the termination exhibit multiple fractures while board warp cracks typically consist of a single crack.

Figure 24. Typical Board Warpage Cracks
