THE PROXIMITY OF MICROVIAS TO PTHs AND ITS IMPACT ON THE RELIABILITY

Abstract

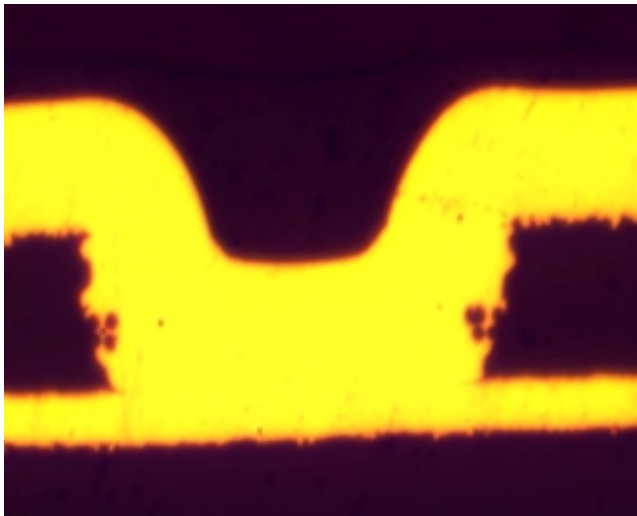
c. YAG and CO₂ Laser Drilled (Vendor 3)

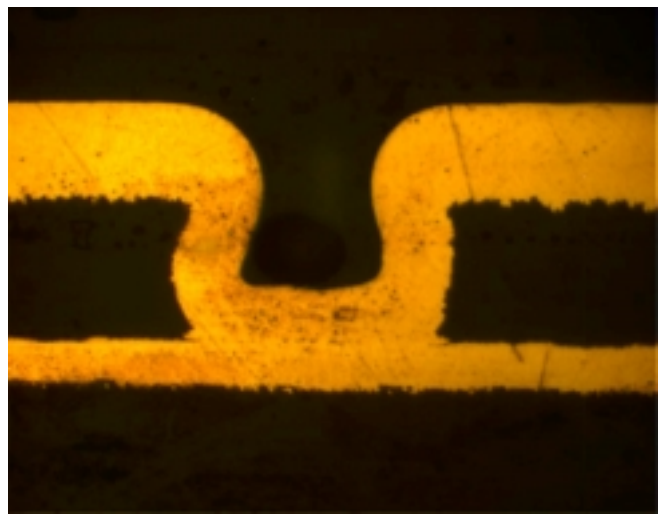
d. YAG Laser Drilled (Vendor 2)

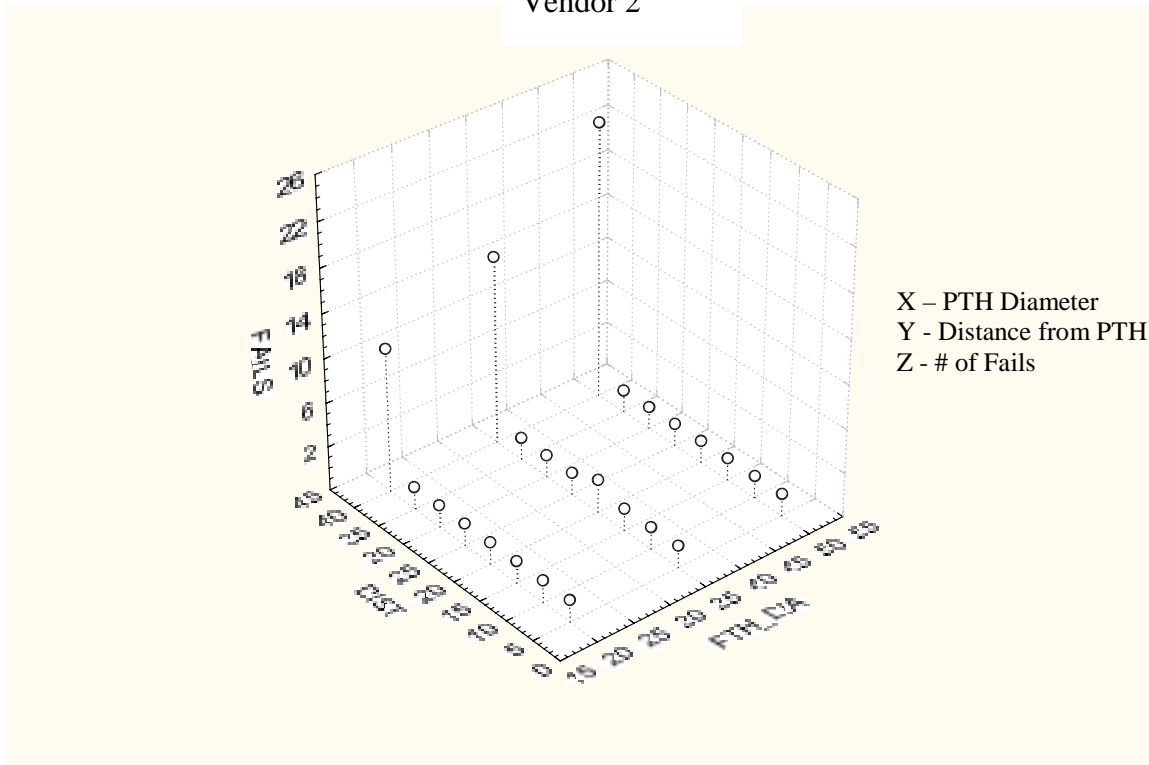
This section of the report presents the via reliability evaluation and the failure analysis. Table 2 shows the number of failed vias at different distances from a PTH for Vendor M. The first failure was reported after 1100 LLTS cycles. Figure 4 shows the 3-dimensional plot for the PTH diameter (X-variable), via distance from PTH (Y-variable), and number of failed vias (Z-variable) for Vendor M. It can be observed that the failure frequency of the vias at a distance of 40 mils from a PTH was found to be the greatest.

Figure 4. Failure Frequency Plot for the Vendor 2

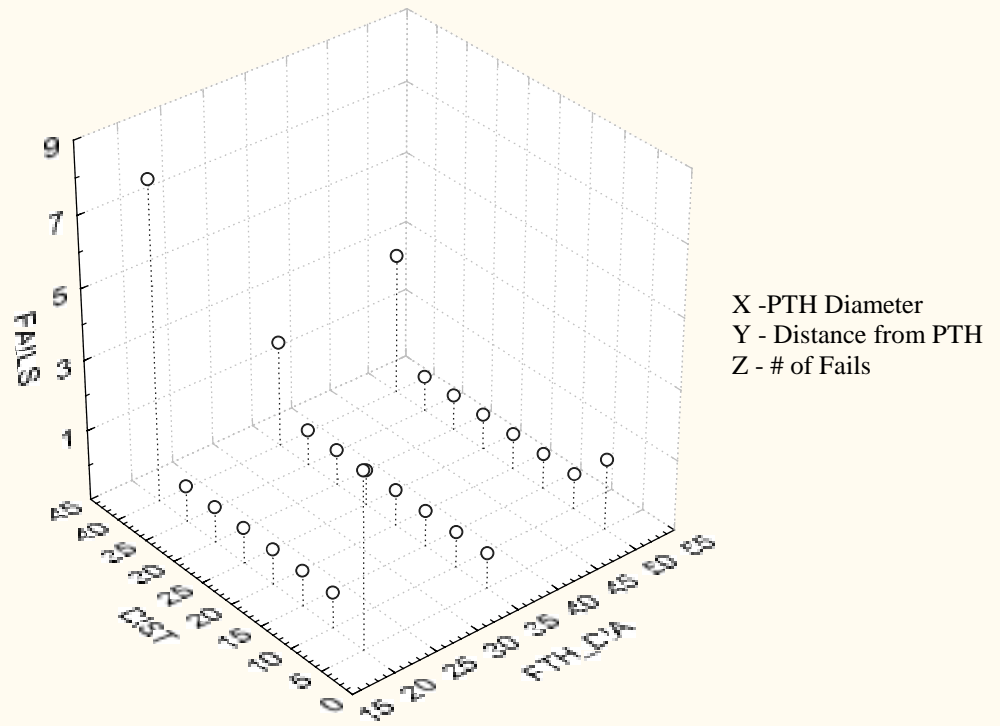
Table 3 shows the number of failed vias at different distances from a PTH (Vendor L). It can be seen that the failure frequency of vias at a distance of 40 mils from a 50 mil PTH is higher than vias at a distance of 5 mils from PTH. Similar trends were observed in the vias near 20 mil PTHs. Figure 6 shows the 3-dimensional failure frequency plot for Vendor L. It shows that the failures were found at a distance of 40 mils from the PTH. In addition, several fails were found on samples at a location of 5 mils from the PTH. However, the failures at a distance of 40 mils from the PTH were more than the failures at a distance of 5 mils.

Figure 6. Failure Frequency Plot for Vendor 1

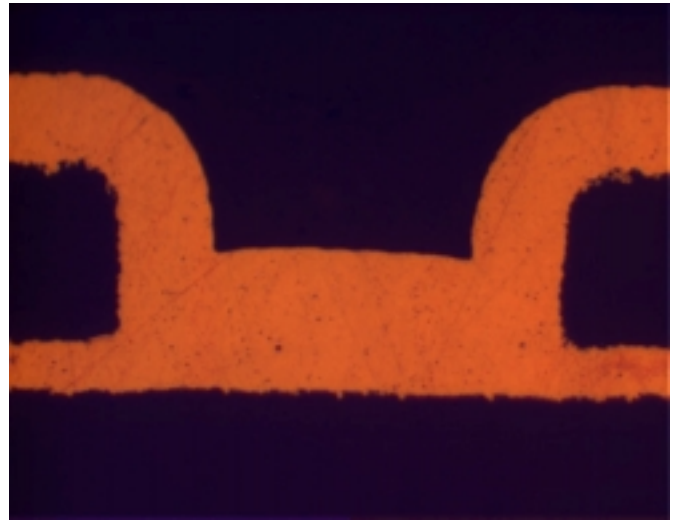
Figure 7 shows cross sections of a microvias from Vendor L after different stages of LLTS testing. Figure 7a shows a failure in a via at 40 mils from a PTH. The cause of failure was found to be a crack at the via-pad interface. Microetching of the cross sectioned sample was carried out to make the crack more visible. It was observed that the crack was initiated at the via-pad interface. Due to a sharp corner at the via-pad interface, it becomes a high stress concentration region and is susceptible to crack initiation. It can be seen that via wall angles are straight, which is characteristic of a photo defined via. It can be observed from Figure 7a that the plating thickness at the bottom of the via is slightly less than the plating thickness at the top. This could be due to the straight via walls. Negative slope can be observed from the cross section after the plating. This might result in a break at the via-pad interface in an extreme case [Joshi, 1999]. A similar failure was observed in the via at a distance of 5 mils from 50 mil PTH after 1100 LLTS cycles. Figure 7b shows the cross section of a functional via at a distance of 5 mils from a 35 mil PTH after 2000 LLTS cycles. Uniform plating thickness can be seen from the cross section.

b. Functional Via after 2000 LLTS Cycles
