# Reliability and Failure Mechanisms of Laminate Substrates in a Pb-free World

Kevin Knadle  
Endicott Interconnect Technologies, Inc.  
Endicott, NY

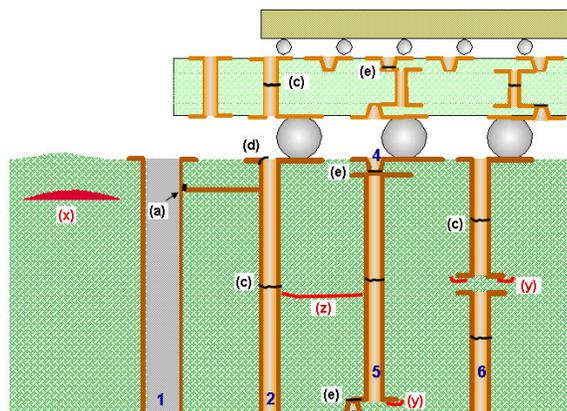
Figure 1—The “PTH” family and related failure mechanisms for today's boards and chip carriers.

The first significant change to the PTH occurred in the 1980-1990's with the advent of surface mount technology (SMT) where plated thru vias shrunk in diameter and were no longer solder filled, resulting in the "wiring via" (Figure 1 via 2). As SMT became ball grid array (BGA) technology, the tight grid and wiring demands of growing array sizes resulted in higher aspect ratio vias until, one by one, suppliers and users crossed the line and faced a new reality— non solder filled wiring vias may not even survive the stresses of board assembly and rework without cracking, especially if the plate is thin or defective in any way. And, as with its predecessor, this new failure mode (c) was often impossible to detect on an assembled board with in-circuit tests. When the author first published about this specific aspect of via failure in 1997<sup>[1]</sup>, the phone rang monthly for years following with confirmations from both users and competitors of such problems with via cracks during assembly and escapes to the field. Of course, the root of this problem is the extreme difference in Z-axis coefficient of thermal expansion (CTE) mismatch between the copper plating and the laminate materials of printed wiring boards (PWB's) and laminate chip carriers (LCC's). This mismatch is especially extreme at assembly temperatures above the glass transition temperature (T<sub>g</sub>) where laminate Z-axis CTE approaches 200–400 ppm/C, compared to 15 ppm/C for copper<sup>[1-9]</sup>. The two mechanisms, z-axis barrel crack and prior X-Y IP separation of solder filled holes, are similar in that they are both activated by assembly processes, difficult to detect with tests, and therefore can present latent or intermittent field risk. But the root causes and stress triggers of the failure mechanisms are entirely different, and required a paradigm shift in both processing and testing— for example, current induced heating replaced solder shock as a quality/reliability test for such unfilled vias, and the processes that produce the "3 point connection" to improve the reliability of a solder filled PTH IP connection can actually reduce the life of today's unfilled wiring vias<sup>[10,11]</sup>.

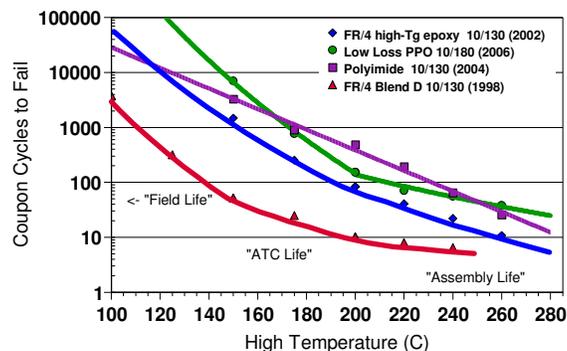
Figure 3-- Select CIRC PTH life curves to illustrate challenge of unfilled wiring vias.

While Figure 3 shows the reason for assembly driven failed vias, Figure 4 illustrates why they can be a serious reliability concern as latent opens in the field. At reflow temperatures above the Tg of the laminate material, the z-axis expansion of the laminate is an order of magnitude much greater than that of the copper, which forces the copper in tension where it plastically deforms—i.e., the copper barrel becomes permanently longer than it was. Similarly, the laminate sees significant compressive forces in the zone around the PTH barrel because the barrel acts as a rivet to constrain it from expanding as it would away from the PTH. These considerable compressive forces create a pressure gradient that causes the laminate, now well above Tg, to “flow” away from the barrels. “Flow” is used in quotes because cross-linked thermoset polymers are not supposed to flow as other polymers, but some form of movement or reshaping is indicated by the permanent deformation seen in laminate x-sections after reflow or solder shock—the laminate is now longer between vias than in the zone directly next to them (Figure 4c). The combination of these permanent deformations (longer barrel, shorter laminate) means that any crack formed at the peak temperature will be forced in slight compression on return to room temperature. In addition to the illustration, figure 4 includes 1) ESEM photos of a barrel crack open at 230C and the same crack closed tightly again after cooling to ambient, and 2) electrical measurements of 8 coupons (left axis) with intentionally very weak barrels through a single simulated reflow cycle in a convection oven showing them open completely during heating (temperature, red line and right axis) between T = 140-185C, and close solidly to original resistance value starting between T=175-110C.

Additionally, note the other material curves in Figure 3. The purple curve shows why polyimide, though expensive and a challenge to process at high aspect ratios, is a popular choice with the military for assembly robustness. The green curve is a high performance low loss PPO filled resin that consistently passes all Pb free testing, and has the overall best PTH performance of any laminate tested, but is still not a universal solution because its price-performance space is also likely outside most applications. Note that the blue curve is a cost effective high Tg phenolic epoxy with excellent PTH life in all regions including 220C assembly (40 cycles), and but at Pb free 260C it lasts only 10 cycles. That is, it can work for Pb free, but each 260C assembly or rework cycle consumes 10% of the PWB's PTH life, compared to only 1/40 of the life per cycle at 220C or 1/20 at 245C. This steep slope of PTH life reduction vs. reflow temperature introduces another point that will be made again in this paper—the key to a cost effective Pb free PWB product is not necessarily to find a material that survives a predefined number of cycles to exactly 260C, but to find a material that survives whatever that specific product requires after

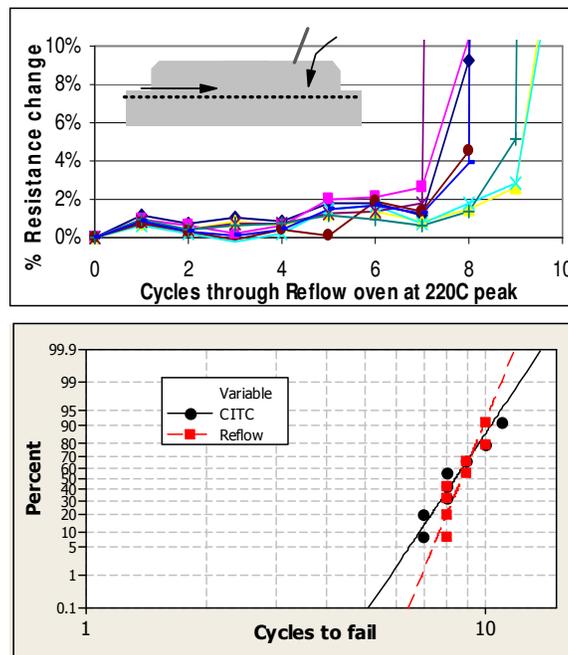
to allow hand probing of the coupons right after the heating peak. That is, at the correct point (by timing) of each pass, the panel was removed and the part quickly measured with 4 wire resistance while still hot. Before pass 1, the oven was profiled with an identical block to 220C peak using the same timing and panel removal. The part was cooled to room temperature, and this process repeated up to 10 passes. Figure 5a plots the hot resistance by coupon and reflow cycle. A 3% failure criterion was used in this case, instead of 5 or 10%, because of the difficulty of reading all the coupons simultaneously while still hot, and because it appears to best fit the sharp slope change of the data. The final results are plotted in Figure 5b— the curve for cycles to fail from actual 220 reflow passes is almost identical to the 220C CITC cycles to fail curve.

**Figure 5-- -- Reflow verification for CITC data of Figure 3; (a) Coupon resistance vs. cycle measured inside reflow oven. (b) Probability plot showing identical cycles to failure between CITC and reflow.**

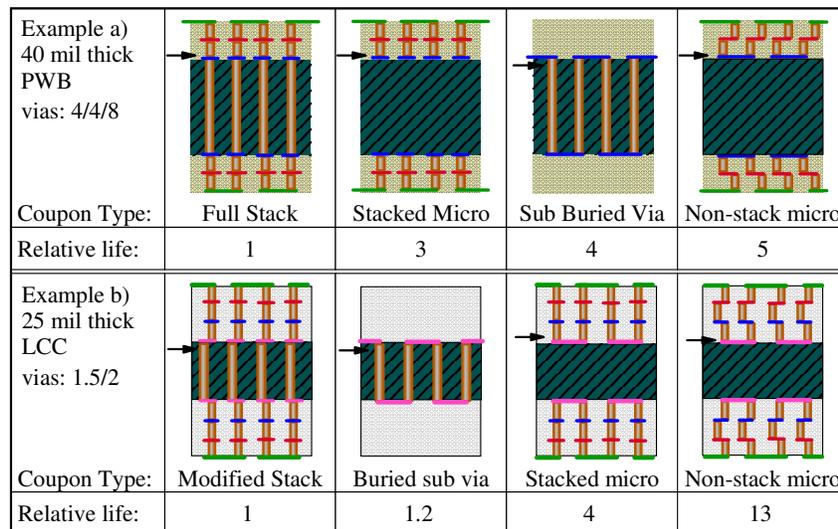
Figure 17 compiles relative via life for 2 different HDI products, one PWB and one dense LCC substrate. Each product had individual CITC coupons covering the 4 different via constructions shown. Relative life is calculated by testing all coupons to fail at CITC 23-220C, and then comparing N50's with a lognormal probability plot. The coupon with the lowest N50 is listed first and defined as with base life =1. In both cases, the first coupon is that structure which most closely resembles a “thru via”, which becomes the first rule of thumb—thru vias or any facsimile see the full force of the Z-axis CTE mismatch as demonstrated by data and photos earlier. That is, the full stack of example a is expected to have about the same via life, and the same propensity for thru via related laminate failure mechanisms if present (e.g. invisible delamination), as would be the equivalent thru via. Therefore in the first example, the full stack structure had the same failure location (indicated with arrows based on failure analysis x-sections) as the next 2 structures, but with cycles to fail 1/3 and 1/4 the values, respectively.

In example b, the first structure is a modified full stack, most similar to a thru via of the four coupons but lacking the full “rivet” nature of a thru via or full stack. Note that though this modified stack is still the first to fail and with the same failure mode as the second coupon, the margin is much closer attributed to the fact that structurally they are more similar than in the first example.

**Figure 17-- Relative life by structure for two HDI examples, PWB and LCC.**

Interestingly, this first rule of thumb also applies similarly on a small scale to microvias. In both examples of Figure 17 the microvias had excellent life, but stacked microvias fail before unstacked microvias, with all else held constant—this is because they are locally more “thru-via” like in geometry and stress state, while the unstacked microvias have an additional degree of freedom in which to flex, reducing the stress on the copper. This situation is illustrated by a final video in Figure 18 for a substrate with 3+3 microvias on a buried via subcomposite. The substrate is cycled from ambient to 220C and back again (no  $N_2$ ). The yellow dotted lines are drawn from the build-up layers at ambient to help show both the Z-axis expansion, and more importantly, the flexing of the non-stacked microvias that occurs at 220C (red arrows). It is clear how this flexing can reduce the stress on the microvia itself, and explains how unstacked microvias last longer than the stacked microvias, which like small “thru vias” are not able to flex. Note however that an eyebrow crack was formed at the green arrow during dwell at 220C, which becomes a “reality check” reminder that at least one more rule of thumb is needed: the reduced stress on copper via interconnections in a “less thru-via-like” design comes with a price— possibility of tensile stresses in the resin, and therefore greater risk of eyebrow cracks. Or stated in more general terms, different HDI structures may trade one failure mechanism for another, once again reiterating the need for smart design and evaluations.
