THE PROXIMITY OF MICROVIAS TO PTHs AND ITS IMPACT ON THE RELIABILITY OF THESE MICROVIAS

Jaydutt Joshi
Principle Program Manager
RF Module Technology Development
Skyworks Solutions, Inc.
Irvine, California 92617.

Anthony Primavera, Ph.D.
Manager - CSP Consortium
Universal Instruments Corporation
Binghamton, New York 13902-0825.

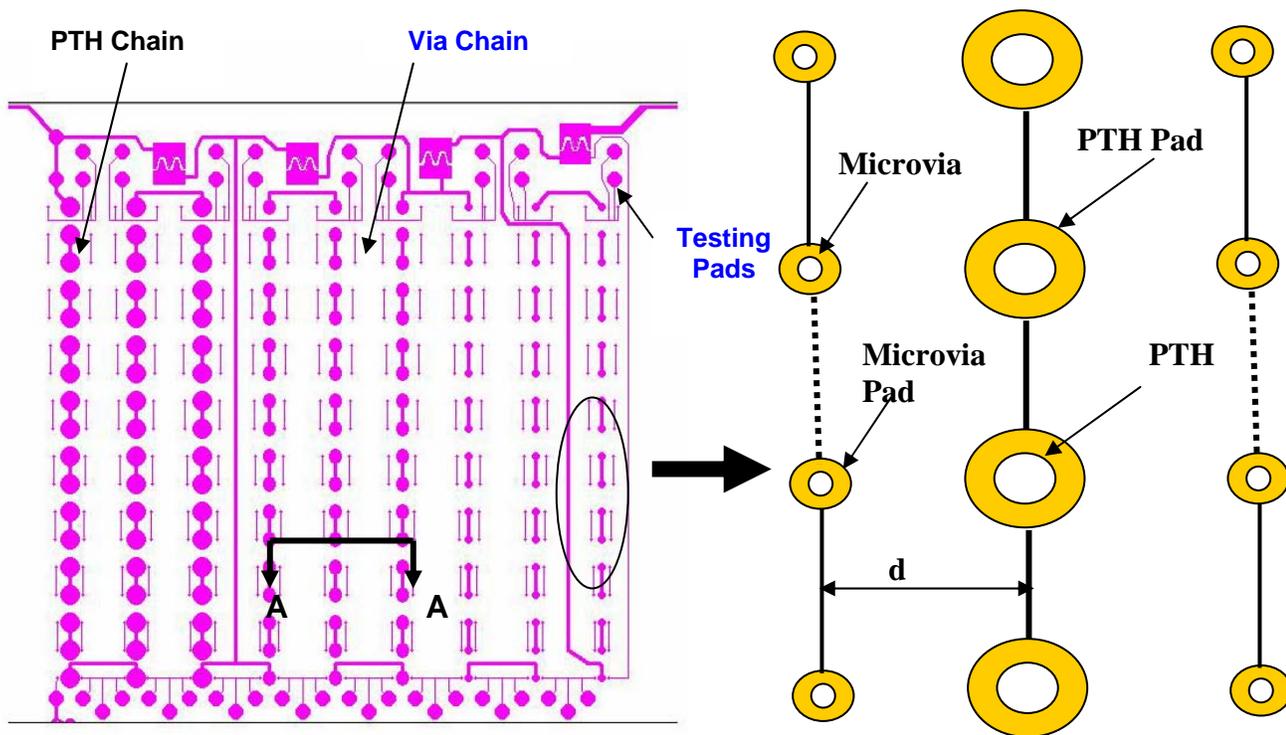
a. Top Down View of the Proximity Test Structure

To evaluate the effect of the proximity of microvias to PTHs, a via proximity test structure was designed. Figure 1 shows the schematic and cross sectional view of the proximity of microvias to PTHs. These vias and PTHs are daisy chained separately to allow the continuity testing. Figure 1a shows the proximity effect test structure used for the evaluation. On a single test site, there are 3 PTH chains containing 18 PTHs per chain per PTH diameter. Five boards from each Vendor were subjected to LLTS testing. Figure 1b shows the schematic of the lay out of the PTH and microvias on the test vehicle. The PTH sizes tested were 20, 35, and 50 mils. The via size was held constant at 5 mils. The distance of the vias from the PTHs is varied from 5 mils to 40 mils in the increment of 5 mils. Effective center to center distance of vias from PTHs varies from 45 mils to 80 mils (for 50 mil PTH), from 36 mils to 71 mils (for 35 mil PTH), and from 27 mils to 62 mils (for 20 mil PTH) in the increment of 5 mils. Table 1a shows the effective center to center distance of the via from the PTH.

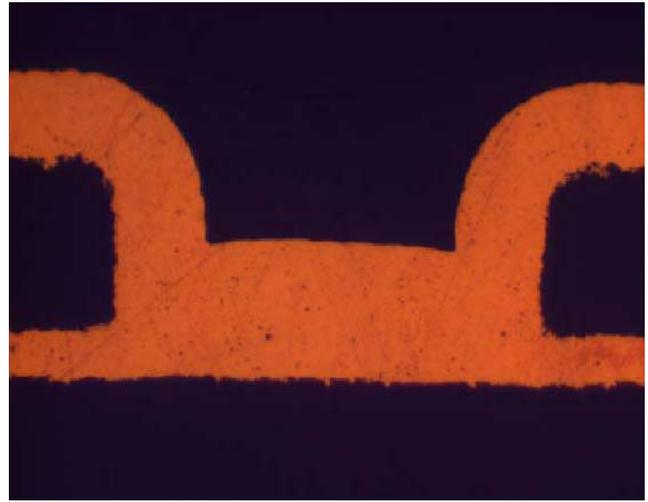
b. Cross Section of a Photo Processed Via from Vendor L

Vendor L provided photodefined microvias for reliability evaluation. The boards from Vendor L were based on IBM's "Surface Laminar Circuit" (SLC[®]), sequentially laminating photoimageable dry film dielectric layers over a multilayer FR-4 sub-composite. Figure 2b shows a cross section of a microvia from Vendor L. It is observed in this cross section that the via wall angles are perpendicular. The straight via wall is characteristic of the photo process.

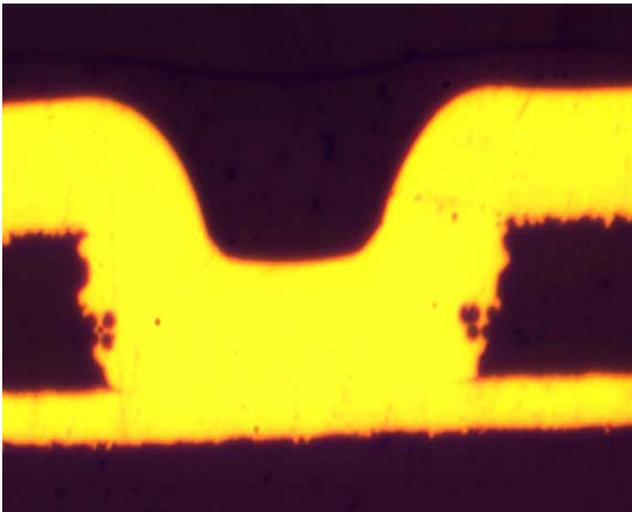
c. YAG and CO₂ Laser Drilled (Vendor H)

Vendor H supplied microvias fabricated by both YAG only and YAG-CO₂ laser. Microvias from Vendor H were drilled using YAG laser only and a combination of YAG-CO₂ laser. The dielectric layer in the board is glass reinforced FR-4. Figure 2c and 2d show the cross section of a via fabricated by Vendor H. It can be observed from the cross section that the via walls have a positive slope that might help in uniform plating.

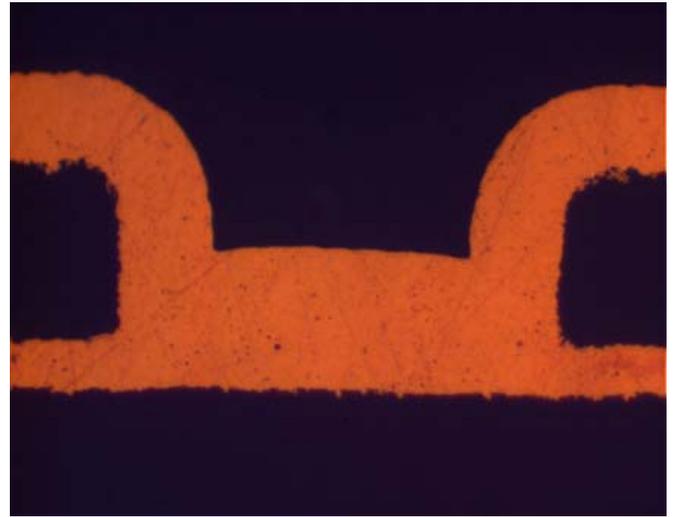
[Figure 7](#) shows cross sections of a microvias from Vendor L after different stages of LLTS testing. [Figure 7a](#) shows a failure in a via at 40 mils from a PTH. The cause of failure was found to be a crack at the via-pad interface. Microetching of the cross sectioned sample was carried out to make the crack more visible. It was observed that the crack was initiated at the via-pad interface. Due to a sharp corner at the via-pad interface, it becomes a high stress concentration region and is susceptible to crack initiation. It can be seen that via wall angles are straight, which is characteristic of a photo defined via. It can be observed from [Figure 7a](#) that the plating thickness at the bottom of the via wall edge and via pad is slightly less than the plating thickness at the top. A similar failure was observed in the via at a distance of 5 mils from 50 mil PTH after 1100 LLTS cycles. [Figure 7b](#) shows the cross section of a functional via at a distance of 5 mils from a 35 mil PTH after 2000 LLTS cycles. Uniform plating thickness can be seen from the cross section.

b. Functional Via after 2000 LLTS Cycles
