深圳市卓茂科技有限公司

## Reasons for BGA insufficient solder & short

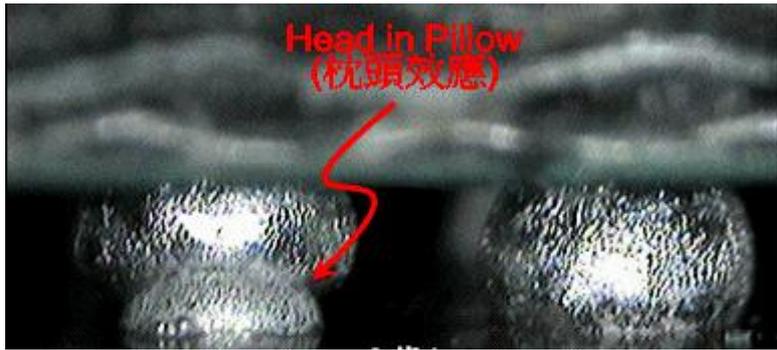
6. Head in Pillow. This phenomenon often occurs when the BGA board or printed circuit board is deformed by reflow. When the solder paste is melted, the BGA solder ball does not touch the solder paste. When cooling, the BGA carrier board and the board are deformed. Decrease, the solder ball falls back to the cured solder paste.

If the cry curve, smile curve is severely deformed, short-circuit and air-welding of the BGA will be formed at the same time, which is usually the case when both occur at the same time. The picture shows that the BGA smile curve and the cry curve on the printed circuit board strongly squeeze the BGA solder balls, causing several short circuits. In general, consider reducing the slope of the reflow oven, either by preheating the BGA to eliminate thermal stress, or by requiring BGA manufacturers to
