# How Mitigation Techniques Affect Reliability Results for BGAs

Greg Caswell and Melissa Keener

DfR Solutions

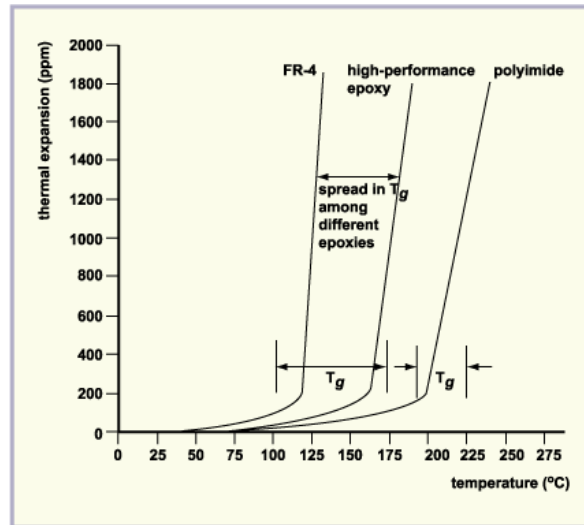
Figure 1: Graph of Glass Transition Behavior of board materials from [www.mtarr.co.uk/courses/topics/0140\\_pl/index.html](http://www.mtarr.co.uk/courses/topics/0140_pl/index.html)

With the enforcement of RoHS requirements, there has been some concern about the reliability of lead-free solders. The reliability of tin lead solder is well known as a robust solder and the failure rate is well characterized, whereas SAC solders are known to be less robust which is a problem for some high reliability applications. One solution is to mitigate the solder joints with a staking material to strengthen the joint, but the problem is choosing the correct material for the application. Several material properties, such as glass transition temperature ( $T_g$ ) and coefficient of thermal expansion (CTE), need to be properly chosen. Improperly chosen mitigation materials will cause premature failures instead of extending the time to failure. If the expected operating temperature of the device is too close to the  $T_g$ , the CTE will drastically change which can cause solder joint failures as shown in Figure 1.

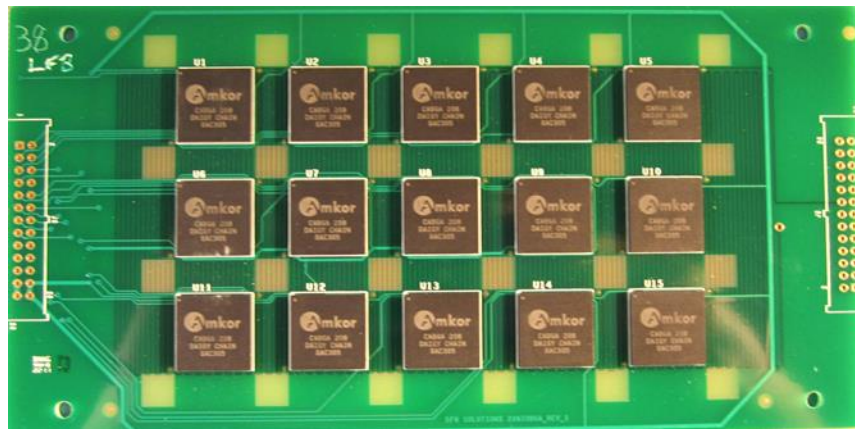
Figure 2: Test PCB

This study chose to focus on one component type: the Ball Grid Array (BGA). The BGAs that were chosen were 15mm by 15mm packages with 208 balls. The balls were 0.5mm in diameter and had a pitch of 0.8mm. The balls were attached to the BGA along the perimeter 4 rows deep. The BGAs were purchased with tin lead (SnPb) balls and reballed to attach the SAC305 and SN100C solder balls. The reballing process does not have an effect on the reliability of the component, it could increase the strength of the solder ball interconnect by at most 10%. [1] These BGAs were attached to 4 layer FR4 printed circuit boards (PCBs) as seen in Figure 2.

The PCBs arranged the components into 4 rows and 5 columns. The placement of the component was determined by first vibration mode as calculated through finite element analysis and shown in Figure 3. The figure shows that the center column and the column on either side are in the highest strain area. The two outside columns are in a lower strain area. This was done so that multiple strain levels could be investigated on one test PCB.

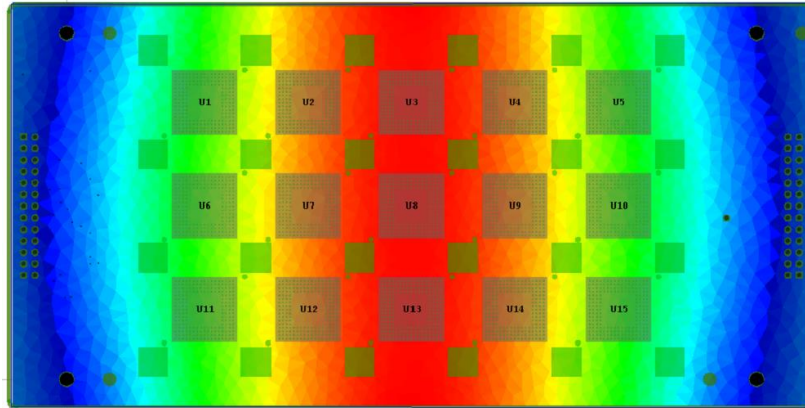
Figure 3: Finite Element Analysis of Test PCB showing natural frequency of the board
