MODERN 2D / 3D X-RAY INSPECTION -- EMPHASIS ON BGA, QFN, 3D PACKAGES, AND COUNTERFEIT COMPONENTS

Evstatin Krastev and David Bernard

Nordson DAGE

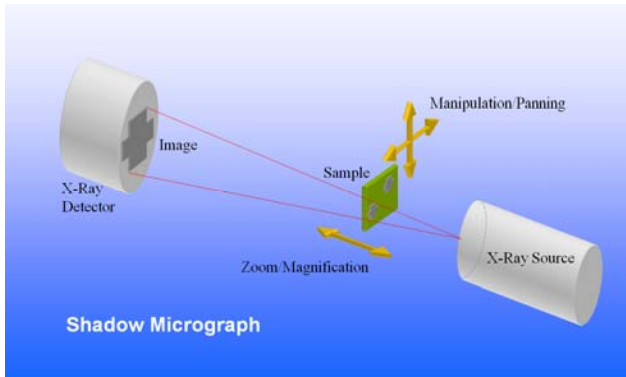
The 2D X-Ray inspection systems are essentially X-Ray microscopes (Figure 1 and Figure 2). A wide cone of X-rays is emitted by the source (X-Ray tube). The inspection is accomplished by moving the sample inside the X-Ray emission cone. All materials absorb the X-Ray radiation differently depending on their density, atomic number and thickness.

Thicker and/or denser material will absorb more of the X-Rays. The resulting image, composed of shades of grey with darker areas corresponding to higher X-Ray absorption, is registered by the X-Ray imaging device, usually a very high quality digital image intensifier or a flat panel. The closer the sample is to the X-Ray source the higher the magnification level (Figure 1). The ability to inspect at an oblique angle view is crucial for finding defects like cracks and open joints. Generally two ways are used to accomplish oblique, or angled views - tilt the sample or tilt the imaging device. As seen in Figure 2, tilting the imaging device has the huge advantage of producing maximum magnification at all tilt angles.

Figure 1. Basic operation principle of X-Ray inspection system

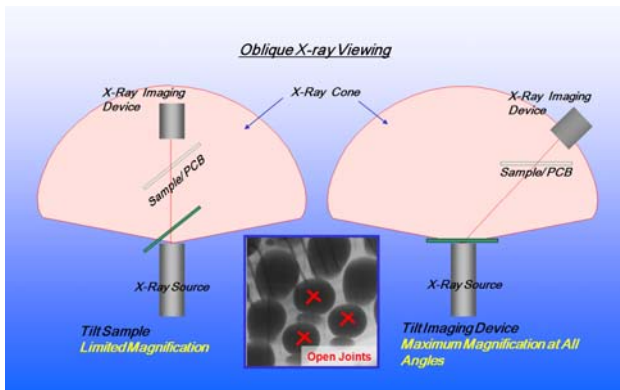
The modern X-Ray machine tilts the imaging device up to 70 degrees at the same time permitting images from 360 degrees around any inspection point. A sophisticated combination of software and hardware keeps the point of interest (for instance a defective joint) in the center of the field of view while the imaging device is rotating around and examining from all directions. Additional advantages of this method are that there is no need to secure the sample (PCB, component or another device) and no risk of dropping, damage or collision during sample manipulation.

Figure 2. Oblique angle viewing

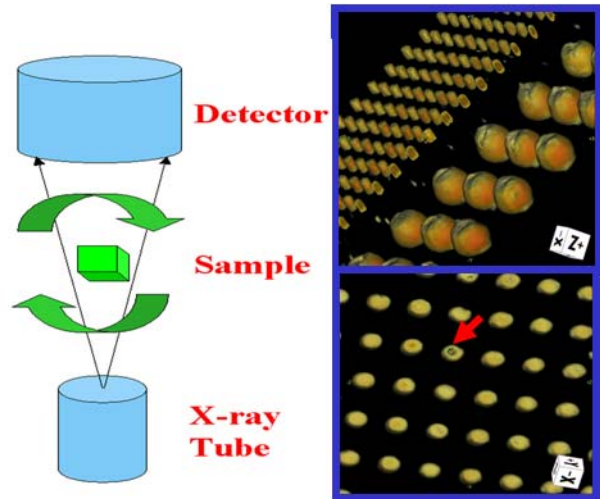
Figure 3. Typical layout of a CT system and an example of a CT model

The layout of a CT system is shown in Figure 3. Once the CT model has been produced, it enables 'virtual microsectioning' by allowing the operator to investigate any two-dimensional plane within the entire model as well as full, real time manipulation of the 3D model. In this way, different layers and different features within the package can be viewed whilst being isolated from other, potentially confusing, detail to enable improved analysis. This allows complete examination of features or defects within a device or package that would otherwise remain hidden by multi-level interconnections. For example, the tiny 100-micron solder bumps within the multi-layered device shown on Figure 3 would be obscured by the much larger 500-micron BGA balls.

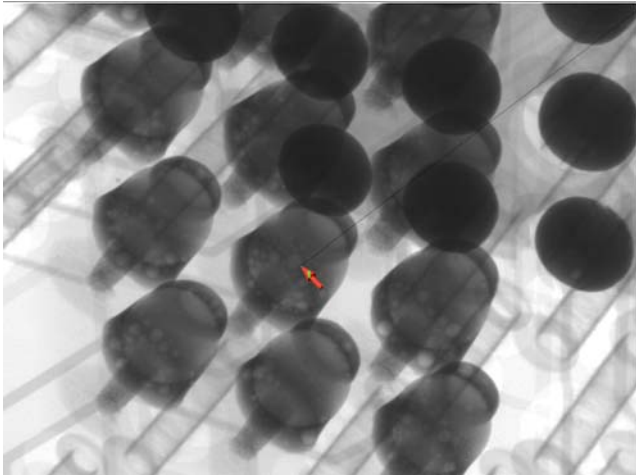
Common BGA defects like voiding, shorts, cracks, and head-in-pillow (HIP) or head-on-pillow (HOP) usually occur during reflow. The oblique angle capability is critical for detecting cracks and HOP defects using viewing angles of 55 to 70 degrees. Voids and shorts are easily visible using a top-down view, but in order to determine the location of the voids oblique angle 2D viewing and 3D CT come very handy. The angled view on Figure 4 reveals

voiding concentrated on the joint interface making the particular connection less reliable and possibly more prone to failure in the field.

Figure 4. Angled/ oblique 2D X-Ray view showing interface voiding

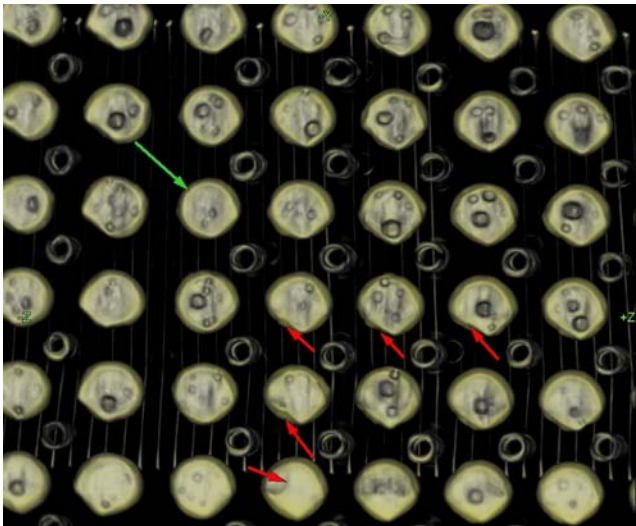
The 3D CT technique permits virtual slicing or cross-sectioning through the devices revealing the exact location of the voids as seen on Figure 5.

Figure 5. CT virtual section through the interface region of a BGA device.

Large amount of interfacial voiding is apparent and many BGA balls marked with red arrows are deformed/ cracked. The modern 2DX machine features automatic routines designed for precise measurement of diameter, voiding percentage, shape and area of the BGA balls. As seen in Figure 6, the BGA balls marked in red outline fail the requirement for shape or roundness, which is the first number accompanying each ball. The second number represents the total voiding percentage for each BGA ball. It is up to the operator to set up the acceptable levels and the machine will automatically flag any values which fall outside.

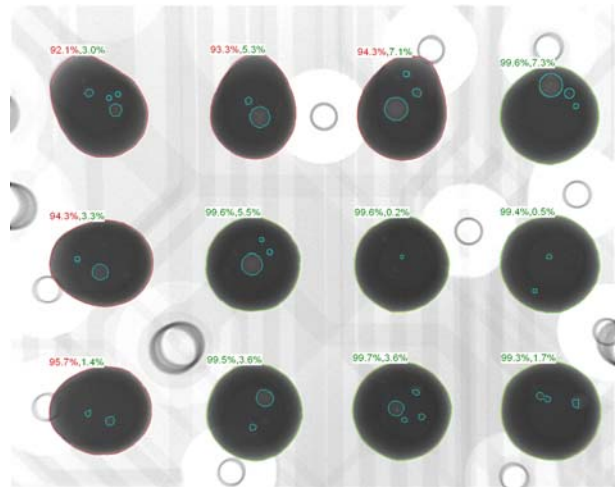
Figure 6. 2D X-Ray voiding and roundness calculation for a BGA device.

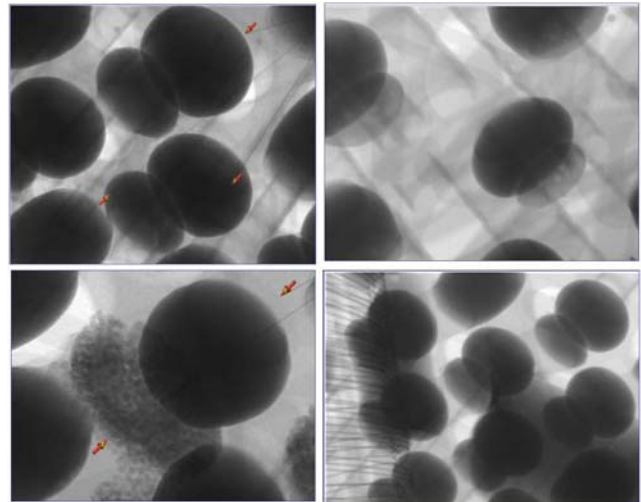
Figure 7. Various examples of HOP defects easily identifiable with off-axis 2D X-Ray inspection

Figure 7 shows various examples of HOP defects. It is obvious why these defects are referred to as head-in-pillow, or better head-on-pillow. The defective BGA solder ball appears to be laying on the reflowed solder paste instead of forming a single joint after reflow. Figure 8 is a virtual CT micro-section through the BGA device revealing a 3D view of the HOP defect.

easily identified using modern high-performance 2D X-ray system with an oblique angle viewing (Figure 7). In addition the inspection process is completely *non-destructive*.

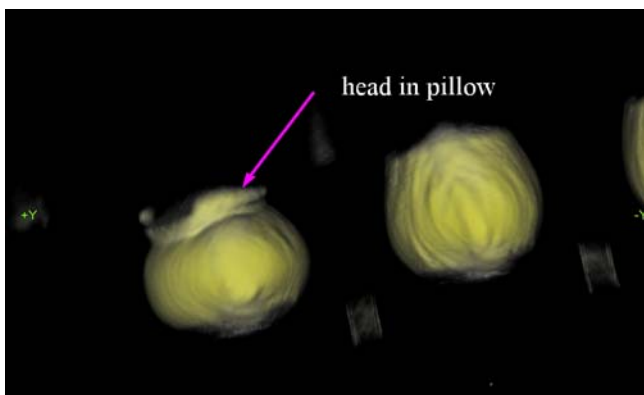
Figure 8. 3D CT section showing HOP defect in a BGA device

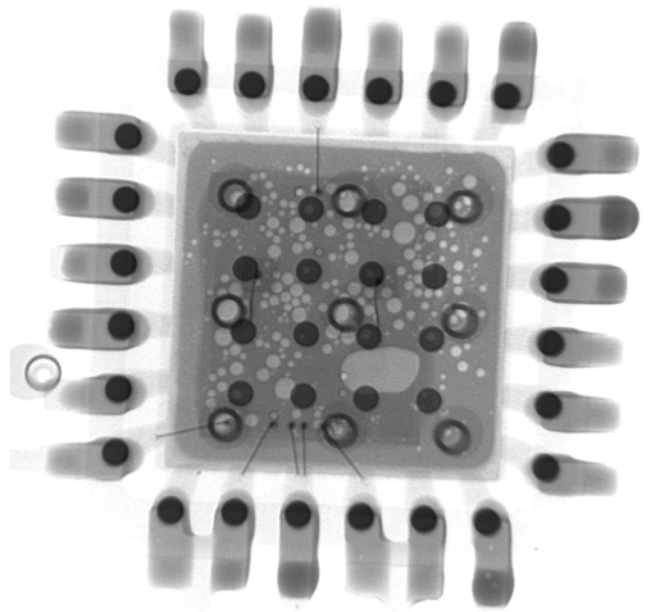
Figure 9. Top X-Ray view of QFN package

As shown on Figure 9, the package terminations are all located under the device. This makes the traditional Automatic Optical Inspection not practical. As with the BGA devices, cross section followed by SEM or optical evaluation is an alternative, but the method is destructive and permanently damages the device and PCB.

It is important to point out that in addition to the quality of the side connection, the voiding within the central large pad is also crucial in some cases when large amounts of heat need to be transferred out of the device in order to prevent overheating. The example (Figure 9) shows significant voiding in the central area which would be a concern or reason for rejection in a high-power application.

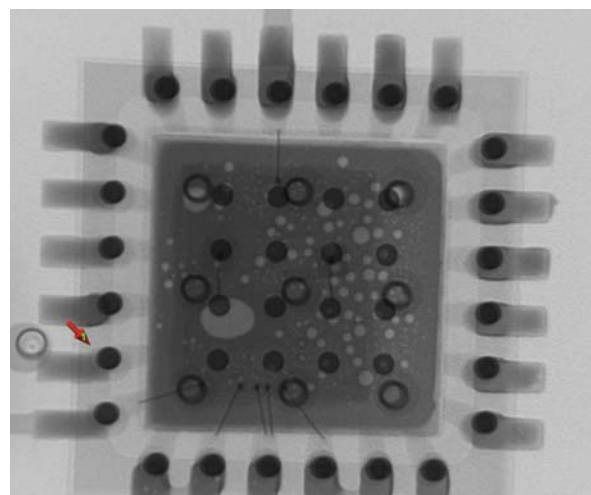
Figure 10. Top X-Ray view of LGA package. Suspected pin pointed by arrow.

Figure 10 shows a low magnification image of a QFN package with a red arrow pointing out to a suspect pin.

Because of the high resolution and contrast sensitivity of the X-Ray system, a possible defect is apparent even at this low magnification image.

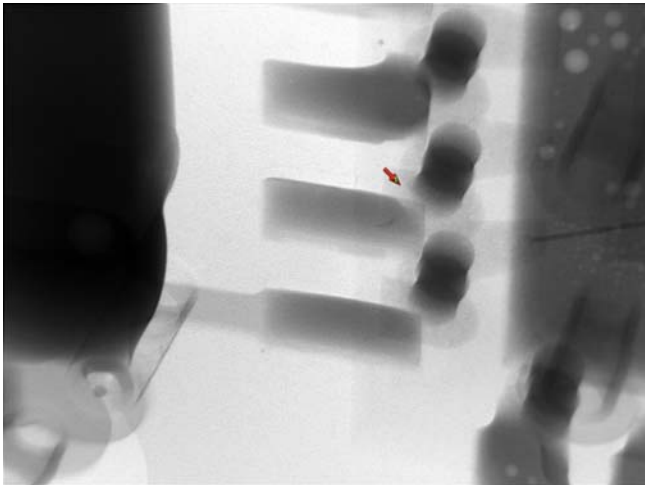
Figure 11. Higher magnification oblique angle view of defective pins from Figure 10.

Using oblique view and higher magnification one can study the open pins in detail as shown in Figure 11. However, even a low magnification oblique view is sufficient to confirm the defect as seen in Figure 12.

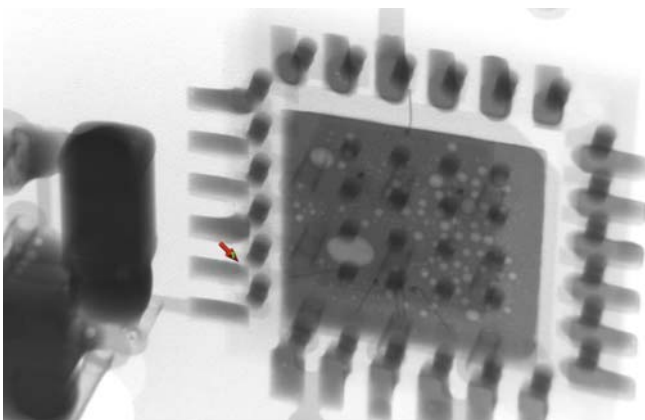
Figure 12. Low magnification oblique X-Ray image showing defective (open) pins in QFN device.

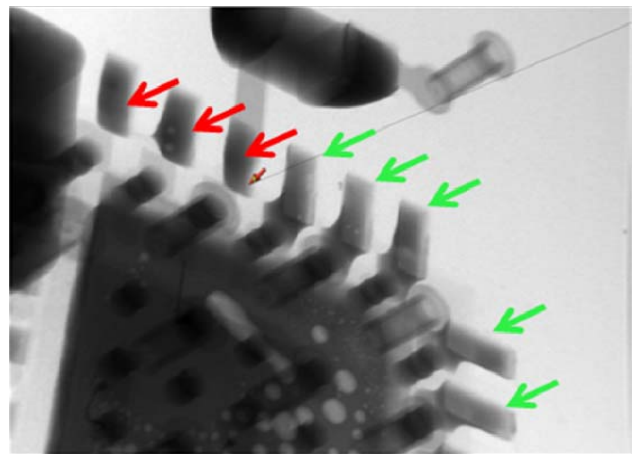
The fact that the defective pins can be identified at such low magnification levels makes the X-Ray inspection process fast, efficient and reliable. Figure 13 represents an oblique angle 2D X-ray view of different QFN device. The red arrows are pointing towards open pins compared to the good pins (green arrows).

Figure 13. Oblique 2D X-Ray view of defective QFN device. Red arrows point toward open pins and the green arrows identify good pins.

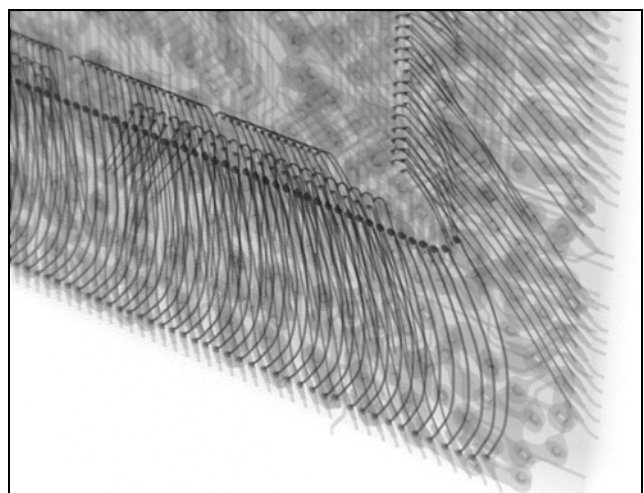
Figure 14. 2D X-ray oblique view of stacked device.

As seen on the 2D X-Ray image in Figure 14, the two wire bonding layers of this stacked device cannot be easily

separated for analysis looking for shorted or open connections.

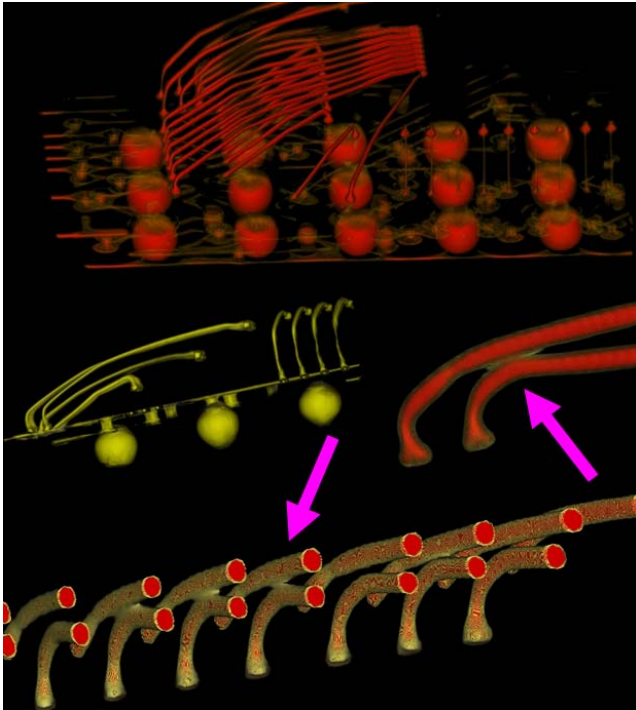
Figure 15. CT images of stacked devices showing shorted bond wires.

Figure 15 is a combination of CT images showing various stacked devices. The CT technique permits the operator to isolate the area of interest and carefully examine for potential failures using virtual micro-sectioning. As seen on Figure 15 the shorted wires are easily identified using CT and this cannot be easily and reliably accomplished using 2D methods.

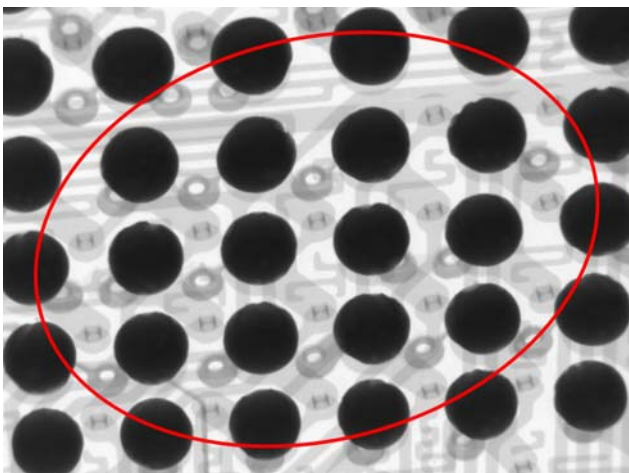
Figure 16. 2D X-Ray image of an area containing suspect shorted vias in a 3D package

The examined 3D device has shorted vias in the region covered by the 2D X-Ray image on Figure 16. Clearly identifying the defect is quite difficult due to the complexity of the 2D X-Ray image. The CT model of the same package is shown on Figure 17. The CT model is also quite complicated, but once the micro-sectioning capability is engaged the shorted vias pop up easily detected -- see inset of Figure 17 representing a virtual micro-section through the CT model.

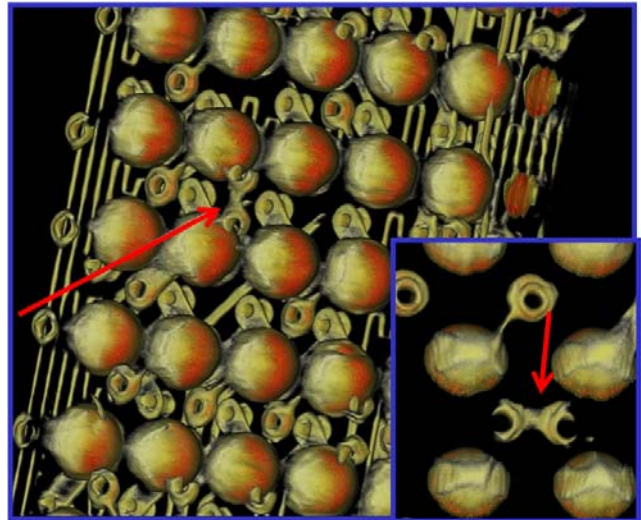
Figure 17. CT model of the 3D device shown on Figure 16. The inset is a virtual cross-section easily detecting the two shorted vias.

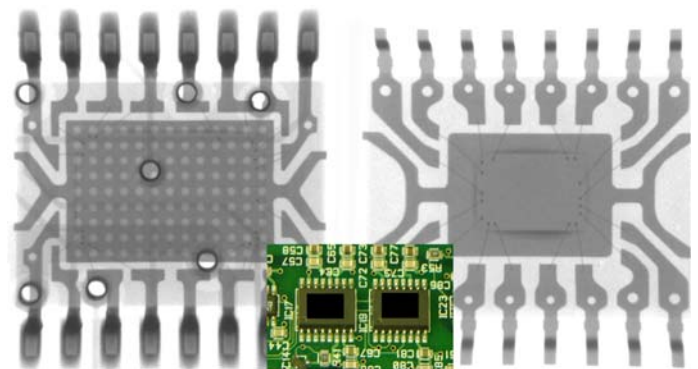
Figure 18. 2D X-Ray image revealing big differences between components looking similar optically, thus easily identifying the counterfeit.

As shown in Figure 18, the real and fake components might look very similar optically, but an X-Ray image reveals big

differences. The modern 2D X-Ray inspection provides a fast and effective method to identify counterfeit components. Being *non-destructive* and offering high magnification, resolution and contrast sensitivity it makes it easy and straightforward for the operator to identify the fake components by observing die placement, internal wiring and comparing to known good samples.
