# **Improving PCBA Yield**

**Improve the Yield of PCBA from 82% to 92% at PCBA functional Test Stage.**

**Current situation: Present Rejection = 18%,  
Sigma Level = 2.42**

**Scope of Project: Vendor PCB Assembly to Functional Testing of PCBA**

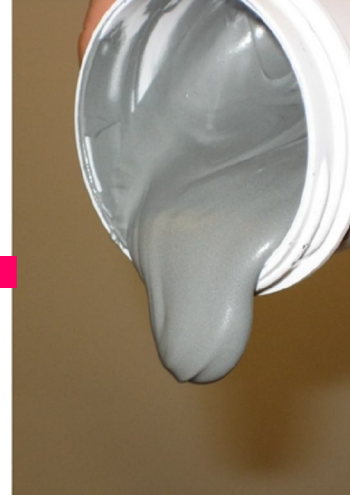
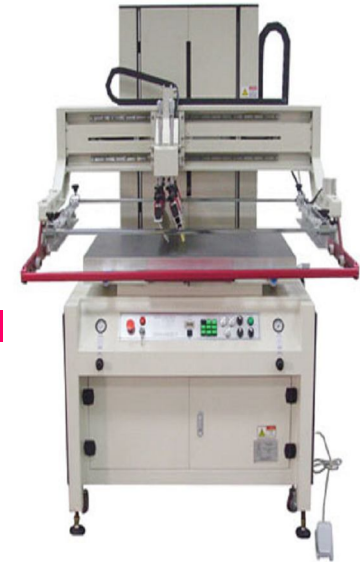
### Screen Printing process

Sample pic

**Observation : From Normal Distribution Summary shows Mean of Paste thickness observed is 7.8 mil (198 micron).**

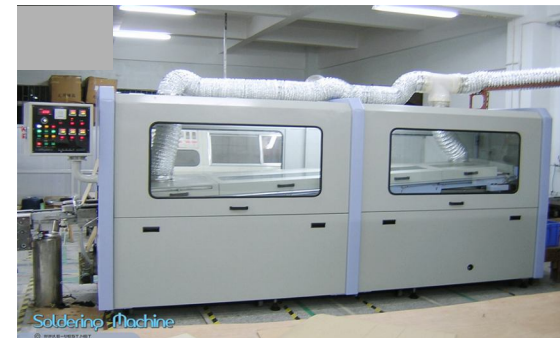
### Reflow Profile running at Vendor – [ RTS – Ramp to Spike Profile ]

Above RTS Profile to be Looked at for stable soldering of PCBA as well as BGA(ROHS Device) soldering in Non-ROHS environment.

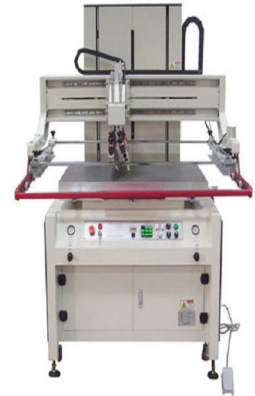
### Stencil 5% reduction & Type-4

Sample Size= 30  
PCBA

Concludes paste thickness lying outside USL reduces to 13% from 80%,  
with Cpk= 0.35 from -0.24

Mean Paste thickness = 6.0 from 7.8 mil

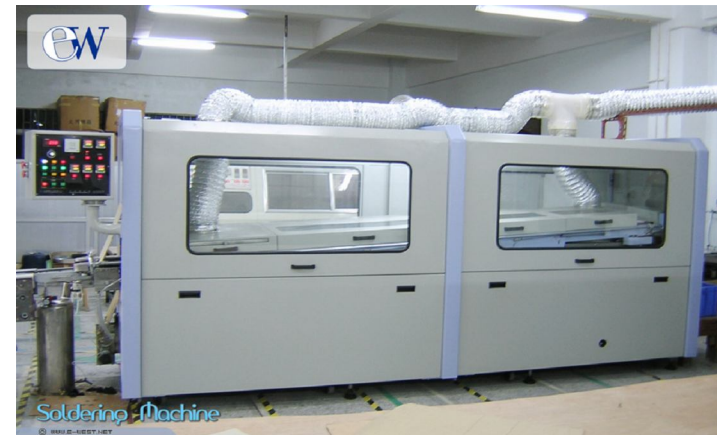
### New RSS - Ramp Soak Spike Profile Deployed

**Benefit:** Due to Soak time it is facilitating flux to get activated which is useful for expired IC, obsolesce IC(As in our case) for getting good Solderability.

**Pilot lot of 150 PCBA run and Quality confirms to IPC 610, class III.**

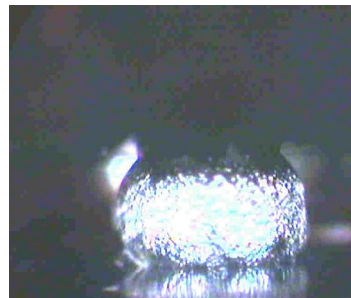
BGA checked in X-ray/Video scope

BGA Ball Snaps shows  
A good wetting  
o/p from video scope-
