# MODERN 2D / 3D X-RAY INSPECTION -- EMPHASIS ON BGA, QFN, 3D PACKAGES, AND COUNTERFEIT COMPONENTS

Evstatin Krastev and David Bernard

Nordson DAGE

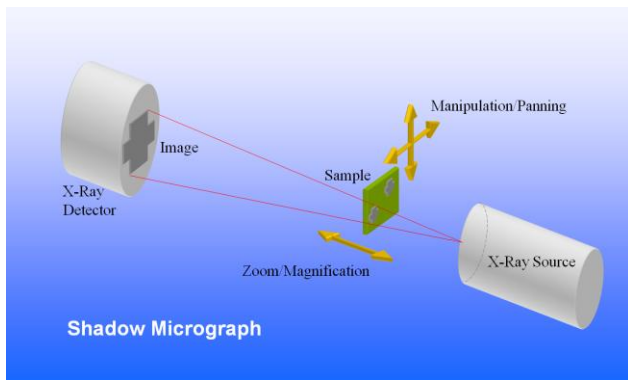
**Figure 1.** Basic operation principle of X-Ray inspection system

The 2D X-Ray inspection systems are essentially X-Ray microscopes (Figure 1 and Figure 2). A wide cone of X-rays is emitted by the source (X-Ray tube). The inspection is accomplished by moving the sample inside the X-Ray emission cone. All materials absorb the X-Ray radiation differently depending on their density, atomic number and thickness.

Thicker and/or denser material will absorb more of the X-Rays. The resulting image, composed of shades of grey with darker areas corresponding to higher X-Ray absorption, is registered by the X-Ray imaging device, usually a very high quality digital image intensifier or a flat panel. The closer the sample is to the X-Ray source the higher the magnification level (Figure 1). The ability to inspect at an oblique angle view is crucial for finding defects like cracks and open joints. Generally two ways are used to accomplish oblique, or angled views - tilt the sample or tilt the imaging device. As seen in Figure 2, tilting the imaging device has the huge advantage of producing maximum magnification at all tilt angles.

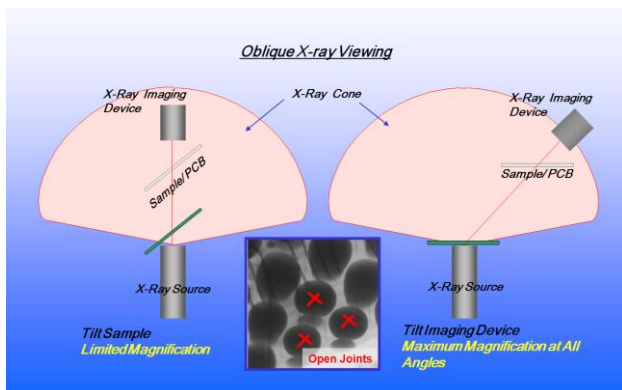
### Figure 2. Oblique angle viewing

The modern X-Ray machine tilts the imaging device up to 70 degrees at the same time permitting images from 360 degrees around any inspection point. A sophisticated combination of software and hardware keeps the point of interest (for instance a defective joint) in the center of the field of view while the imaging device is rotating around and examining from all directions. Additional advantages of this method are that there is no need to secure the sample (PCB, component or another device) and no risk of dropping, damage or collision during sample manipulation.

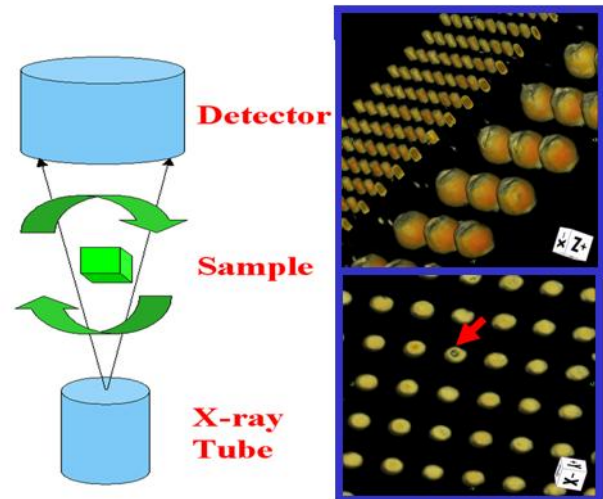
**Figure 3.** Typical layout of a CT system and an example of a CT model

The layout of a CT system is shown in Figure 3. Once the CT model has been produced, it enables ‘virtual micro-sectioning’ by allowing the operator to investigate any two-dimensional plane within the entire model as well as full, real time manipulation of the 3D model. In this way, different layers and different features within the package can be viewed whilst being isolated from other, potentially confusing, detail to enable improved analysis. This allows complete examination of features or defects within a device or package that would otherwise remain hidden by multi-level interconnections. For example, the tiny 100-micron solder bumps within the multi-layered device shown on Figure 3 would be obscured by the much larger 500-micron BGA balls.

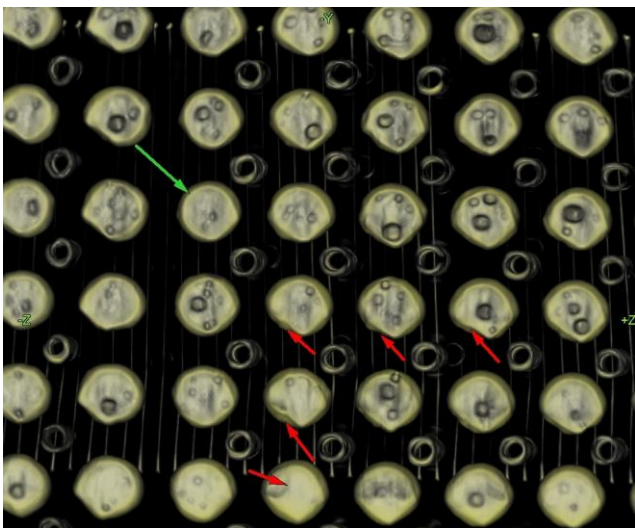
**Figure 5.** CT virtual section through the interface region of a BGA device.

The 3D CT technique permits virtual slicing or cross-sectioning through the devices revealing the exact location of the voids as seen on Figure 5.

Large amount of interfacial voiding is apparent and many BGA balls marked with red arrows are deformed/ cracked. The modern 2DX machine features automatic routines designed for precise measurement of diameter, voiding percentage, shape and area of the BGA balls. As seen in Figure 6, the BGA balls marked in red outline fail the requirement for shape or roundness, which is the first number accompanying each ball. The second number represents the total voiding percentage for each BGA ball. It is up to the operator to set up the acceptable levels and the machine will automatically flag any values which fall outside.

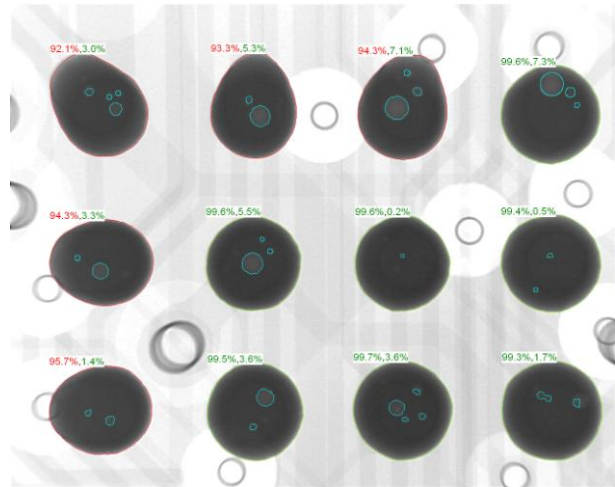
**Figure 6.** 2D X-Ray voiding and roundness calculation for a BGA device.

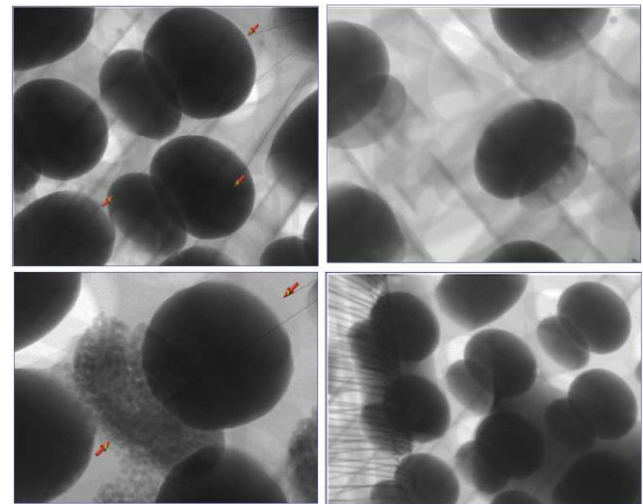
**Figure 7.** Various examples of HOP defects easily identifiable with off-axis 2D X-Ray inspection

lower performance 2D systems, they can be quickly and easily identified using modern high-performance 2D X-ray system with an oblique angle viewing (Figure 7). In addition the inspection process is completely *non-destructive*.

Figure 7 shows various examples of HOP defects. It is obvious why these defects are referred to as head-in-pillow, or better head-on-pillow. The defective BGA solder ball appears to be laying on the reflowed solder paste instead of forming a single joint after reflow. Figure 8 is a virtual CT micro-section through the BGA device revealing a 3D view of the HOP defect.

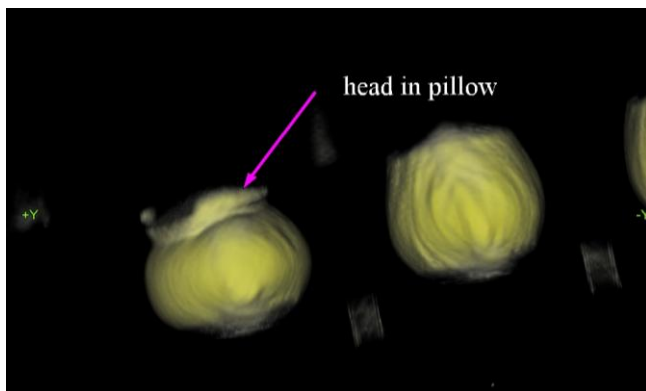
**Figure 8.** 3D CT section showing HOP defect in a BGA device

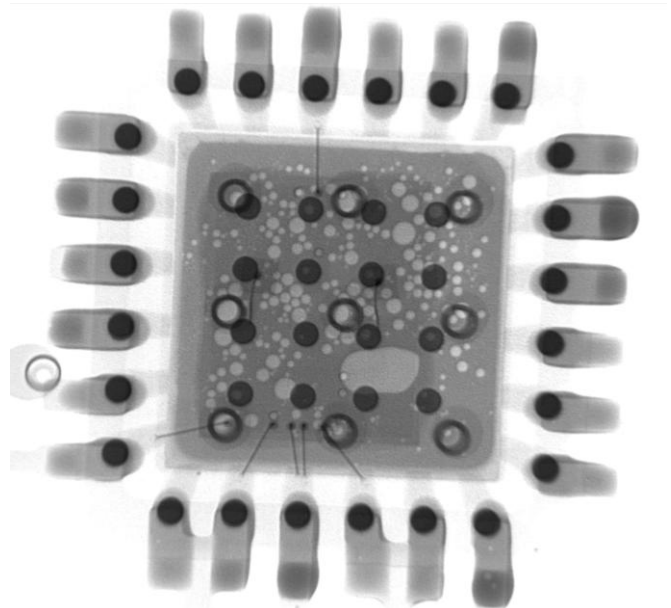
**Figure 9.** Top X-Ray view of QFN package

As shown on Figure 9, the package terminations are all located under the device. This makes the traditional Automatic Optical Inspection not practical. As with the BGA devices, cross section followed by SEM or optical evaluation is an alternative, but the method is destructive and permanently damages the device and PCB.

It is important to point out that in addition to the quality of the side connection, the voiding within the central large pad is also crucial in some cases when large amounts of heat need to be transferred out of the device in order to prevent overheating. The example (Figure 9) shows significant

voiding in the central area which would be a concern or reason for rejection in a high-power application.

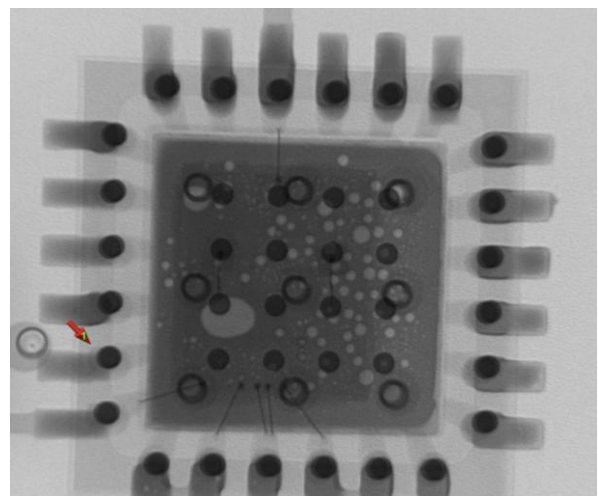
**Figure 10.** Top X-Ray view of LGA package. Suspected pin pointed by arrow.

Figure 10 shows a low magnification image of a QFN package with a red arrow pointing out to a suspect pin. Because of the high resolution and contrast sensitivity of the X-Ray system, a possible defect is apparent even at this low magnification image.

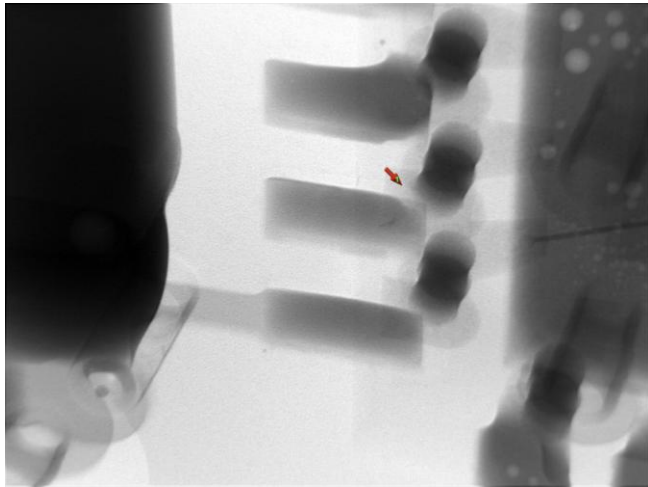
**Figure 11.** Higher magnification oblique angle view of defective pins from Figure 10.

Using oblique view and higher magnification one can study the open pins in detail as shown in Figure 11. However, even a low magnification oblique view is sufficient to confirm the defect as seen in Figure 12.

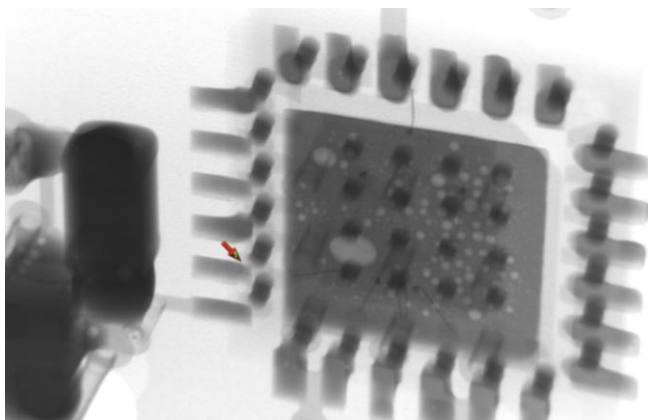
**Figure 12.** Low magnification oblique X-Ray image showing defective (open) pins in QFN device.

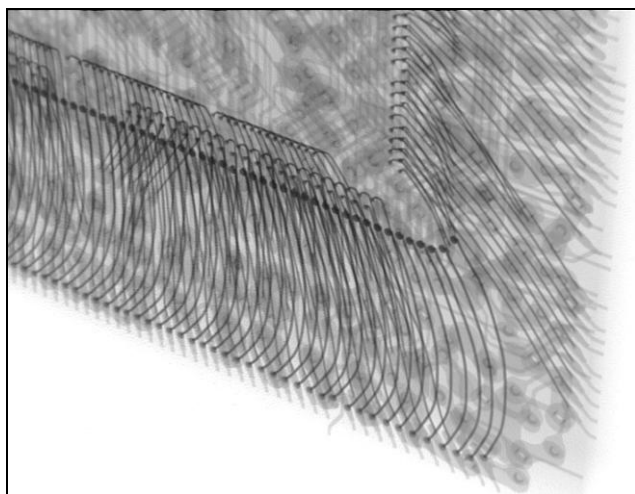
**Figure 14.** 2D X-ray oblique view of stacked device.

As seen on the 2D X-Ray image in Figure 14, the two wire bonding layers of this stacked device cannot be easily separated for analysis looking for shorted or open connections.

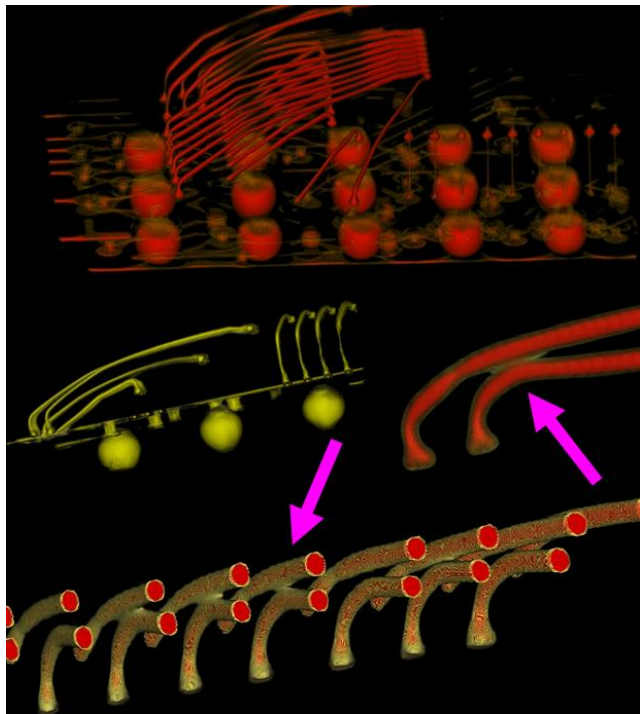
**Figure 15.** CT images of stacked devices showing shorted bond wires.

Figure 15 is a combination of CT images showing various stacked devices. The CT technique permits the operator to isolate the area of interest and carefully examine for potential failures using virtual micro-sectioning. As seen on Figure 15 the shorted wires are easily identified using CT and this cannot be easily and reliably accomplished using 2D methods.

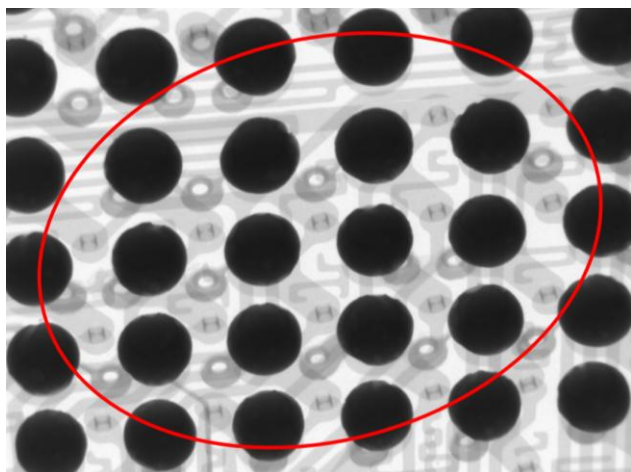
**Figure 16.** 2D X-Ray image of an area containing suspect shorted vias in a 3D package

The examined 3D device has shorted vias in the region covered by the 2D X-Ray image on Figure 16. Clearly identifying the defect is quite difficult due to the complexity of the 2D X-Ray image. The CT model of the same package is shown on Figure 17. The CT model is also quite complicated, but once the micro-sectioning capability is engaged the shorted vias pop up easily detected -- see inset of Figure 17 representing a virtual micro-section through the CT model.

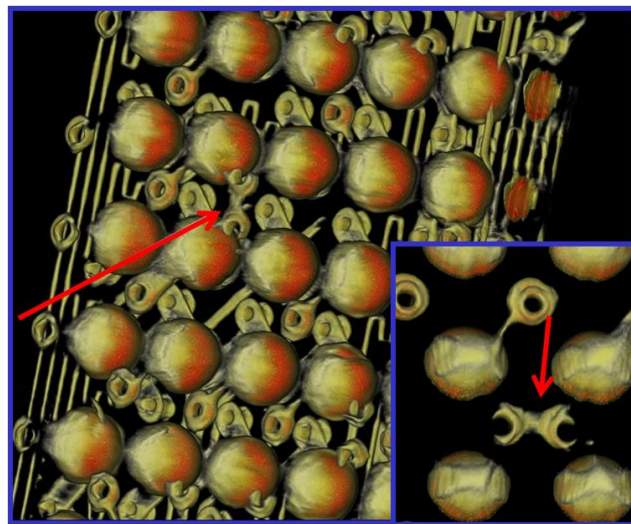
**Figure 17.** CT model of the 3D device shown on Figure 16. The inset is a virtual cross-section easily detecting the two shorted vias.

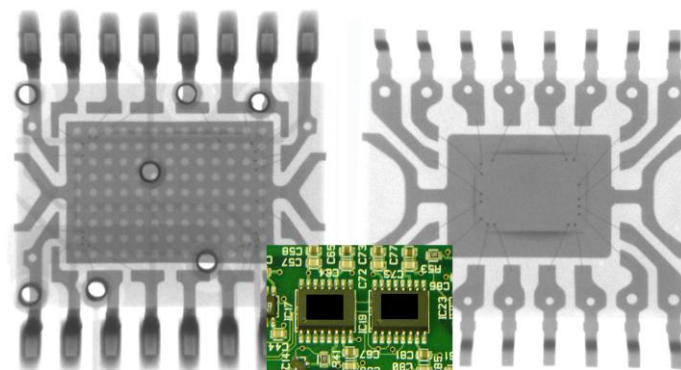
**Figure 18.** 2D X-Ray image revealing big differences between components looking similar optically, thus easily identifying the counterfeit.

As shown in Figure 18, the real and fake components might look very similar optically, but an X-Ray image reveals big differences. The modern 2D X-Ray inspection provides a fast and effective method to identify counterfeit components. Being *non-destructive* and offering high magnification, resolution and contrast sensitivity it makes it easy and straightforward for the operator to identify the fake components by observing die placement, internal wiring and comparing to known good samples.
