# CONFORMAL COATING OVER NO CLEAN FLUX RESIDUES PART II

Timothy O'Neill, Technical Marketing Manager  
AIM  
Cranston, RI, USA  
toneill@aimsolder.com

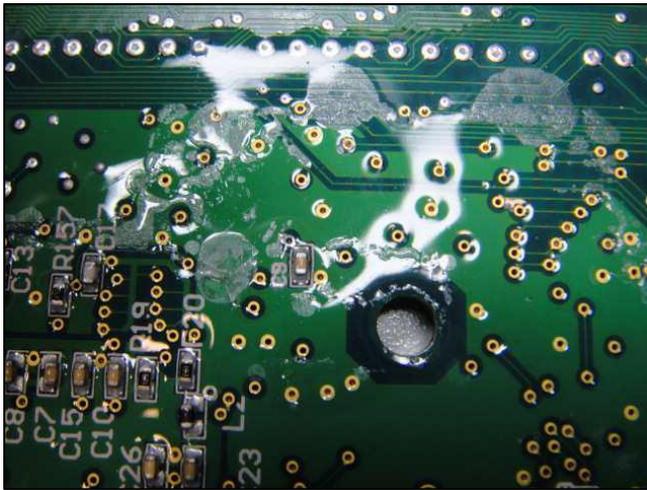
**Figure 1.** Blisters immediately appeared with this combination of flux and coating.

The first level of establishing compatibility is a simple visual inspection of the test sample after application of the coating. There were circumstances where a combination that was clearly incompatible and was evident while applying the coating. No clean liquid fluxes may contain surfactants to reduce the surface tension of the flux to improve wetting and flow characteristics during the fluxing process. These same surfactants can inhibit a coatings flow and wetting properties. These interactions would lead to an immediate and easily observed de-wetting, 'orange peeling' or measles of the coating. These samples were eliminated if this condition was observed.

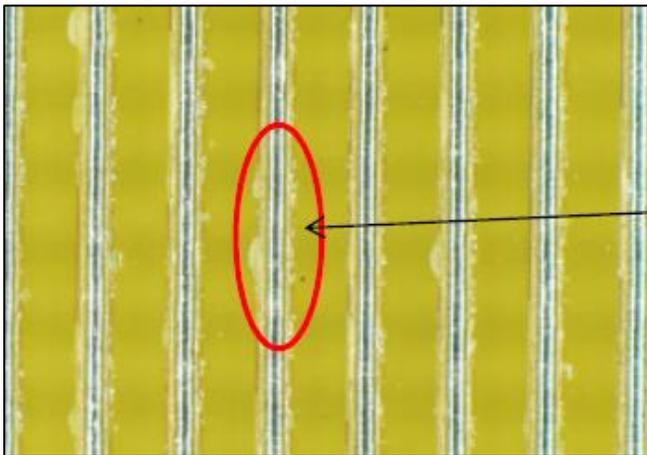
**Figure 2.** Post-cure example of imminent adhesion failure

If a material set passed the first test, the second portion of the visual test was to cure the material and inspect for any evidence of delamination of the coating from the fluxed area of the coupon. As we gained experience inspecting materials, it became possible to determine that a set would likely not pass post thermal shock tests. These coupons were subjected to tape adhesion testing per IPC-CC 830/IPC 650 2.4.28.1 and ASTM-3359 prior to T-Shock rather than post T-Shock.

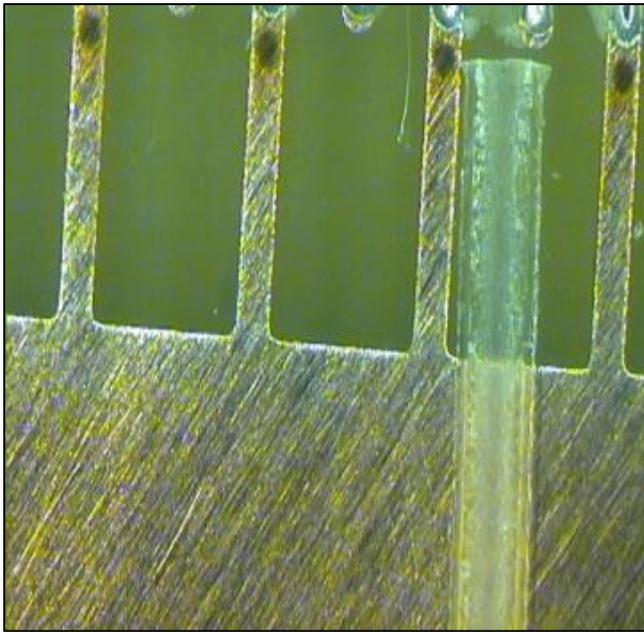
**Figure 3. Coating with flux residue still adhered post T-Shock**

Below is an example of the failure mode. The coating remains a contiguous sheet, but adhesion has failed at the interface of the flux residue and the coating. Upon inspection, the flux residue is still adhered to both the board and the coating, but had suffered a cohesive failure and disintegrated, leading to a delamination condition. Fig.3-4

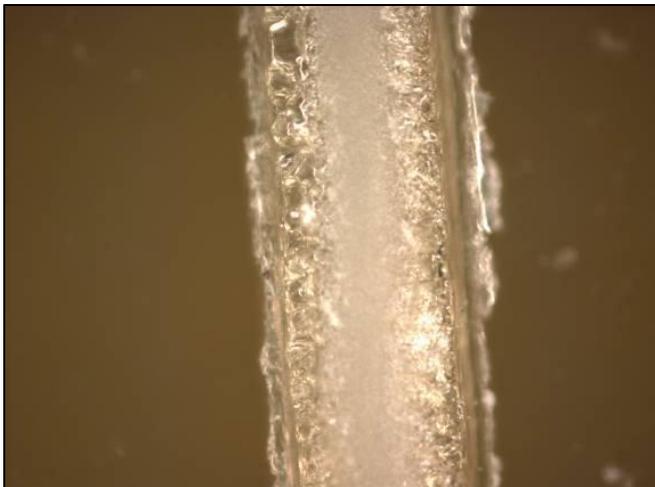
**Figure 4. Close up of flux residue on conformal coating**

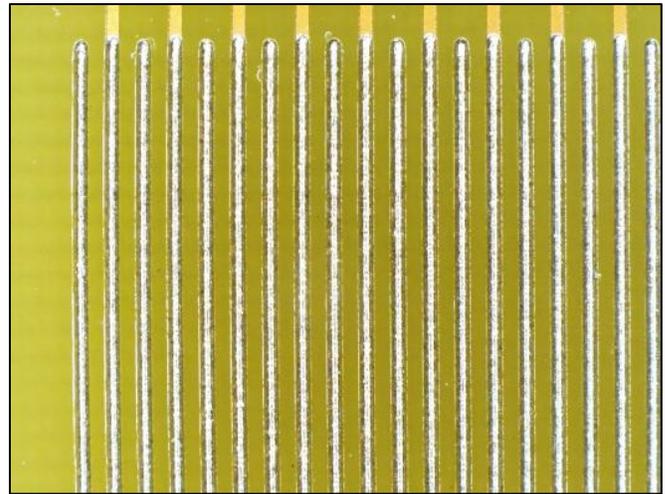
**Figure 5. Resin-free paste + coating pre-T-Shock**

To further prove the theory that modulus of the materials and CTE mismatches were the root cause of the failure, we delved in to the basic chemistry of the solder paste. No clean solder paste flux chemistry consists of 3 primary components, a suite of activators in a resin base combined with various stabilizers, solvents and rheological additives. AIM had developed a resin free no clean solder paste for a very specific customer requirement. With resin omitted from the formula, it would validate the assumption that the resin component of solder paste was leading to the hardening, fracture and disintegration of the solder paste under the conformal coating as the flux medium is roughly fifty percent resin prior to reflow. Samples were prepared and coated with a urethane acrylate UV cure coating and subjected to -65+125C T-Shock.

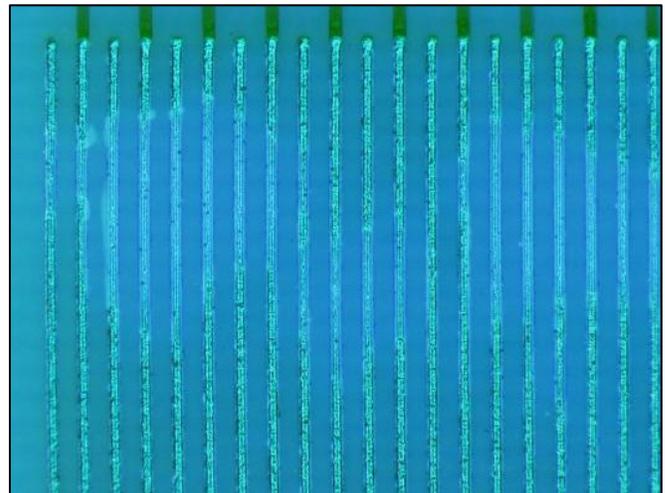
**Figure 6. Resin-free paste + coating post-T-Shock**

Careful examination of the fluxed area in Fig. 6 revealed some areas of concern as evidenced by the image under UV inspection. Re-inspection of coupons not subjected to T-Shock revealed the issue was evident, indicating a wetting issue with the coating over the flux residue and was not related to T-Shock. What was noteworthy was the fracturing condition was not observed, further implicating the resin component of the solder paste residue as cause for failure.

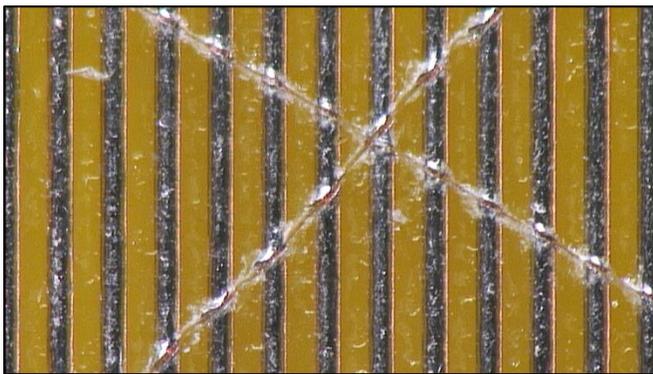
**Figure 7. Moisture cure silicone post T-Shock passed adhesion testing**

As seen in Fig.7, the silicone conformal coating alleviated the T-Shock failures associated with the harder acrylic and urethane materials.

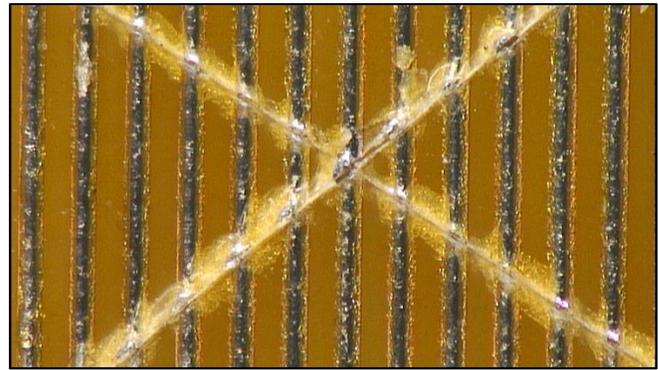
**Figure 8. Low modulus, urethane acrylate based, UV cure post T-Shock – Passes adhesion testing**

During the course of our investigation, coating manufacturers involved in the study recognized the need for a product that had the positive attributes of the urethane acrylates but a lower modulus to improve performance at low temperature. As a result, new materials became available that were included in the study to determine their characteristics in comparison to the materials already tested. We also consider this a final data point in determining the fact that the modulus of the coating in relation to the flux residue was the root cause of the adhesion failure.

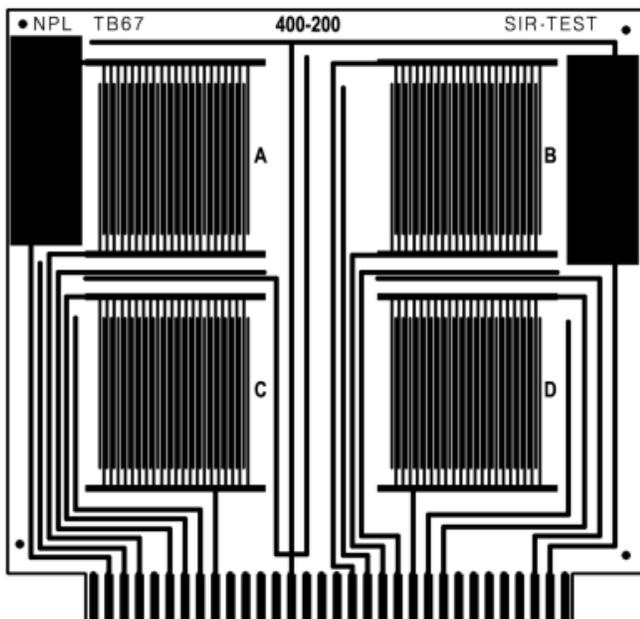
Figure 9. B24 SIR Test Coupon

The SIR test consists of a test coupon (IPC B-24) with a pattern of traces with very precise spacing called a comb pattern. (Fig. 9) Samples of the flux are applied to the comb pattern per the J-Std. requirements and subjected to conditions (40°C 90%Rh 10V Bias) that encourage the growth of metallic dendrites and corrosion. Precise measurements of the electrical current that passes between the ‘tines’ of the comb at prescribed intervals and these measurements are recorded as Ohms ( $\Omega$ ). A failure is any reading that falls below  $1 \times 10^8 \Omega$ .

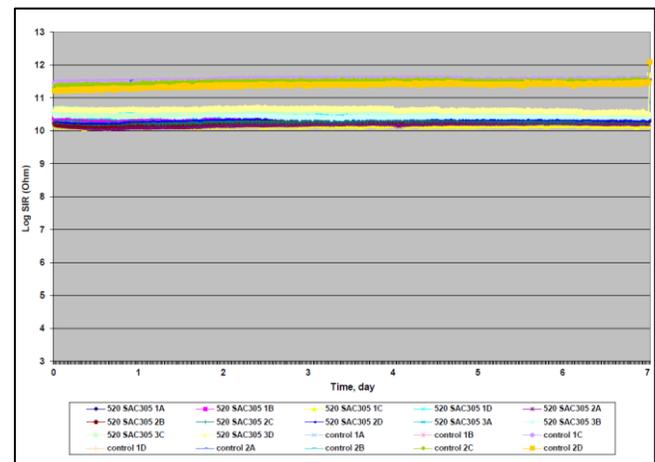
Figure 10. AIM NC Solder Paste SAC305 SIR Test Results

- AIM NC SAC305 Solder Paste (Fig.10)
- AIM NC IPA-Based Liquid Flux (Fig.11)
- AIM NC Water Based VOC-Free Liquid Flux (Fig.12)

The keen observer will note that the SIR results of solder paste, opposed to liquid flux are considerably higher at the outset and remain so throughout the test. This is due to an inherent difference between the products. As mentioned previously, solder paste formulations consist of a significant amount of resin/rosin. These materials are used because when they are heated in the reflow process they become ‘active’ and aid in reducing the oxides and removing contamination from the solderable surfaces. When they cool, they become inert. They also serve to contain other activator components within their chemical matrix. Conversely, low solids liquid fluxes contain very little or no resin/rosin and rely on oxidation and decomposition of the flux activators during processing to render them inert. Without the resin/rosin component, they will exhibit lower initial SIR values which tend to rise (improve) as the flux oxidizes and decomposes in to more benign substances.

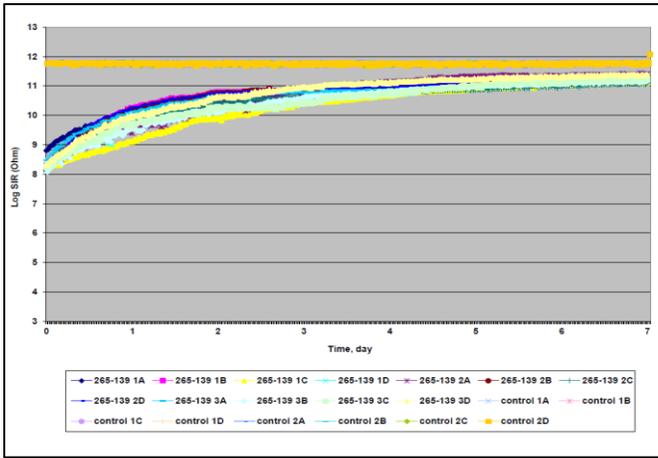
**Figure 11.** AIM IPA-Based NC Liquid Flux SIR Test Results

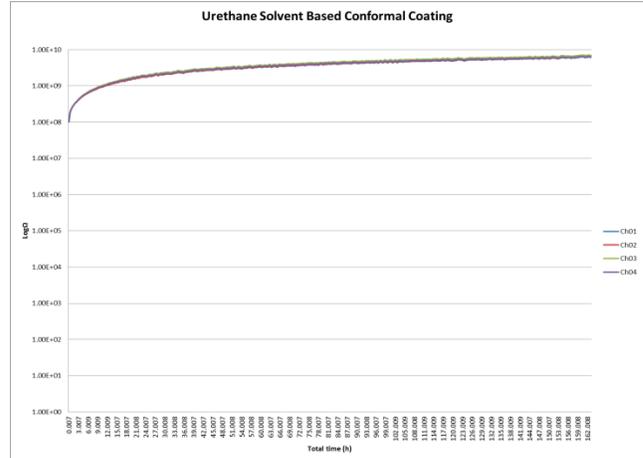
**Figure 13.** Urethane Solvent Based Conformal Coating SIR Test Results

The coatings that were tested represent the most commonly used materials, acrylic, urethane and acrylate-urethane UV curable coatings. Below are examples of SIR data for these materials on cleaned samples with no flux residues.

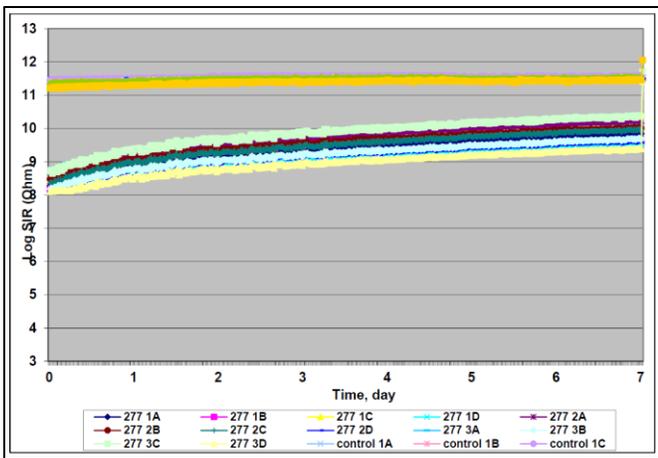
**Figure 12.** AIM Water Based VOC-Free NC Liquid Flux SIR Test Results

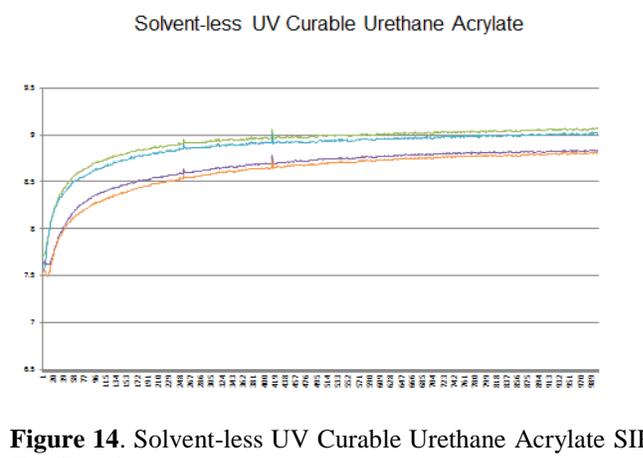
**Figure 14.** Solvent-less UV Curable Urethane Acrylate SIR Test Results

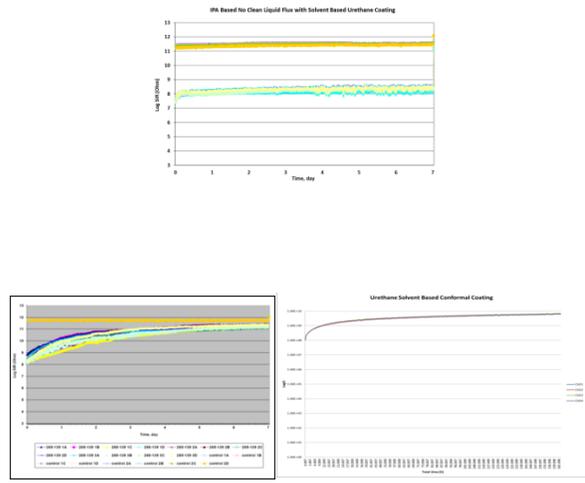
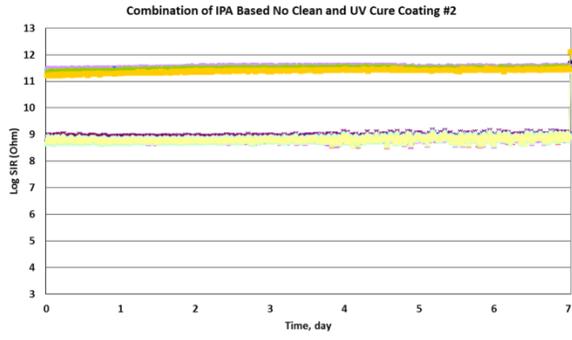
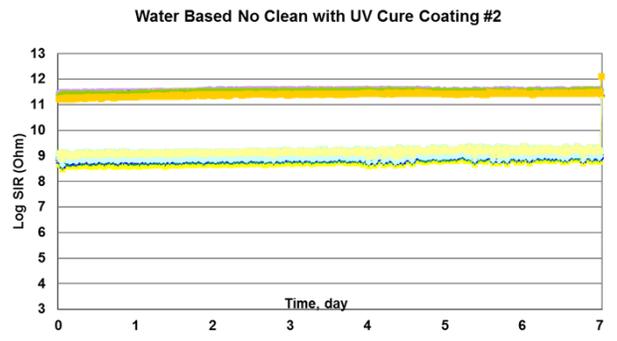
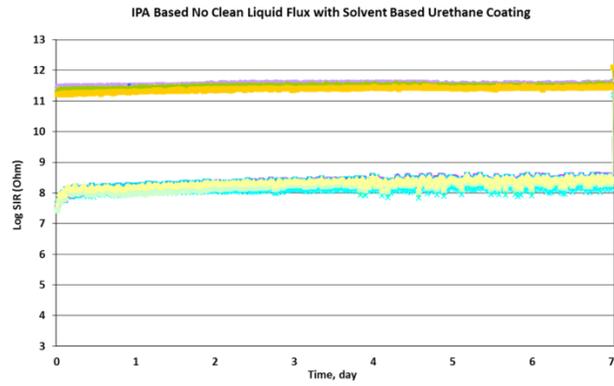
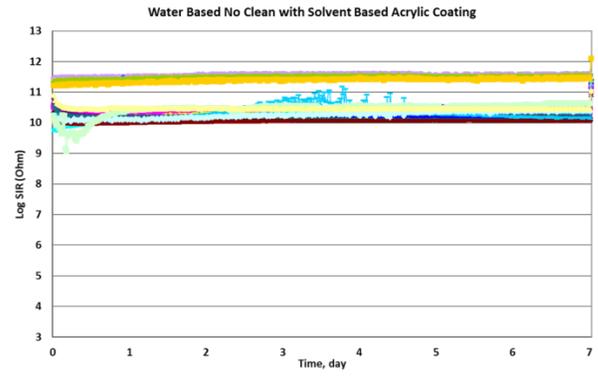
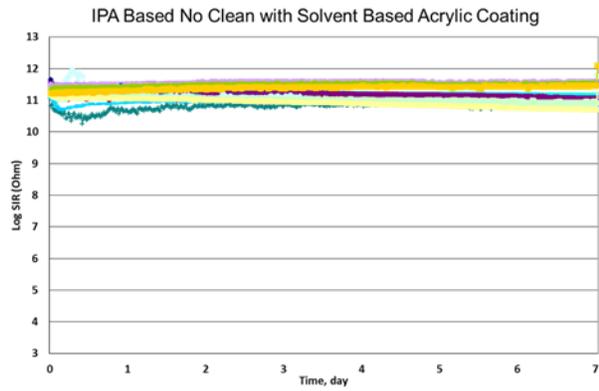
All of the material sets pass SIR testing individually. The results below indicate how resistivity is affected when the materials are tested in combination.
