# THE EFFECT OF VACUUM REFLOW PROCESSING ON SOLDER JOINT VOIDING AND THERMAL FATIGUE RELIABILITY

## ABSTRACT

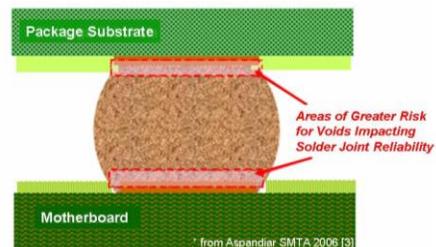
Figure 2a. Locations within a BGA solder joint where voids are expected to have a greater risk on joint reliability [3].

be differentiated with respect to how they are formed, where they reside in the solder joint and how they affect the reliability of the solder joint. Aspandiar further argues that during various types of stress testing such as temperature cycling, or mechanical shock and bending, cracks are more prone to initiate and propagate through these near-interfacial regions than in proximity to the geometric center of the solder joint. This hypothesis is illustrated in Figure 2a and Figure 2b.

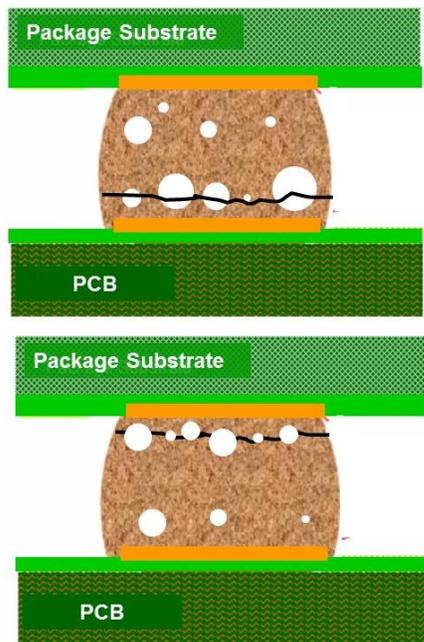
**Figure 2b.** Illustrations of void-assisted cracking at the PCB side (above) and package side (below) of the solder joints.

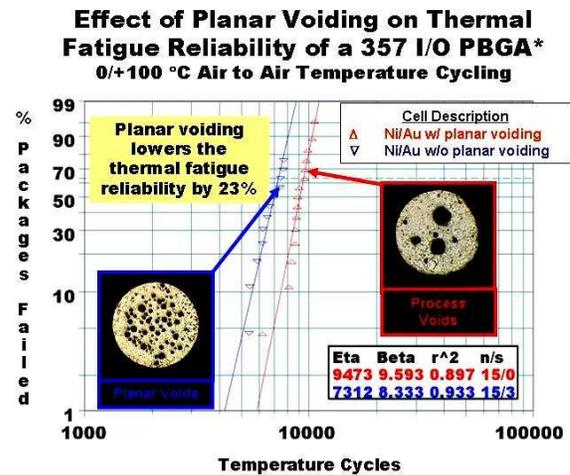
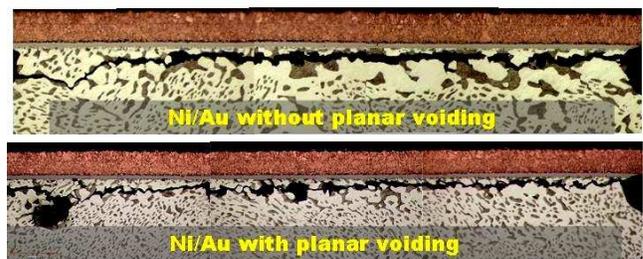
\* adapted from Coyle et al IEEE Trans. CPMT 2003 [5]

**Figure 3.** The Weibull plot illustrates the influence of planar microvoiding on thermal fatigue reliability. The imbedded planar or flat section photomicrographs show the reduction in solder joint attachment area caused by planar voiding. The lower photomicrographs are fatigue failures that show that the planar microvoiding is not always obvious in orthogonal cross sections [9].

A specific type of voiding called planar microvoiding has been shown to lower reliability either by effectively reducing the attachment area or by weakening the solder in regions of the solder joint where cracks tend to propagate [9]. This effect is illustrated by the Weibull plot in Figure 3, in which planar microvoiding reduces the characteristic lifetime  $\eta$  (thermal fatigue reliability) by 23%. The photomicrographs taken from orthogonal cross sections of failed thermal cycling samples show that microvoiding and its effects on crack propagation are not always evident or easy to detect using standard failure analysis techniques. A similar effect due to planar voiding was reported for mechanical reliability testing performed by Mukadam et al [10]. Planar microvoiding however, is a specialized case of voiding most often associated with surface finish issues or surface contamination.

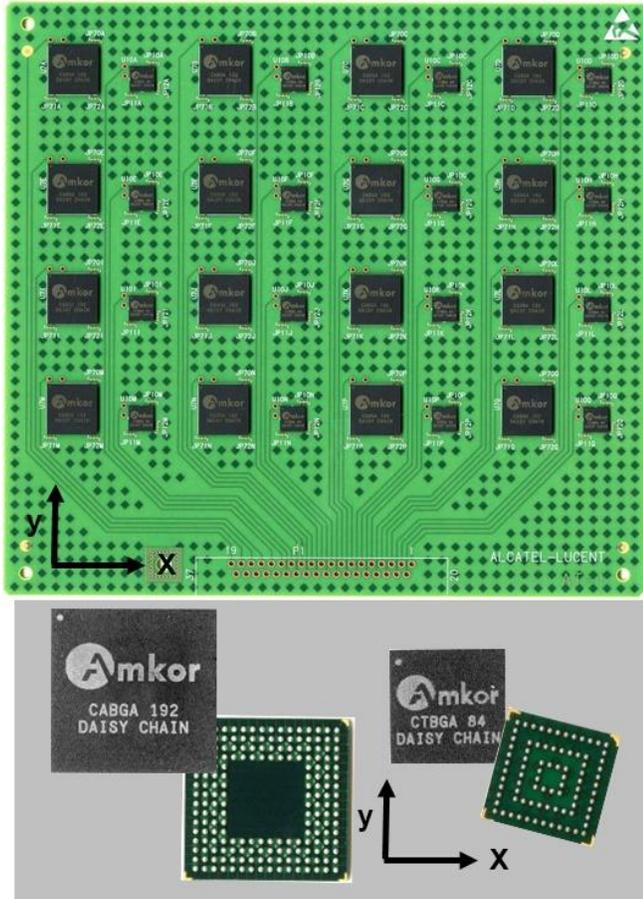
**Figure 4.** A populated printed circuit board test vehicle.

The printed circuit board (PCB) test vehicle and components, shown in Figure 4, was developed originally for the iNEMI Alloy Alternatives study [19].

The test boards were populated with daisy-chained 192CABGA and 84CTBGA packages fabricated with Pb-free solder spheres. The printed circuit board (PCB) test vehicle is 2.36 mm (93 mils) thick, with a 6 layer construction and 16 sites each for the 192CABGA and 84CTBGA. The test boards were fabricated with Panasonic R-1755V high temperature PCB laminate and Entek HT Plus organic solderability preservative (OSP) final finish. The component and PCB attributes are shown in Table 1.

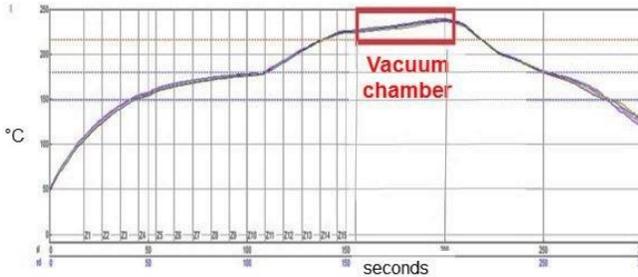
**Figure 5.** Vacuum reflow profile used in the re-assembly process. The total time in the vacuum chamber, outlined by the red rectangle, is 60 seconds. The vacuum dwell time at 10 torr is 20 seconds.

The vacuum reflow profile for the re-assembly process is shown in Figure 5. The red rectangle denotes the total time the substrates were in the vacuum chamber, which is approximately 60 seconds. This total time includes transport of the test vehicles in and out of the vacuum chamber as well as pump down, refill and dwell times. The pump down time is 8 seconds, the dwell time at 10 torr vacuum is 20 seconds, and the refill time is approximately 5 seconds. The peak temperature in the reflow profile is achieved while the substrates are in the vacuum chamber under IR Panel heating.

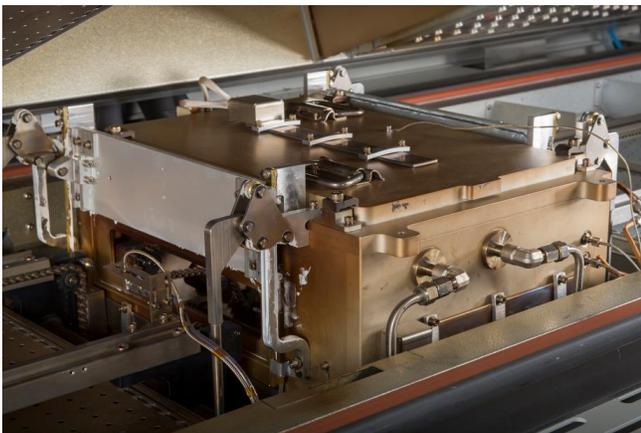
**Figure 6.** Vacuum reflow chamber shown within the convection reflow oven.

The vacuum chamber located within the convection reflow oven is shown in Figure 6 with the vacuum doors open, ready to receive a substrate.

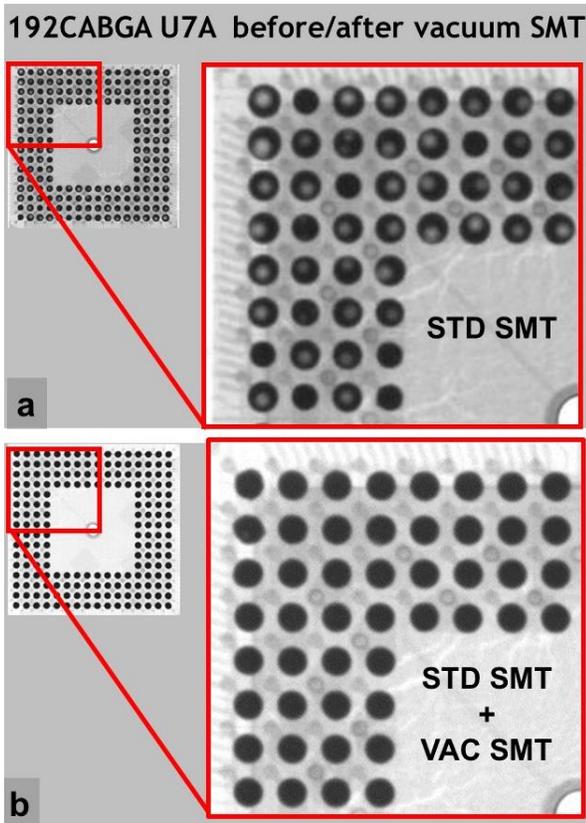
**Figure 7.** Transmission x-ray images of a) a typical heavily voided 192CABGA after SMT assembly and b) the same 192CABGA with solder voiding eliminated by subsequent vacuum reflow processing.

The factory x-ray inspection on the conventional or standard SMT (STD SMT) reflow assembly revealed substantial void content in the BGA solder joints of both components. The x-ray images in Figure 7a (192CABGA) and Figure 8a (84CTBGA) are typical of the extent and size of the solder voids. Note that the largest voids result in a noticeable increase in the diameter of the solidified solder spheres.

Half of the population of voided test vehicles was subjected to secondary assembly using vacuum reflow processing to reduce the voiding. The x-ray images in Figure 7b (192CABGA) and Figure 8b (84CTBGA) show the resultant solder joint quality after vacuum reflow. In the expanded x-ray images (identified as STD SMT + VAC SMT), there is no indication of solder voiding in either component after vacuum reflow processing.

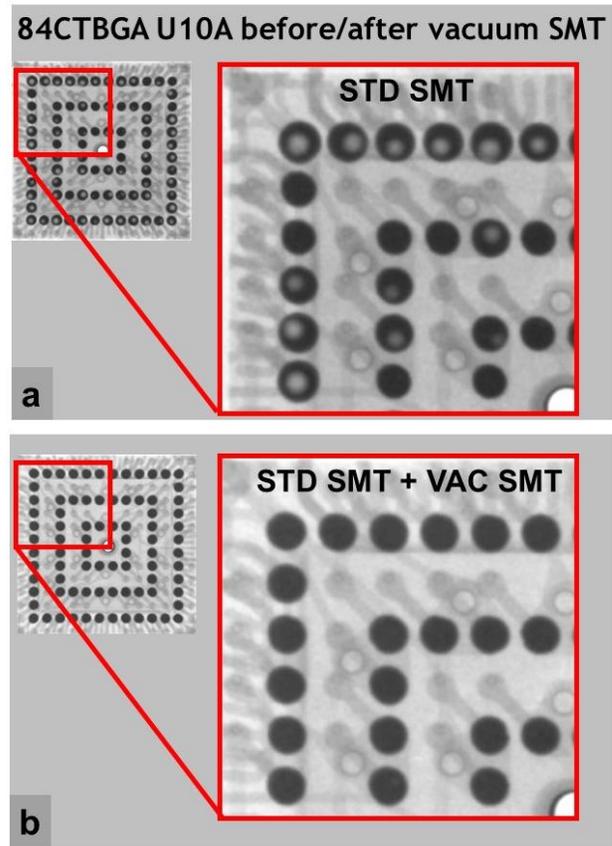
**Figure 8.** Transmission x-ray images of a) a typical heavily voided 84CTBGA after SMT assembly and b) the same 84CTBGA with solder voiding eliminated by subsequent vacuum reflow processing.

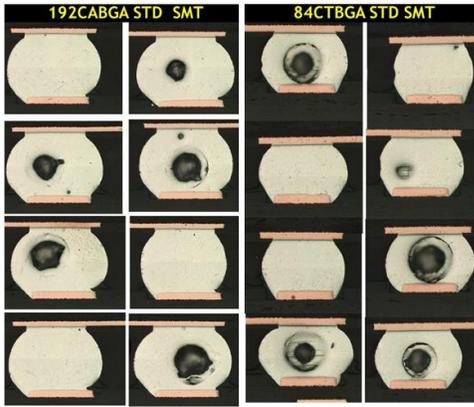
**Figure 9.** Optical photomicrographs showing a variety of solder joint voids and void locations in the 192CABGA and 84CTBGA components. Note, the voids in some solder joints are located near a soldered interface where fatigue cracks propagate (shown schematically in Figure 2b), thereby increasing the risk of earlier failure in thermal cycling.

Cross sectional views of the voiding are shown in the optical photomicrographs in Figure 9. Many of the voids observed in the cross-sectional analysis exceed the IPC-JSTD-001 BGA maximum void criteria of 30% of the X-ray image area [23]. This observation is supported qualitatively by the noticeable increase in the diameter of the solidified solder spheres shown in the x-ray images in Figure 7.

In comparison to the planar x-ray images in Figures 8 and 9, cross sectional images can show the position of the void relative to the soldered interfaces where fatigue cracks are expected to propagate (see Figure 2). Because the voiding is not always centered in the solder sphere or on the pads (see x-ray images), cross sectional images may not represent the size of the voids accurately. In the worst case, an offset void may not appear at all in a cross sectional image. However, some of the images in Figure 9 illustrate the risk of void location at a soldered interface, thereby increasing the risk of earlier failure in thermal cycling. For failure analysis, cross sectional images can be used to complement the x-ray images, but destructive cross sectioning obviously cannot be used to characterize samples before they are placed into thermal cycling.

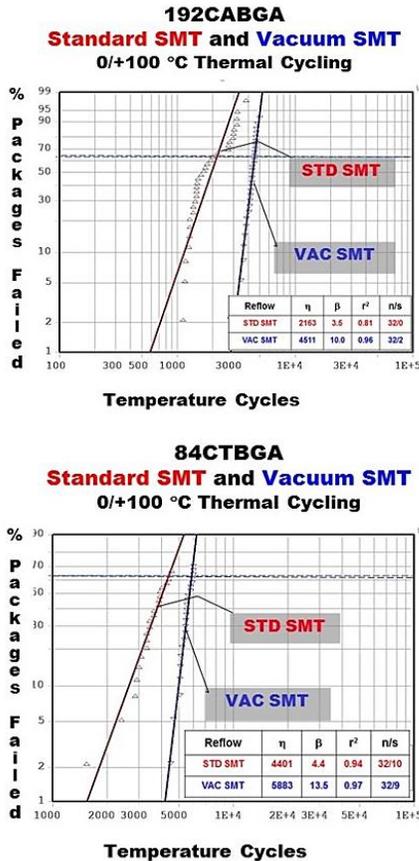
**Figure 10.** The Weibull distribution plots for the 192CABGA and 84CTBGA packages from the 0/100 °C thermal cycling showing the improved reliability after eliminating voiding with vacuum SMT processing.

Figure 10 and Figure 11 are Weibull distribution plots from the 0/100 °C and -55/125 °C thermal cycling tests respectively. Table 6 provides a summary of the Weibull statistics for those two tests.

The thermal cycling results show a clear improvement in characteristic lifetime (reliability) and Weibull slope (data quality) with vacuum processing. Although BGA solder joint voiding very often does not present an attachment reliability

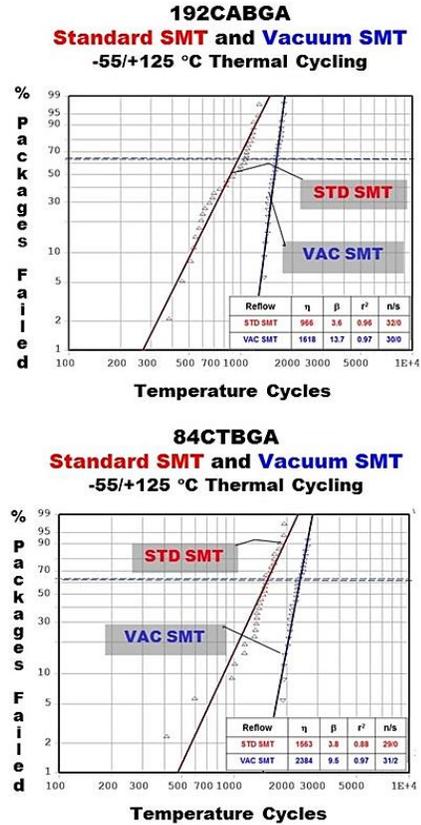
**Figure 11.** The Weibull distribution plots for the 192CABGA and 84CTBGA packages from the -55/125 °C thermal cycling showing the improved reliability after eliminating voiding with vacuum SMT processing.

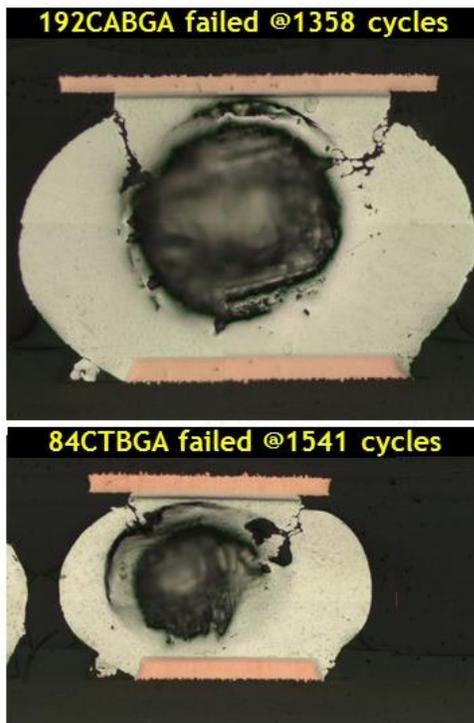
**Figure 12.** Optical photomicrographs showing void-assisted solder joint failures after in 0/100 °C thermal cycling for the 192CABGA and 84CTBGA (STD SMT).

The -55/125 °C thermal cycling test started substantially after the 0/100 °C test, and only samples from the 0/100 °C cycle were available for failure analysis at the time of this writing. Examples of void-assisted solder joint failures from the TC1 0/100 °C thermal cycling test are shown in the optical photomicrographs in Figure 12. The large solder voids reduce the effective attachment area through which the crack propagates, thereby reducing the number of cycles to failure. The failure mode remains solder fatigue, and the reduction in fatigue life is attributed to the geometric effect of reducing the crack path. These samples are two of the earliest failures in the 0/100 °C thermal cycling test, and it certainly is reasonable to assume that the earlier failure is related to the immense size of the voids.

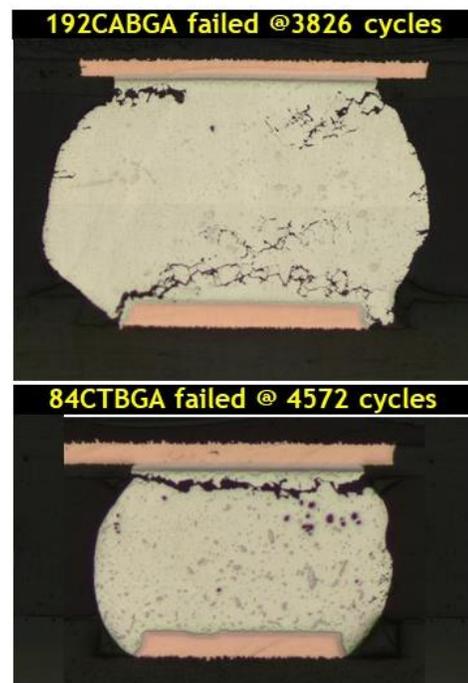
**Figure 13.** Optical photomicrographs showing solder joint fatigue failures in the 192CABGA and 84CTBGA packages. The thermal cycling profile was 0/100 °C.

The optical photomicrographs in Figure 13 show examples of solder joint failures (0/100 °C thermal cycling) in samples that were vacuum processed. These images show bulk solder cracking characteristic of thermal fatigue in SAC alloys. In the 192CABGA package, the failures occur mostly at the PCB side of the solder joints, with some fatigue crack initiation is found at the package side. Although package-side solder joint failures are typical in BGA thermal cycling experiments, PCB-side failures are known to occur with this

192CABGA package [24]. The fatigue failures in the 84CTBGA package are found in the bulk solder at the package-side location more typical for BGA fatigue cracking.
